VOLUME 2: EXISTING CONDITIONS

aloha stadium PLANNING STUDY FINAL REPORT - 12.22.05

SECTION II: CONDITION SURVEY

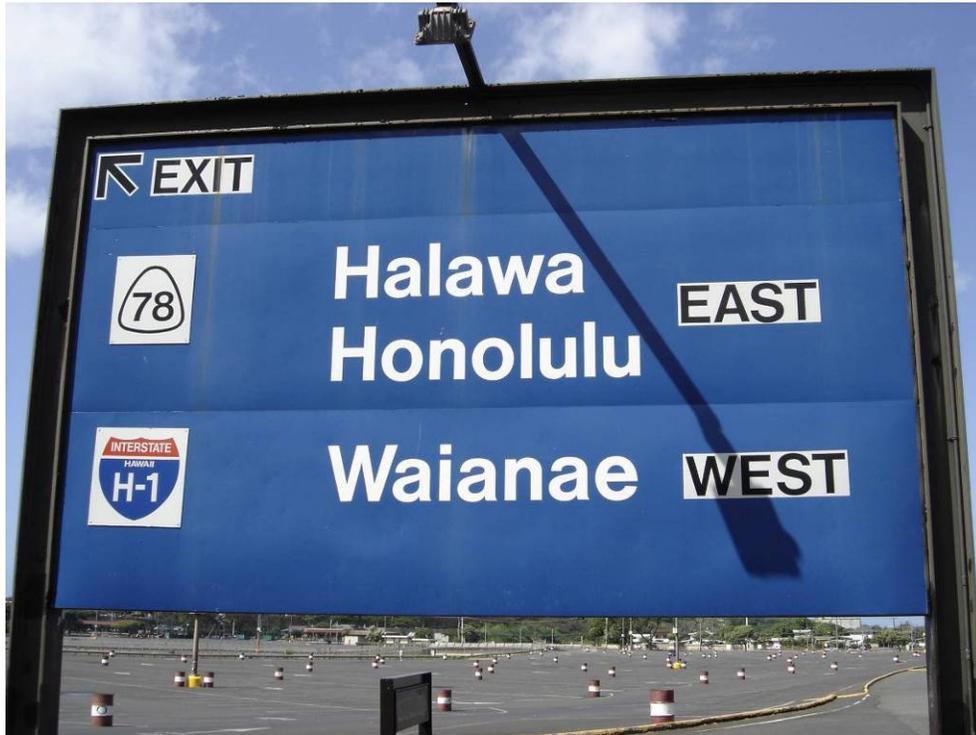
- A5. Exit sign from stadium area is rusting along with the support structure. Recommend a regularly scheduled maintenance program to address the painting of signs and support structures.

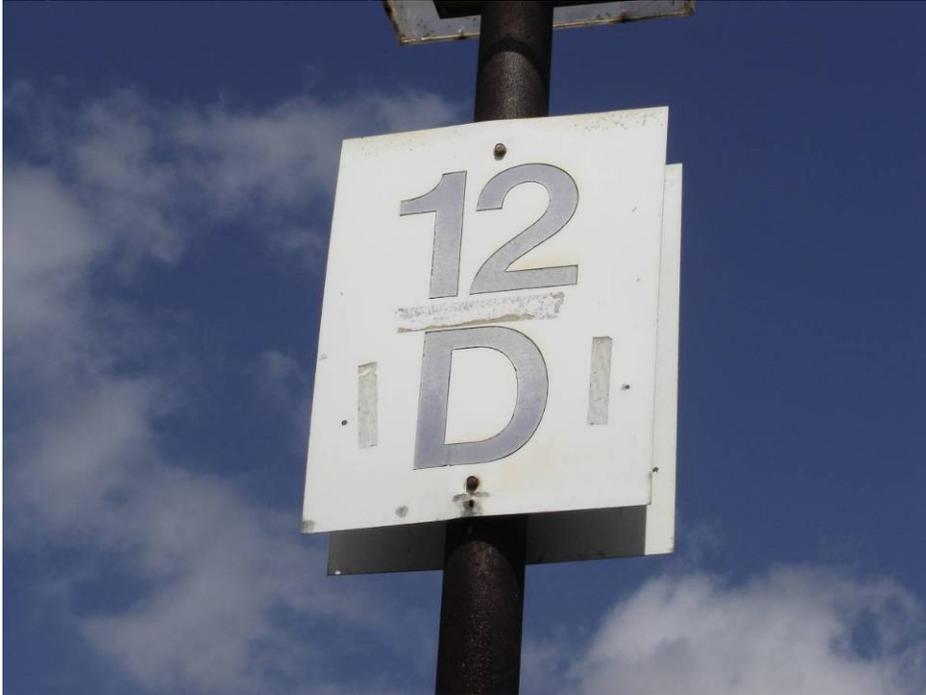
- A10. Sign at Gate 2 is bent and in need of repair. Recommend replacing sign as part of overall site signage refurbishment.

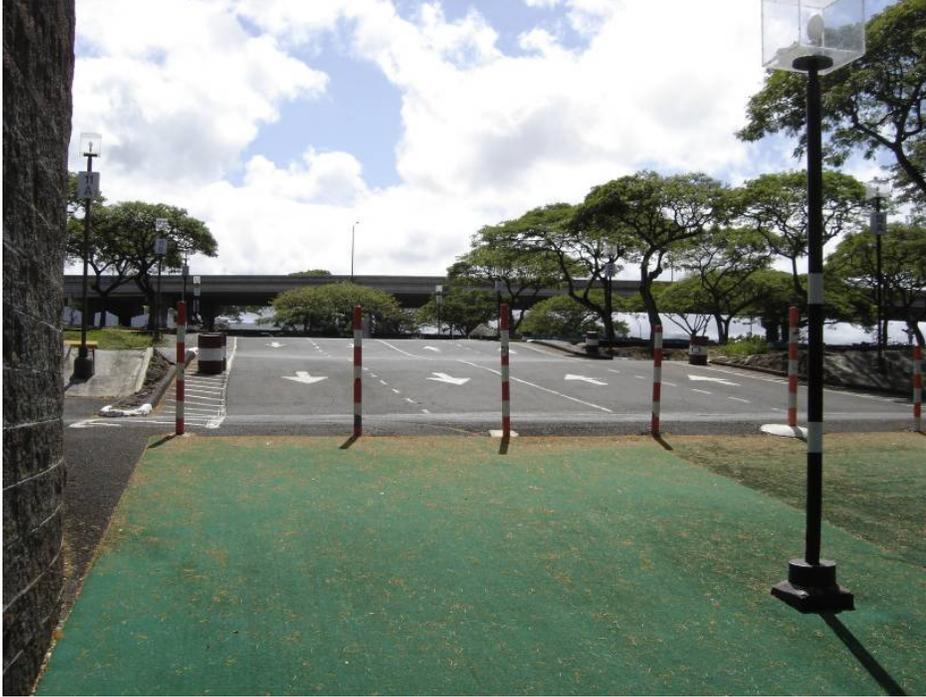
- A12. Gate 6 vehicle intrusion protection. Recommend larger concrete bollards at entry points.

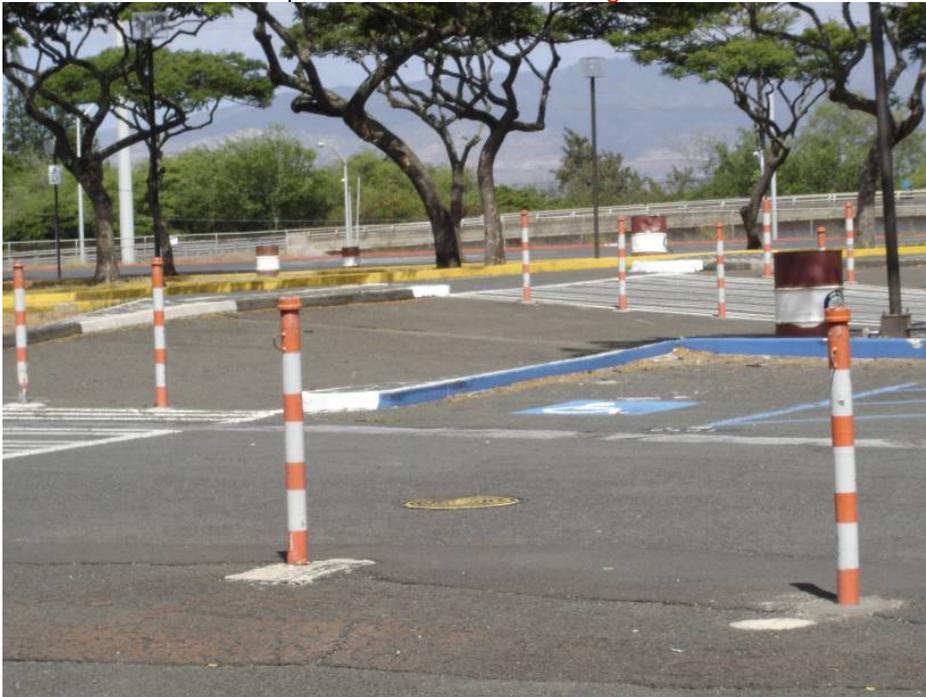
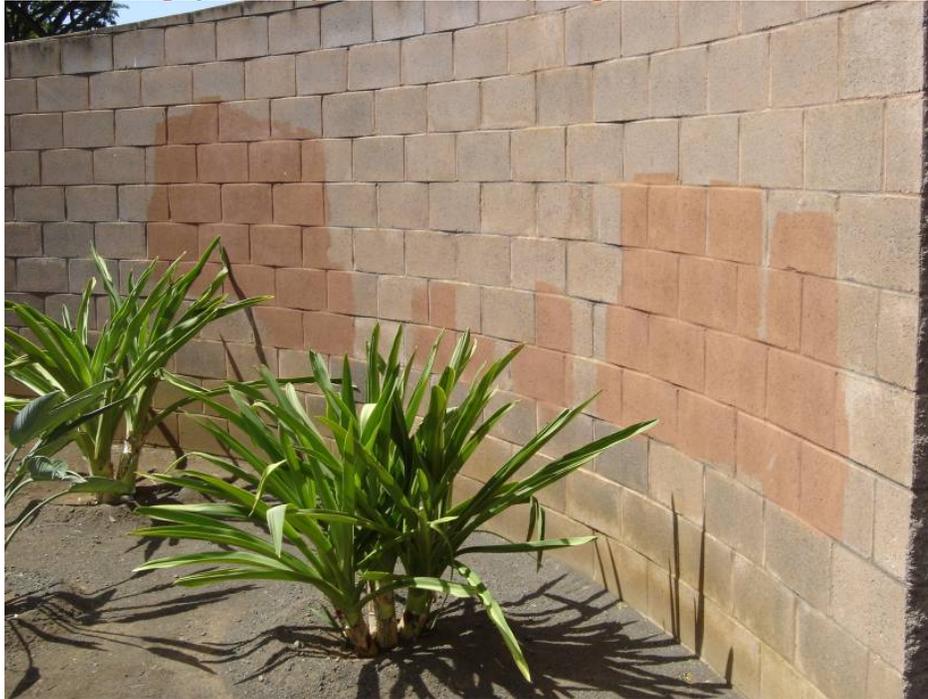
- A13. The block wall to the outside Gate 5 is discolored, probably by water from irrigation system. The wall also shows signs of efflorescence. **Recommend cleaning and sealing the entire wall. A coating system may also be worth exploring for all stained walls.**

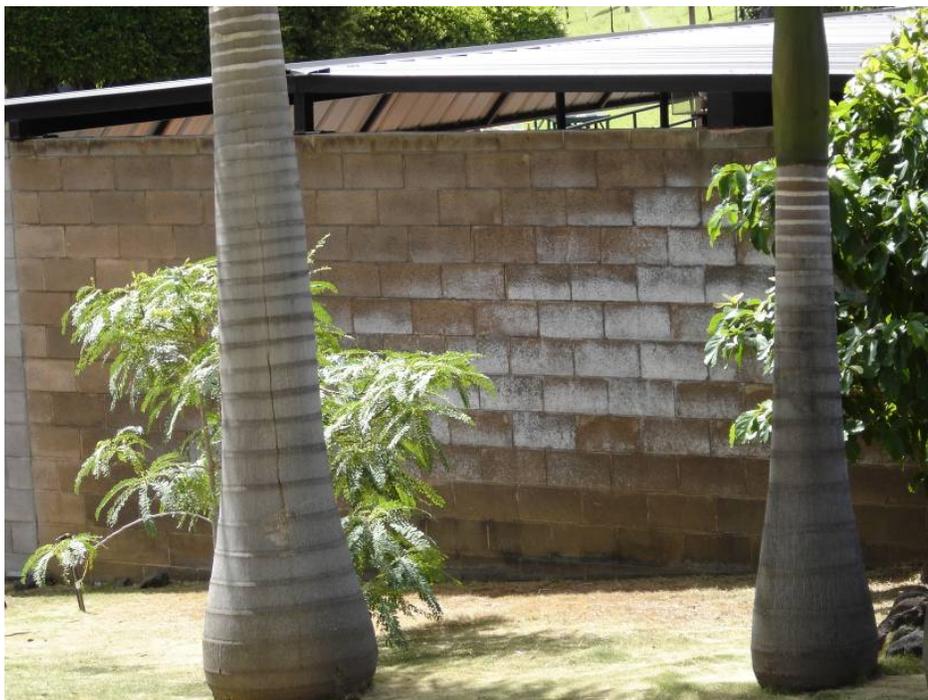
A13. Wall next to Gate 4 shows signs of rust.

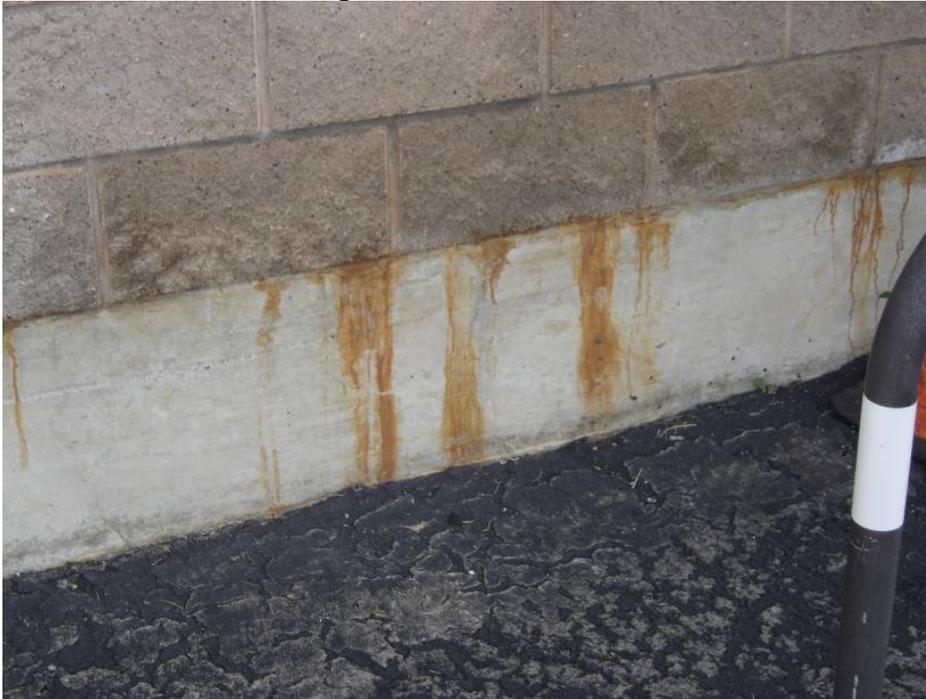
A13. Between Gates 6 and 7 it appears that somebody has tried clean the block wall. Recommend sandblasting or power washing the entire wall followed by application of a sealer.

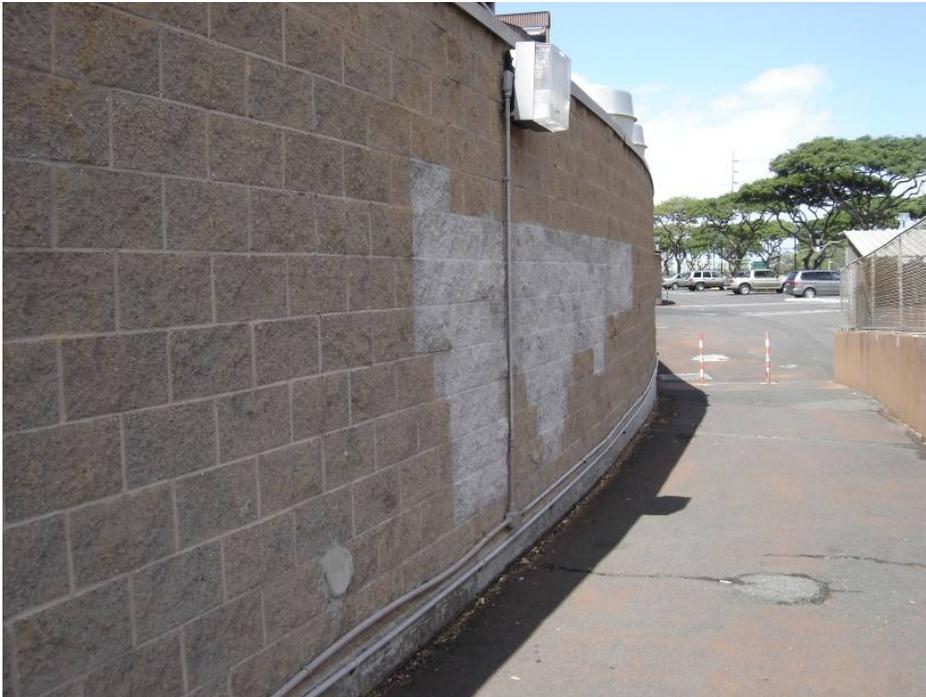
- A13. Outside Gate 8 again the wall on the back side it appears the wall has been painted to cover staining from efflorescence. **Recommend painting the entire wall although it may not prevent efflorescence from continuing.**

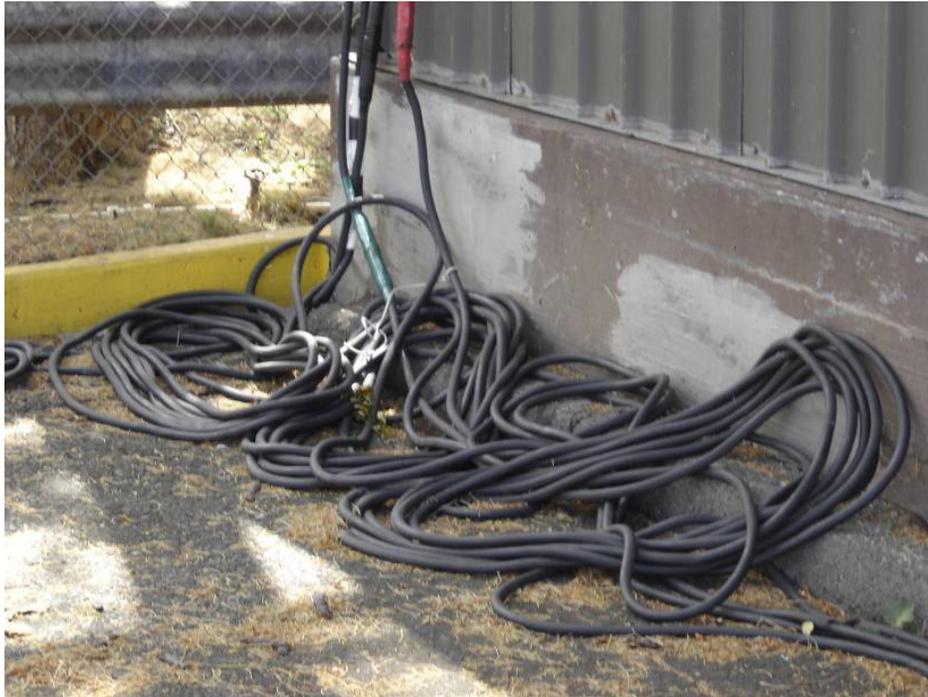
- A16. Power cables emanating from show power building exposed to the elements. Recommend encasing exposed power cables in underground conduit to prevent degradation due to weather.

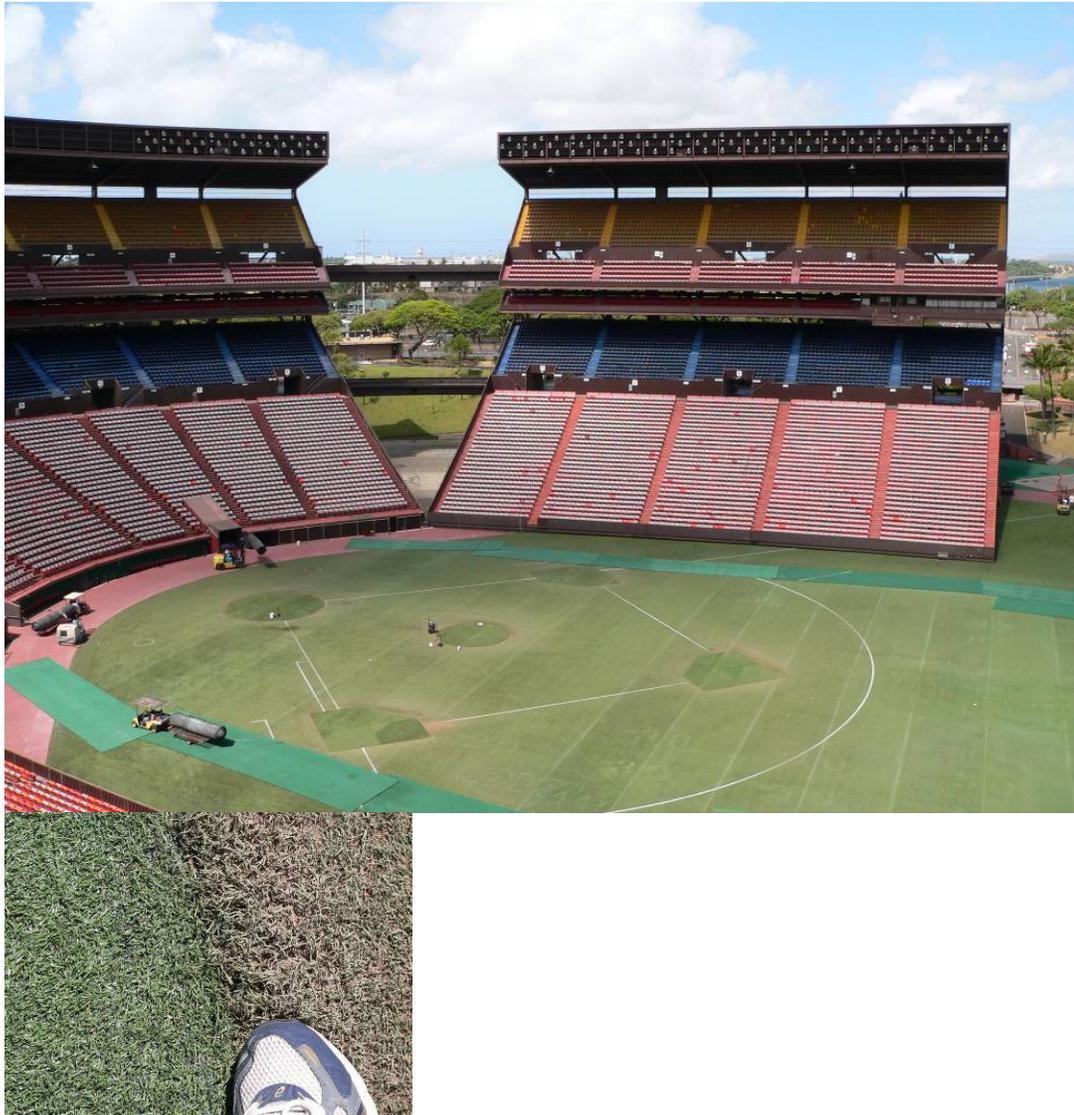
- B.1 View of seam depression. Recommend reviewing grooming procedures and tray installation procedures with manufacturer's representative to implement their recommended practice.

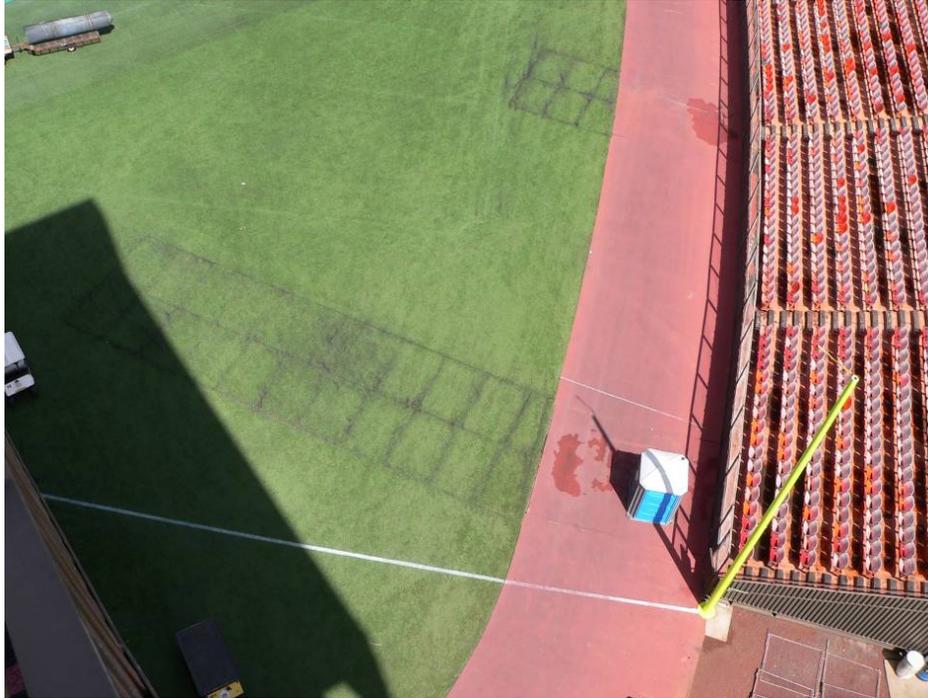
- B2. The second area of concern is the visible track area of the moveable stands exposed in the baseball configuration. This condition doesn't appear to be a performance issue, but does have minimal negative appearance. Recommendation: The condition of the track area should be monitored for potential deterioration. Review dressing procedures and tray installation procedures with manufacturer's representative to obtain their recommended practice. Assume track will need replacement when field is replaced.

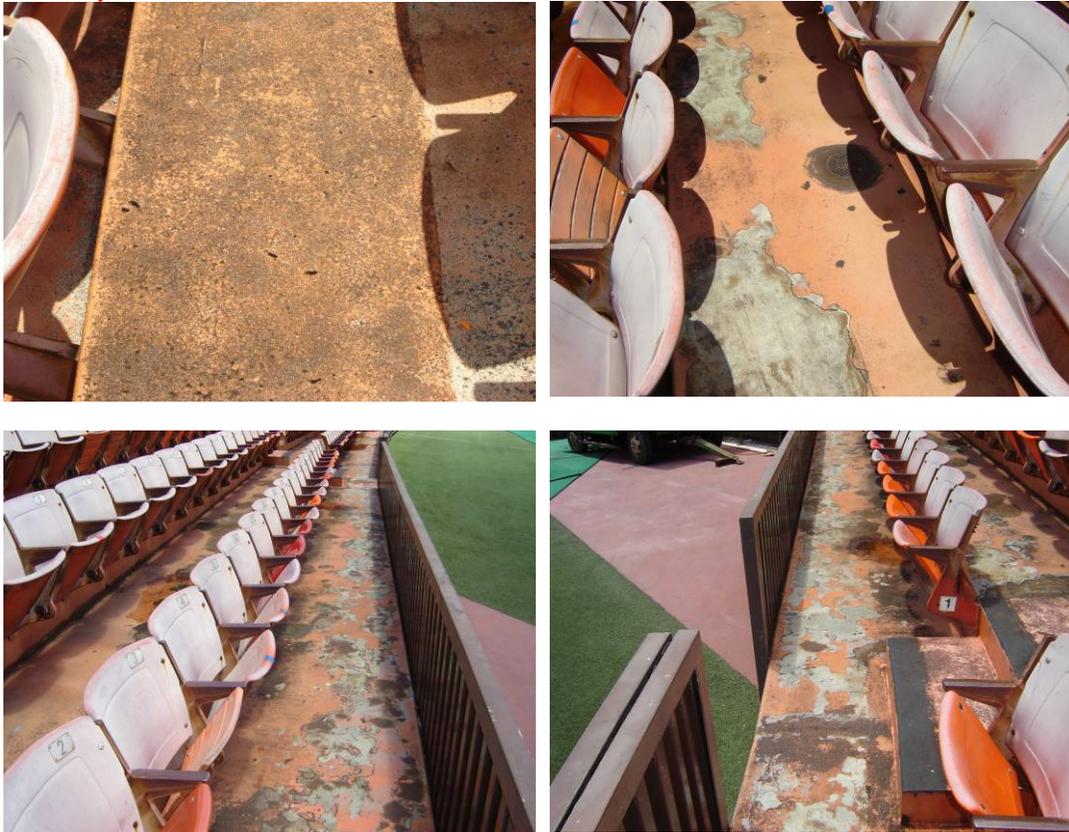
D1. Treads / Risers condition – The lower field seating bowl area (orange seating area) is constructed of precast concrete units on the north and south fixed sides and steel plate on the east and west movable sides. The depth of the seating bowl treads is 2'-11 3/8" and the height of the risers ranges between 1'-0" to 1'-3". The upper field seating bowl area (blue seating area) is steel plate and riser in all areas. The depth of these seating treads is 2'-9" and the height of the risers is 1'-3". A coating system has been applied to all treads and risers and cross aisles in both seating areas. The overall condition of this coating system is very poor particularly in the lower field seating areas. There are several areas where the coating system is missing completely and bare steel or concrete is exposed. The coating on the upper field seating areas treads and risers is also in need of replacement for the same reasons. In the north and south lower field seating bowl areas there are sealant joints installed between the pieces of the precast seating units. These joints are in poor condition and allow water to enter the finished spaces below which has caused damage.

Recommendation – Replace entire coating system on treads and risers with the highest priority being given to the lower field seating areas. A replacement of the sealant joints in the precast seating areas should also be done at the time that the coating is replaced to prevent further damage to the interior spaces below. This work should be sequenced with other improvements such as seat replacement and overhead painting to avoid damage caused by other trades.

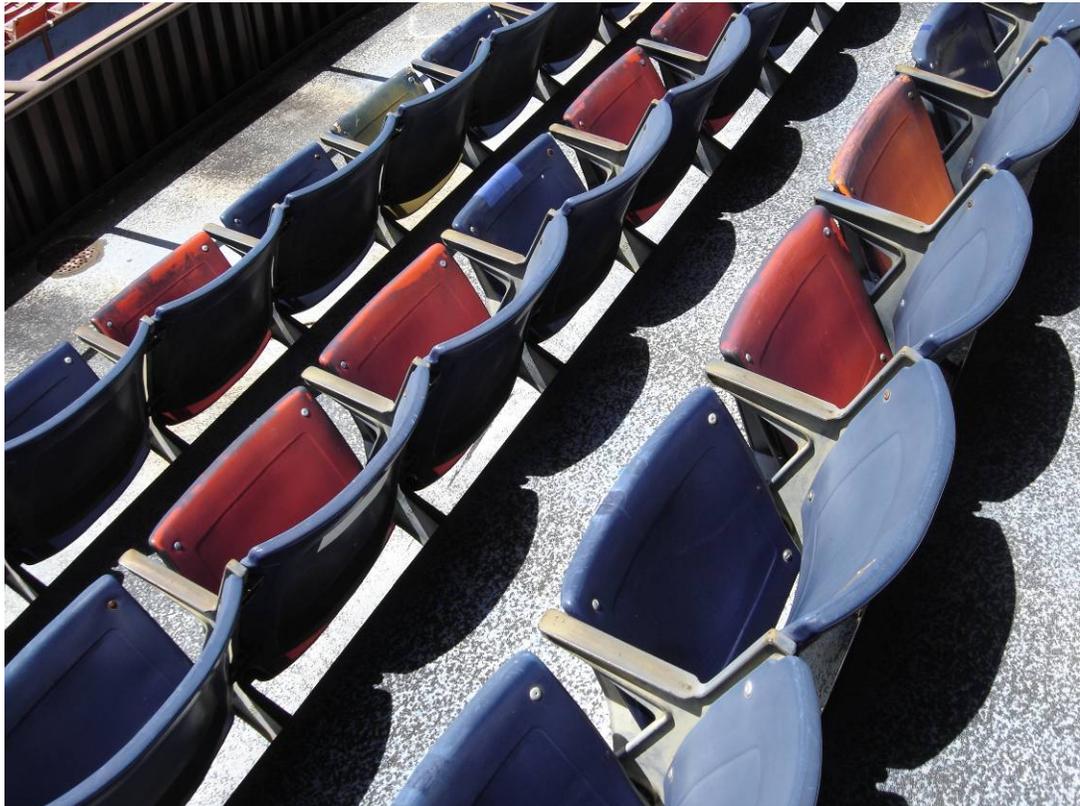
- D2. Replacement seat bottoms in Section S have been painted blue and the paint is worn away revealing an original red seat. Recommendation – replacement of all seats throughout the stadium.

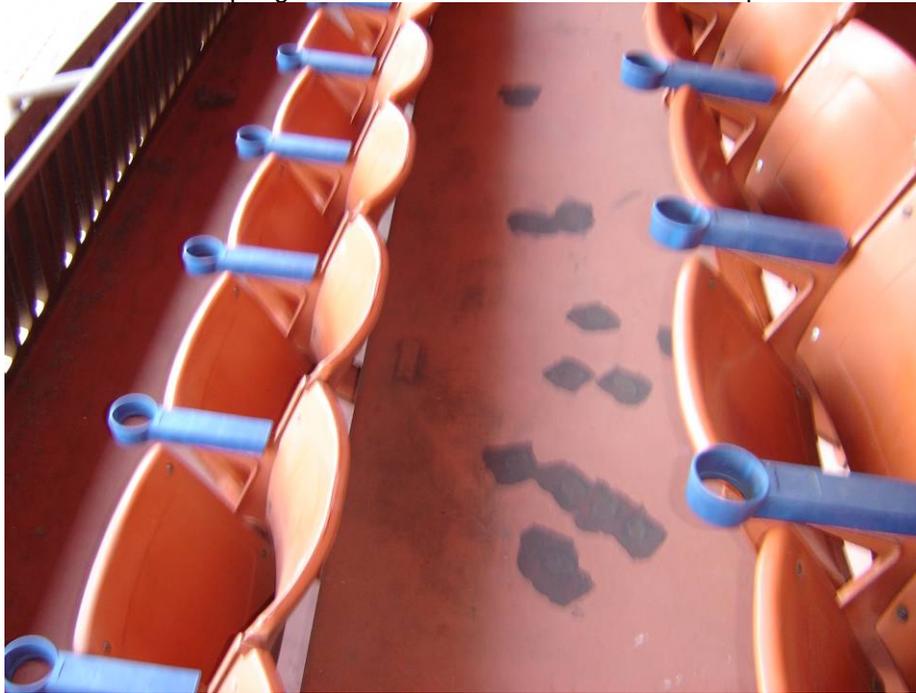
- D2. Seats are in better condition on this level than in most areas of the stadium, however, they still need to be replaced due to extent of corrosion on seat standards, fading of seats and backs and loss of spring action on seats. Recommendation: Replace all seats on this level.

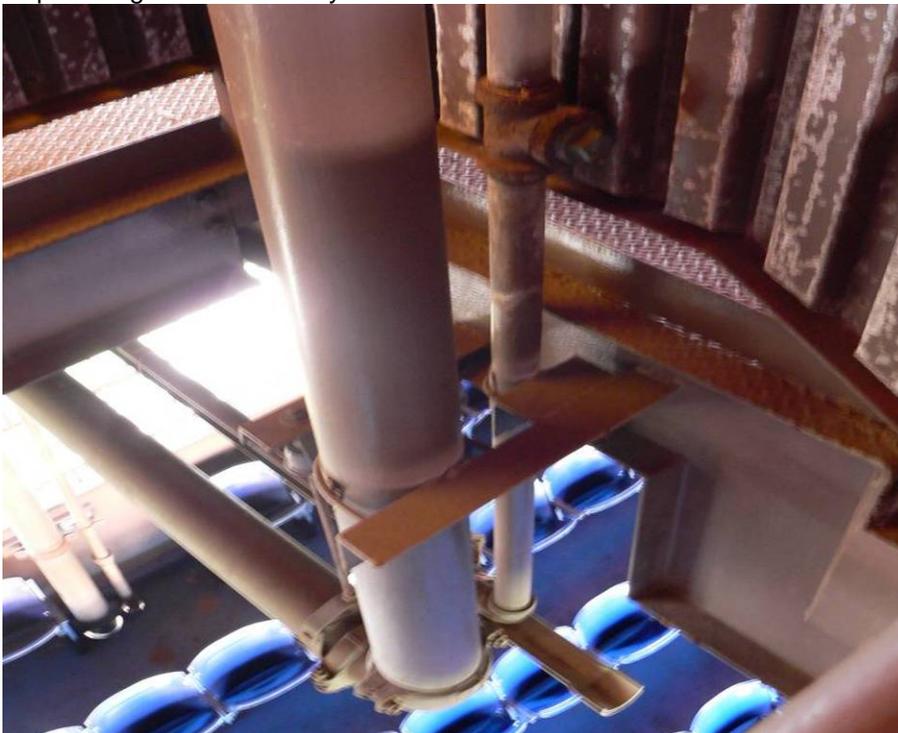
Fittings on plumbing lines are heavily corroded.

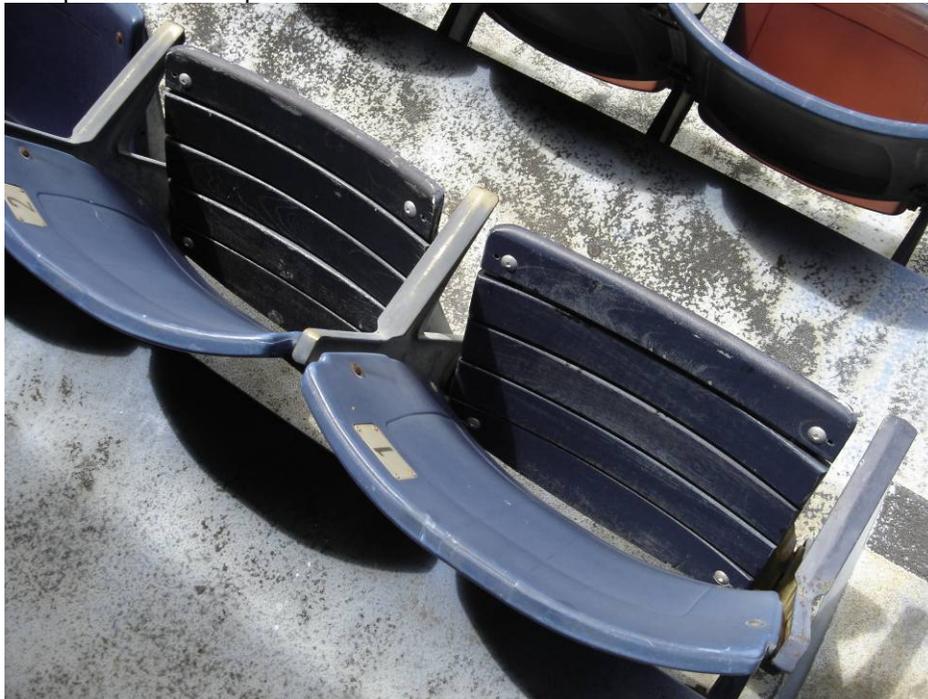
D2. Section T row there are several instances where wooden slat bottoms have been utilized as replacements for plastic bottoms.

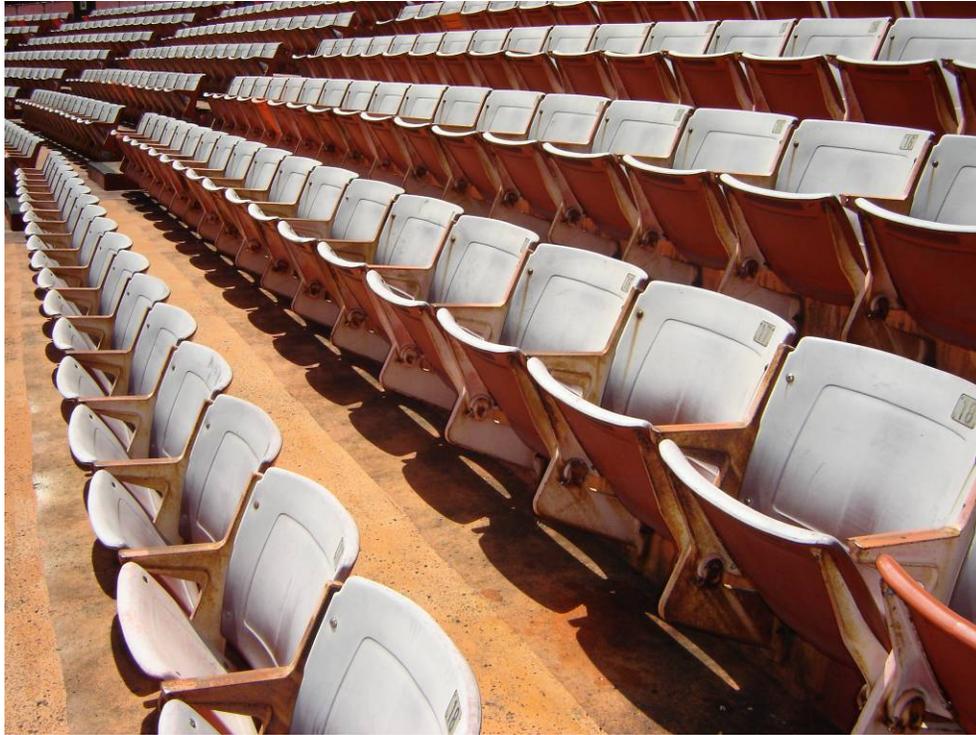
- D2. Seats / bleachers – The seating at all locations of the stadium is in poor shape and in need of replacement. The majority of the seating standards and hinge arm assemblies are showing significant rust. Most of the anchorage into the seating treads and risers appeared sturdy and most of the hinge arm assemblies appear to still function properly. The plastic seat backs and bottoms are severely faded and there are many locations where they have been replaced with a piece that is a different color, been painted to match, or a piece that is wooden instead of plastic. The seating in the lower and upper field seating areas are 21 inches wide which is wider than the current standard of 19” in most modern stadium general seating areas. **Recommendation – Replace entire seating system.**

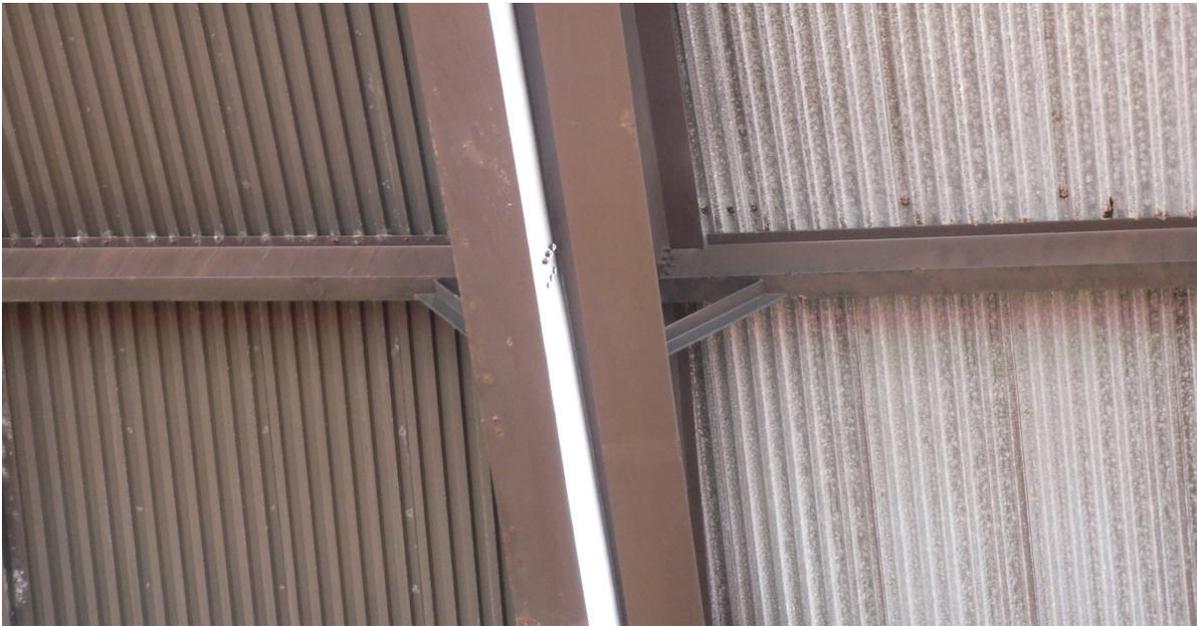
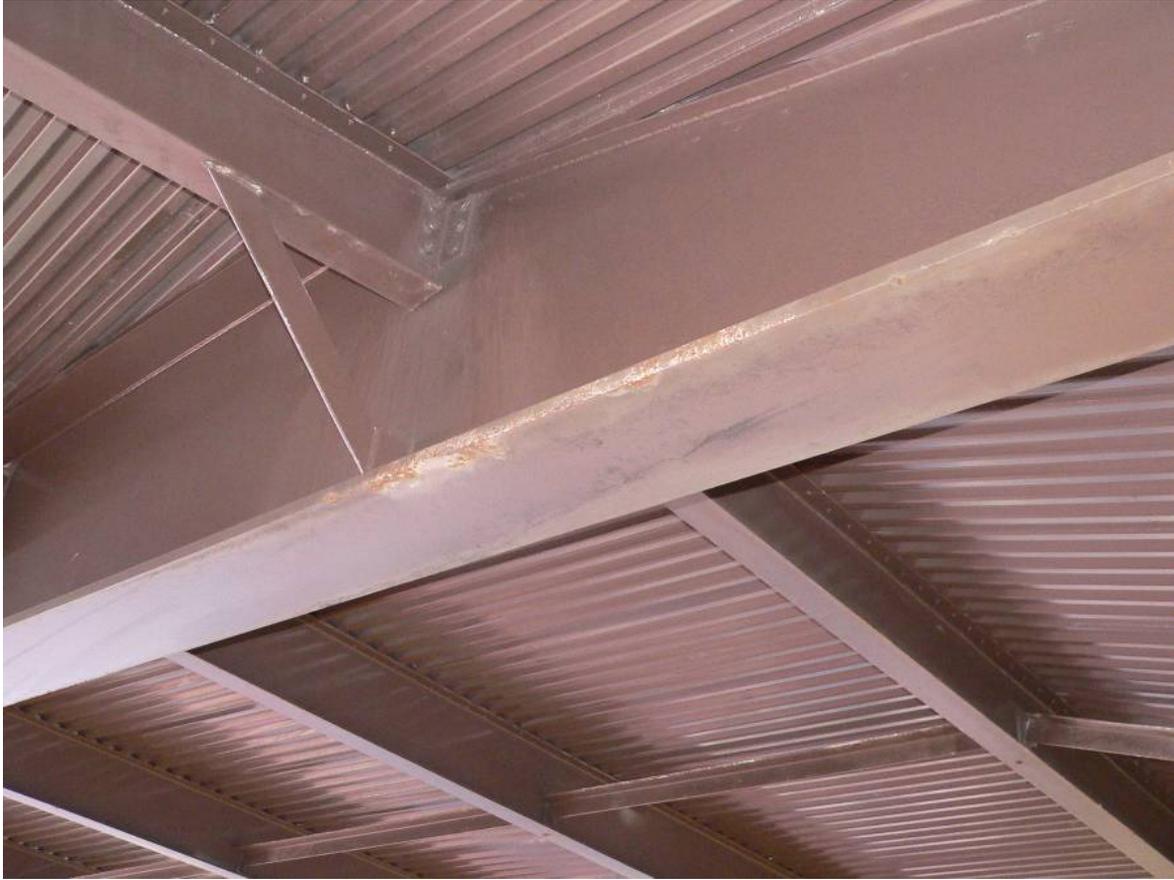
Roof canopy above the southeast moveable section (right side of photo below) shows greatest signs of corrosion. Steel roof beams are corroding in several areas of the roof.

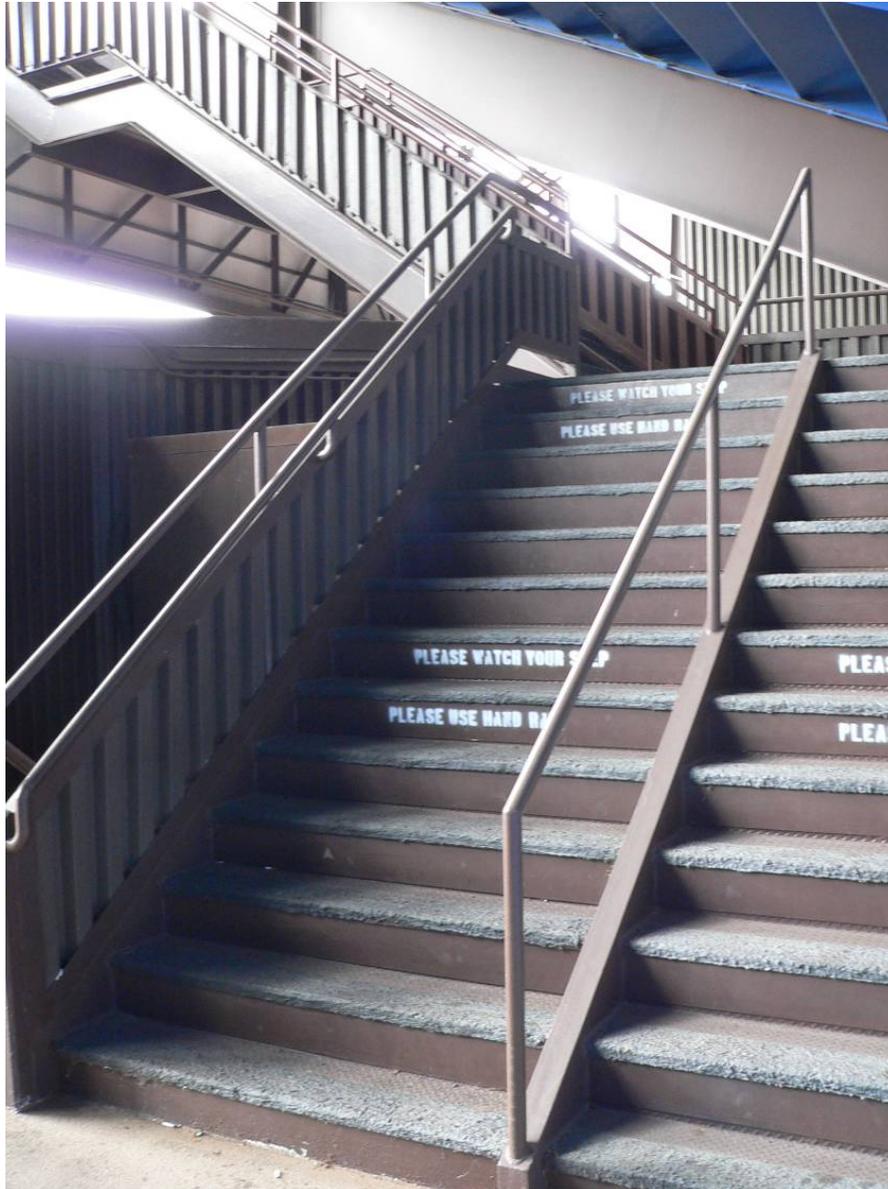
- J1. The main stadium exit stairs (1, 2, 3 and 4) connect the field level, main concourse and upper concourse and are located in the middle of each moveable seating section. Although an exit analysis is beyond the scope of this study, the size and distribution of exit stairs and ramps appear adequate. The stairs reportedly are not used heavily during football events. Most patrons circulate along the concourse to the ramp closest to their destination. Enhanced lighting, lighter paint color selection and graphics could increase their utilization. The stairs are generally in good condition. **Recommendation: Recoat exposed steel railings and risers. Suggest lighter color for railings. Upgrade lighting and graphics. Nosings are in good condition.**

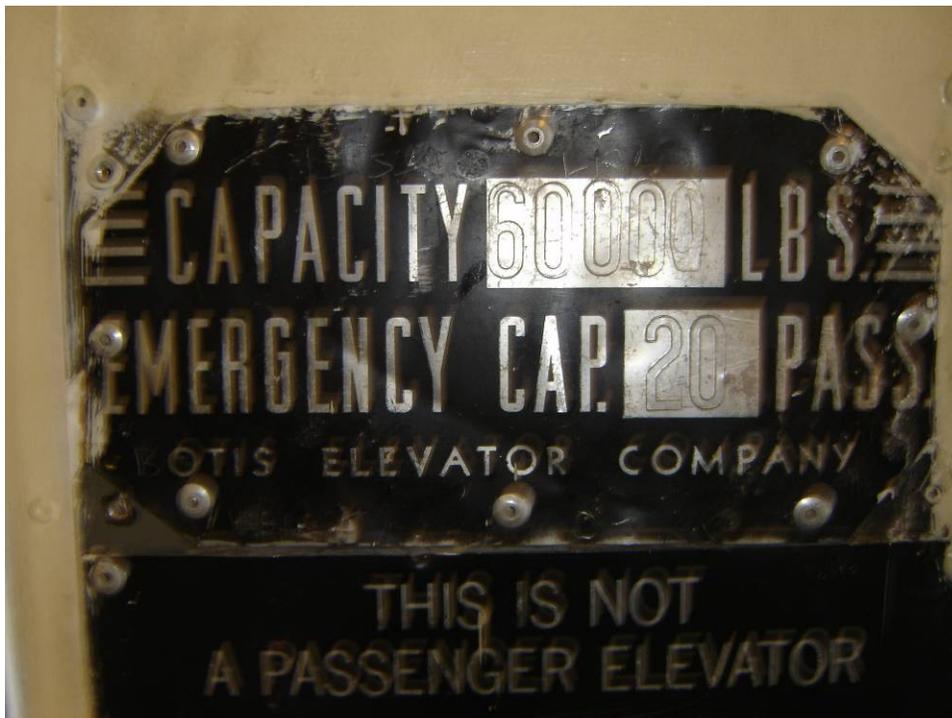
K1. Two freight elevators serve the stadium. These are utilized for passengers on game day and serve medical staff, VIP's, media and food service staff and supplies. The south elevator provides access for disabled patrons to various concourses. The cabs are in good condition for freight elevators, but do not project a positive image for passenger use. Recent inspection reports indicated they are in good working order. **Recommendation – Add one bank of two passenger elevators to each quadrant serving the Loge Level at minimum and preferably, the Main and Upper Concourses for disabled patron and premium seating patron access.**

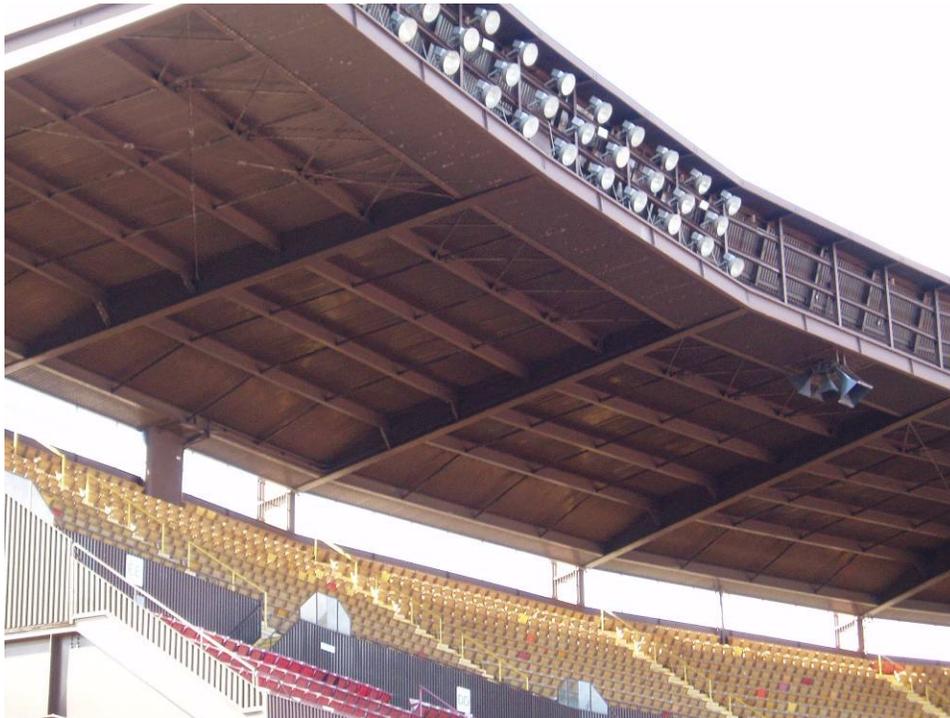
Q1 Replace field sporting event lights.

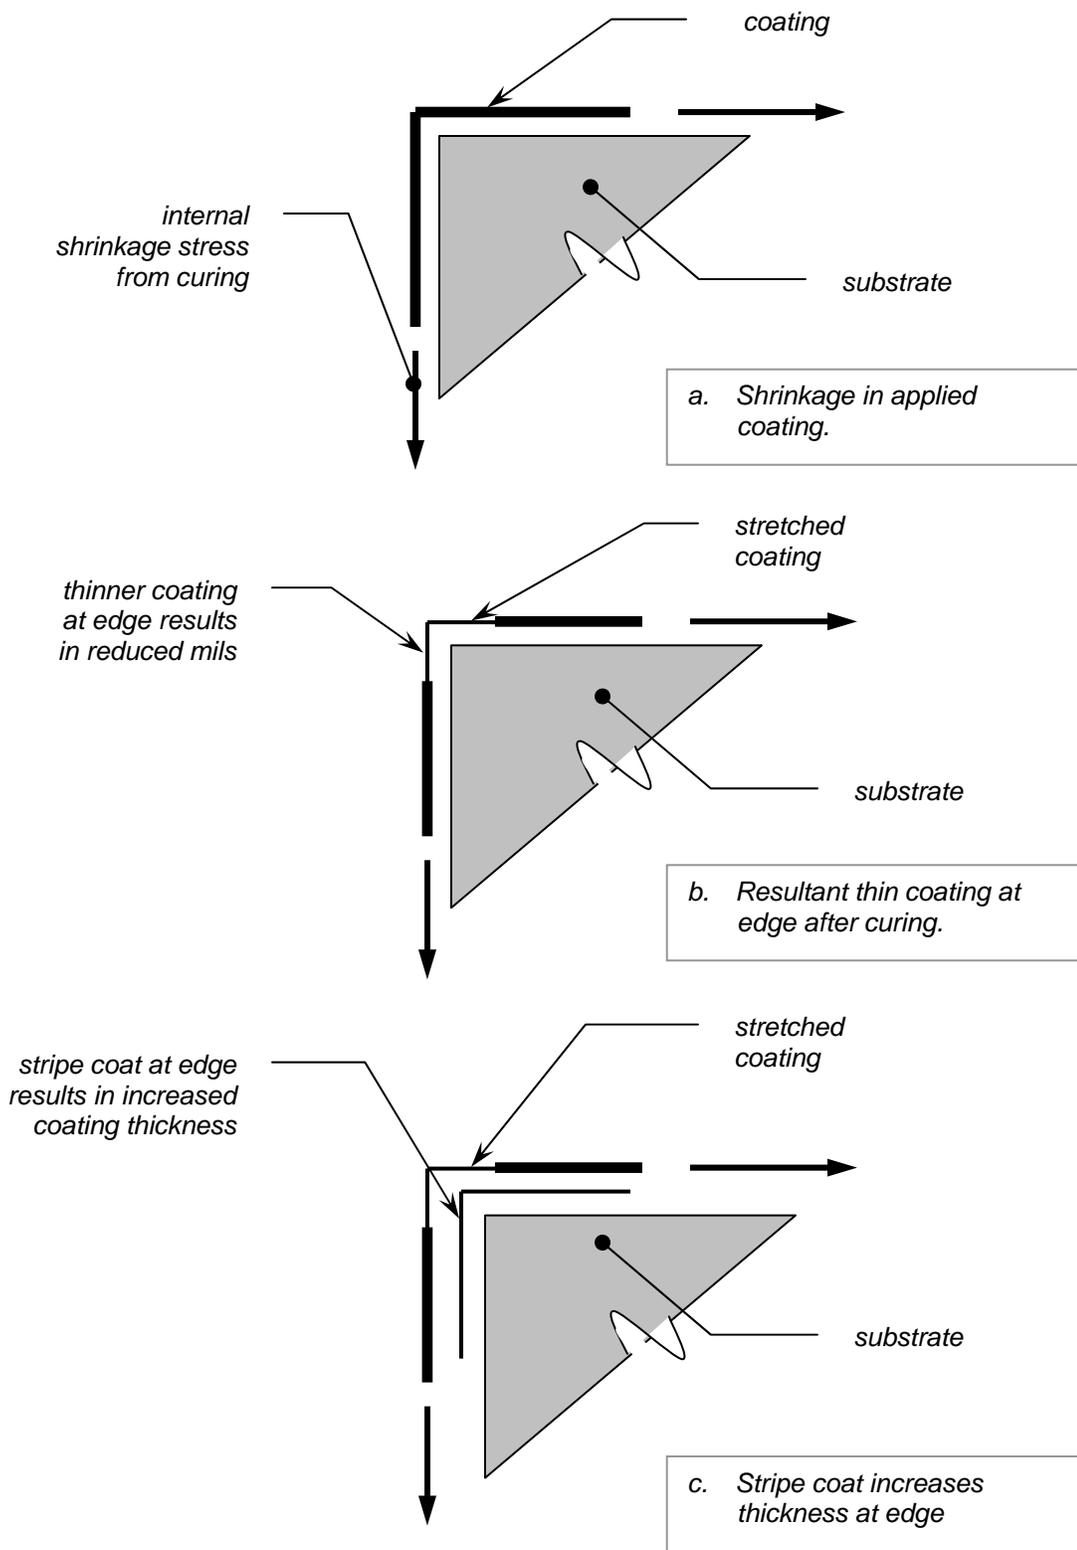
Figure R-29. Thin coating phenomenon at edges and typical method to address the condition.

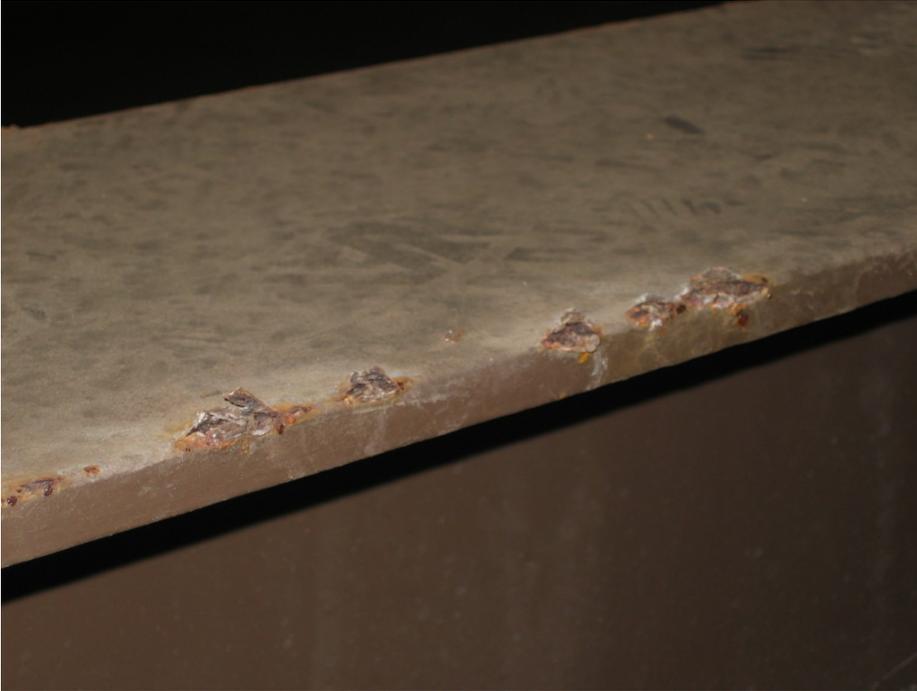
Figure S-16. Coating failure and corrosion typically observed at flange tips

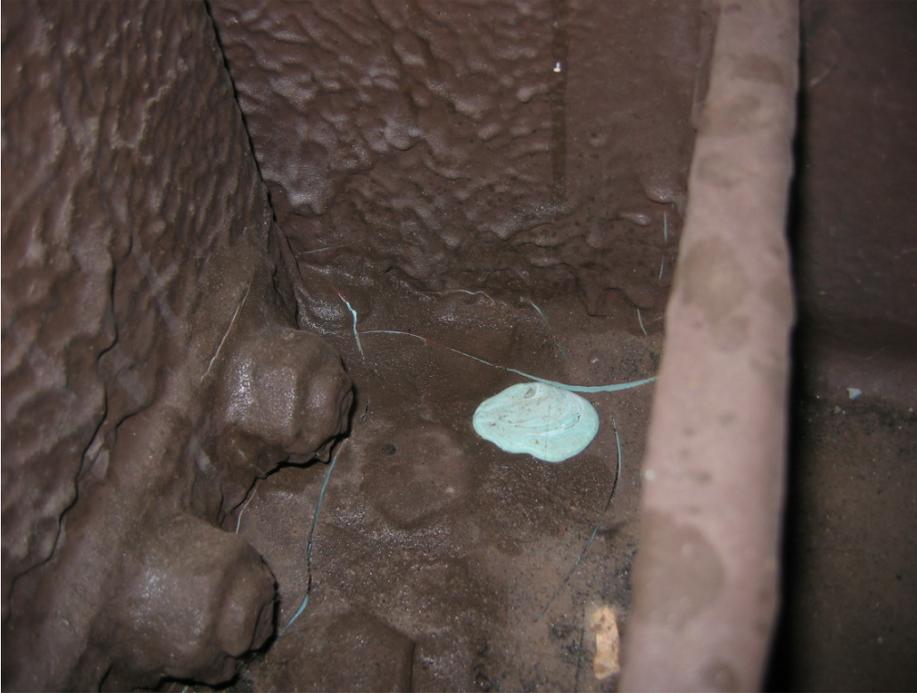
Figure S-18. Typical epoxy filler retrofit at connection node that has cracked

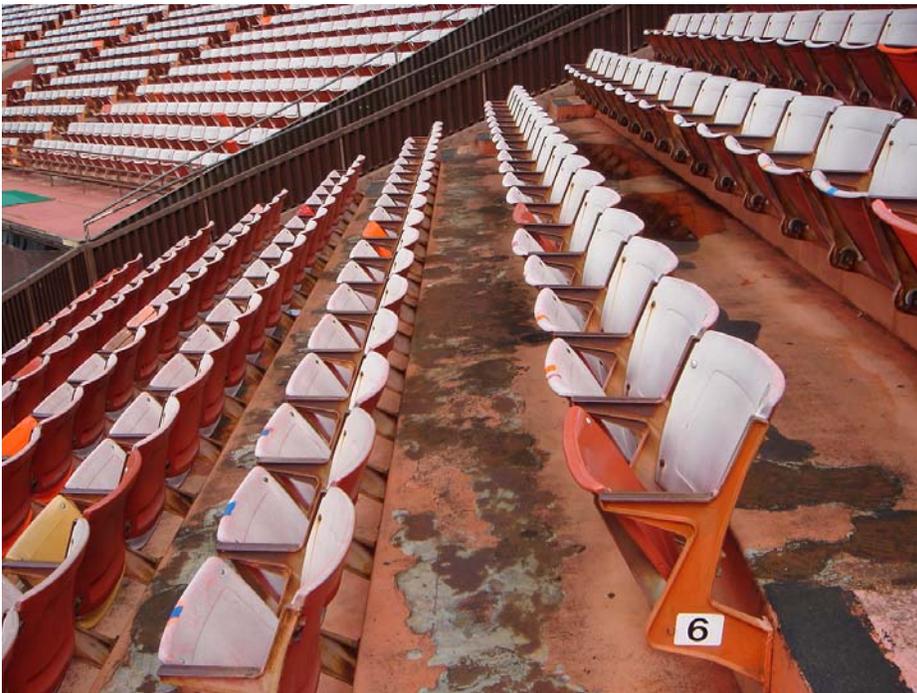
Figure S-19. Areas of surface corrosion observed on the top surface of the tread and riser plate

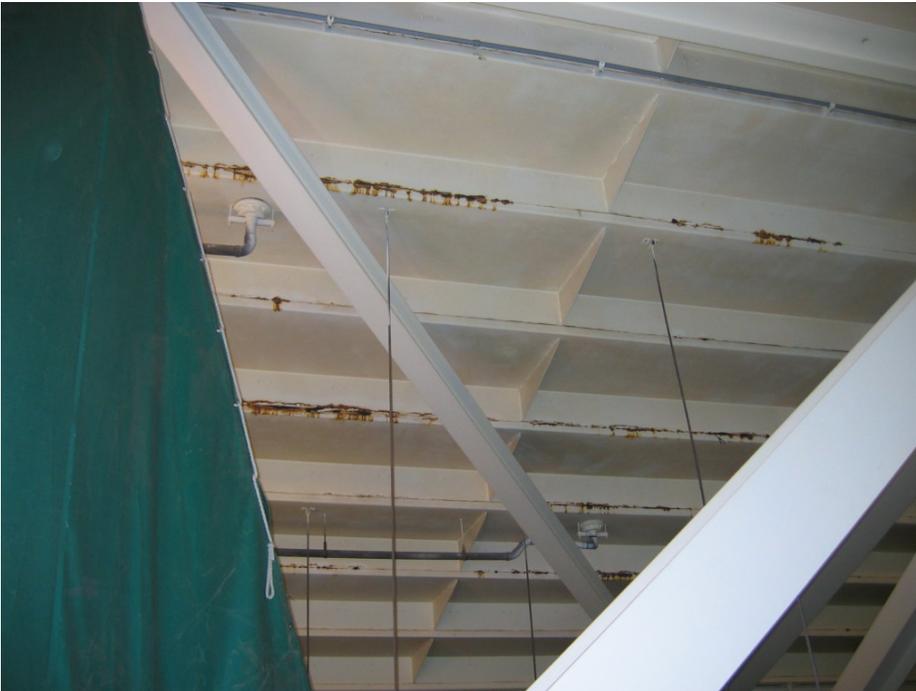
Figure S-21. Corrosion and pack rust observed on the back side of the seat plate at the horizontal joint between tread and riser plates
