VOLUME 2: EXISTING CONDITIONS

aloha stadium PLANNING STUDY FINAL REPORT - 12.22.05

SECTION II: CONDITION SURVEY

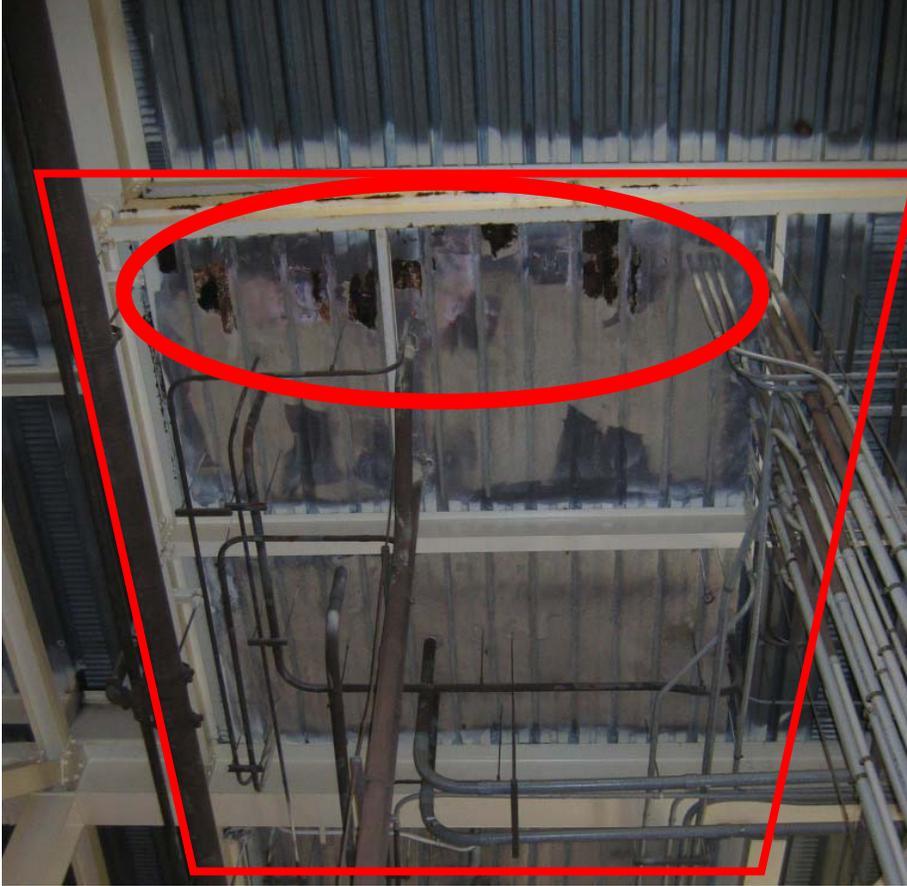
Figure S-26. Metal deck deterioration beneath the electrical (transformer) room, appears to be original metal deck

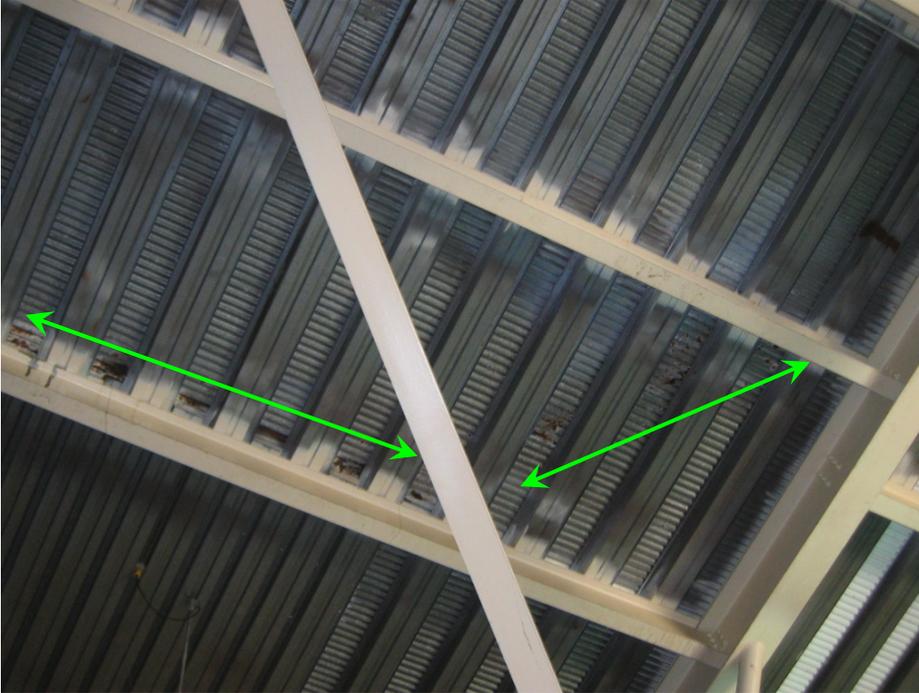
Figure S-27. Corrosion observed beneath the vomitory wall

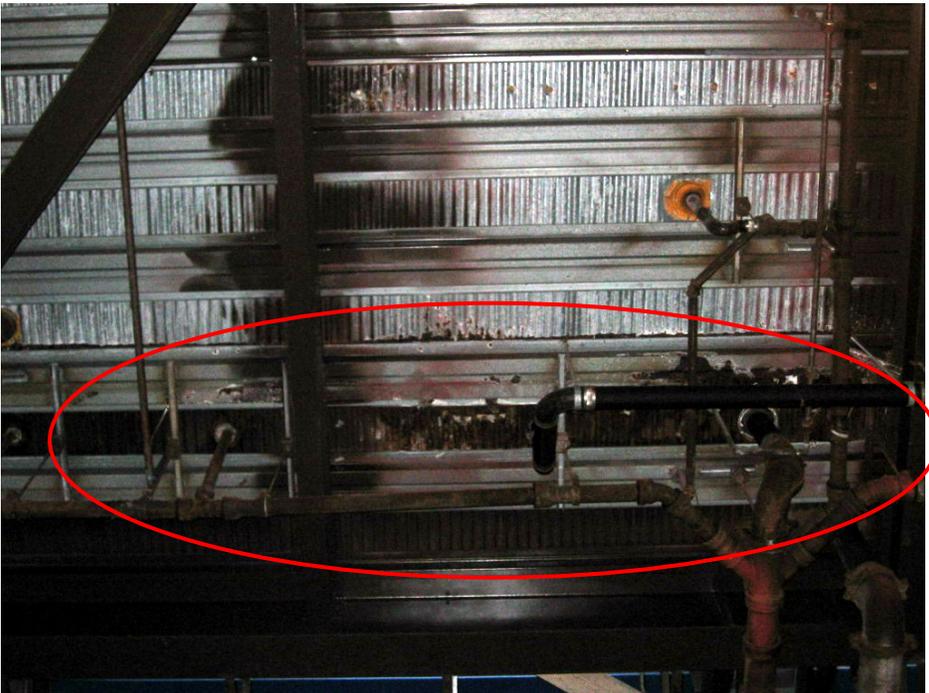
Figure S-28. Area of metal deck corrosion along drain line penetrations

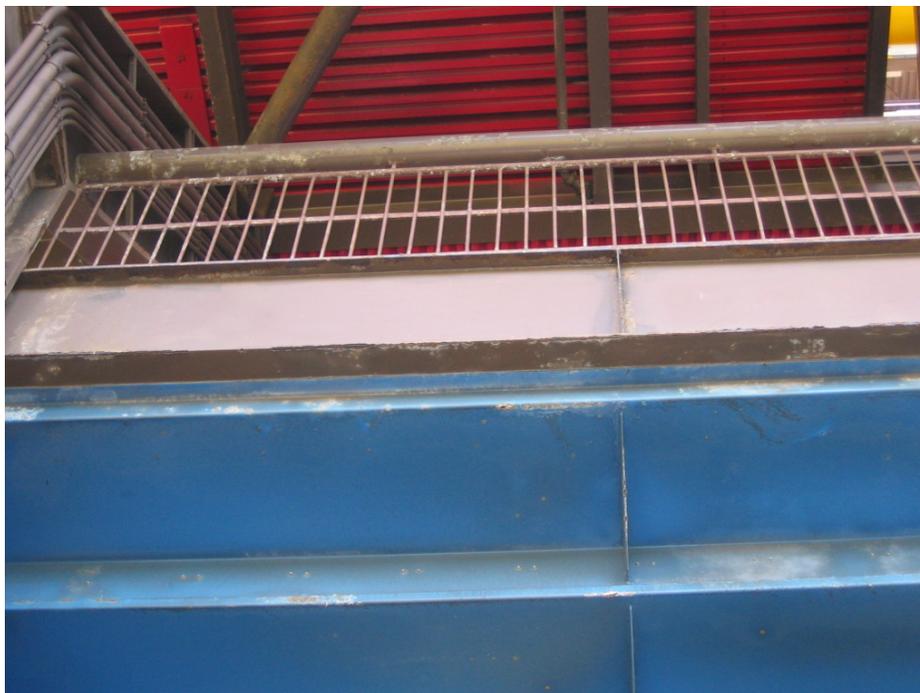
Figure S-30. Corrosion observed on the plate girder and seat plate at the rear of the lower field seating section

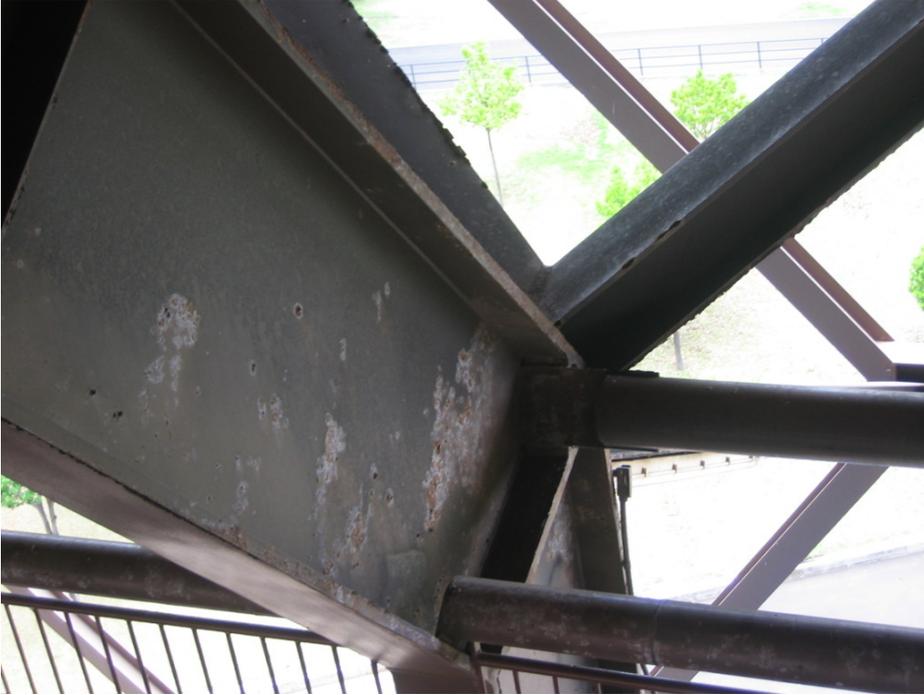
Figure S-31. Typical surface corrosion observed at the lower elbow in the eastern quadrants of the Stadium

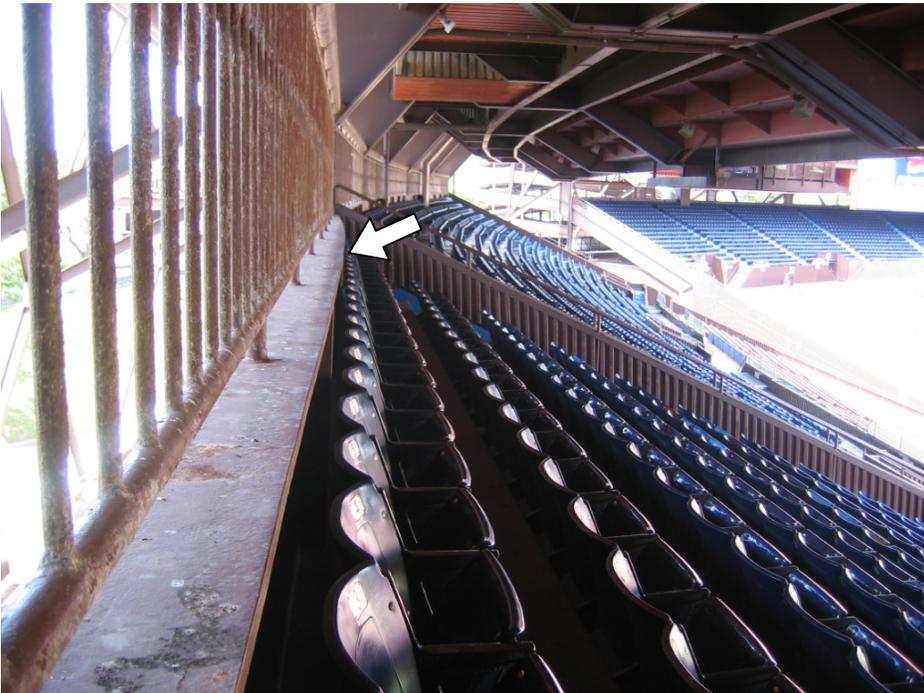
Figure S-32. Lateral sweep of the plate girder between raker lines

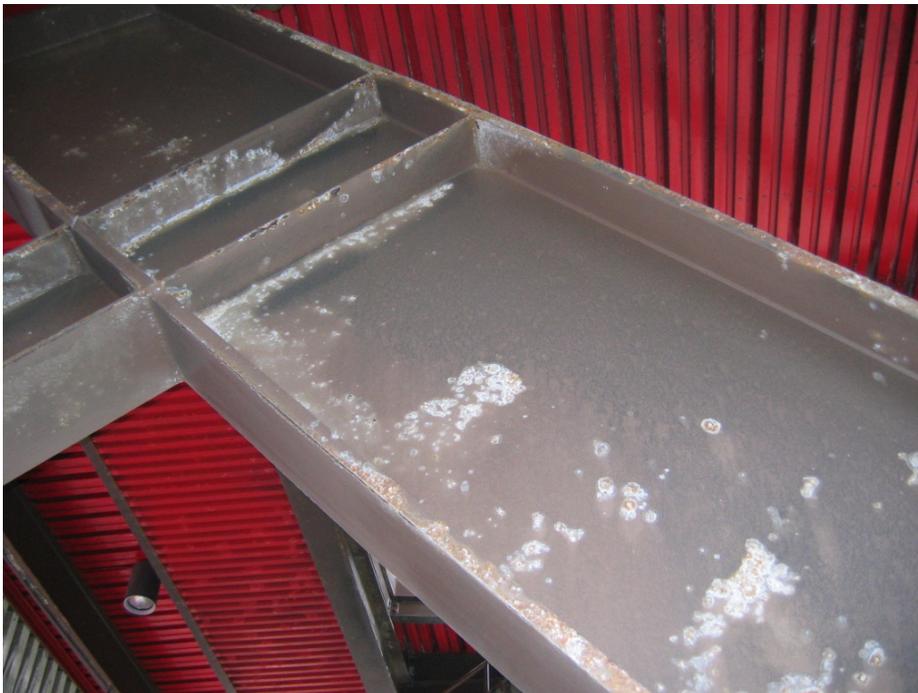
Figure S-34. Corrosion of the primary raker girder and cantilevered portion of the raker in the Loge Level

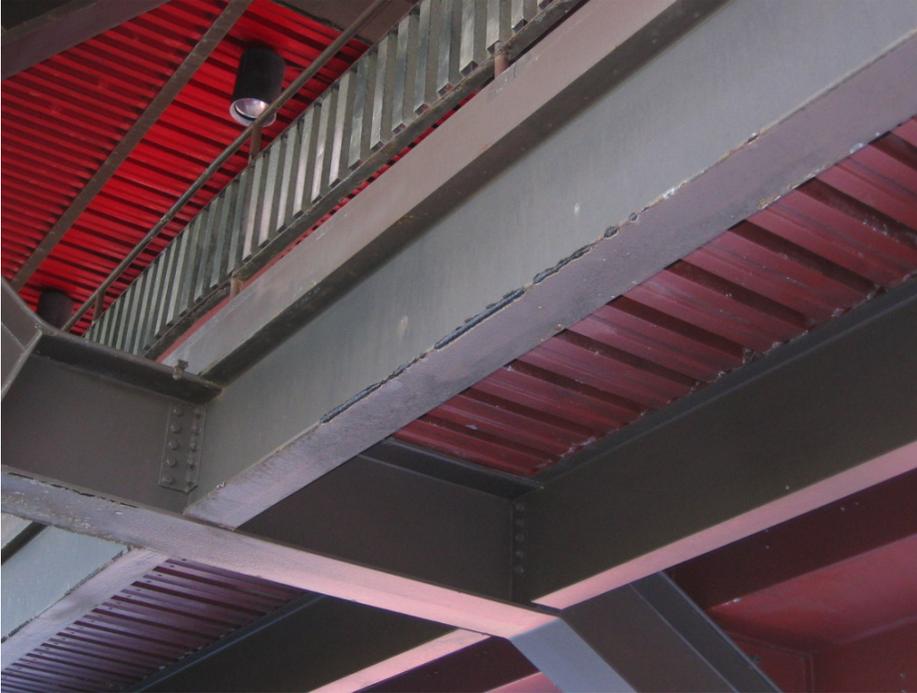
Figure S-35. Flange tip corrosion observed in Loge Level framing members

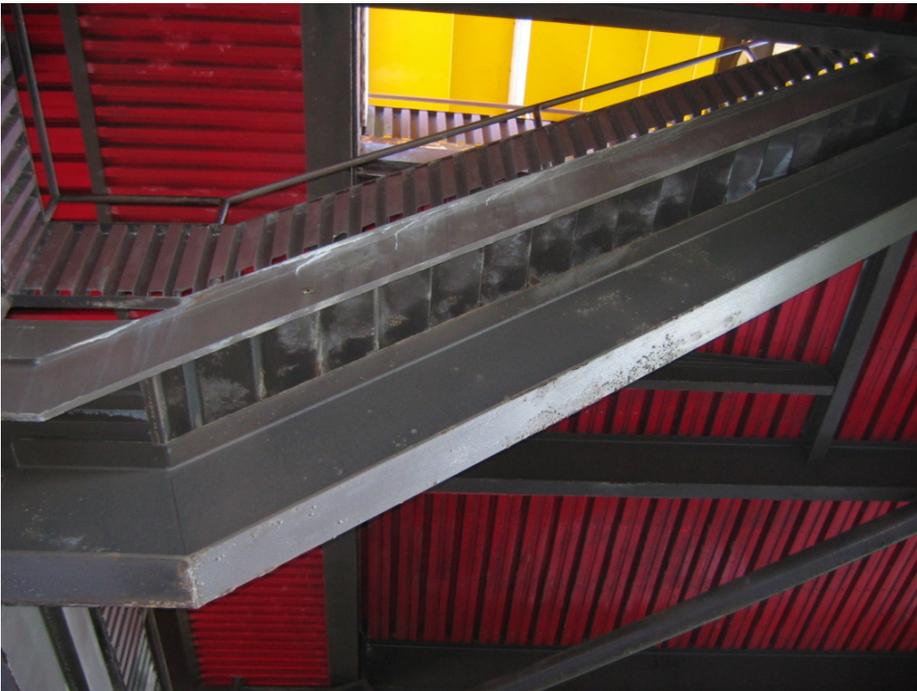
Figure S-36. Observed corrosion at the Loge Level stairwell

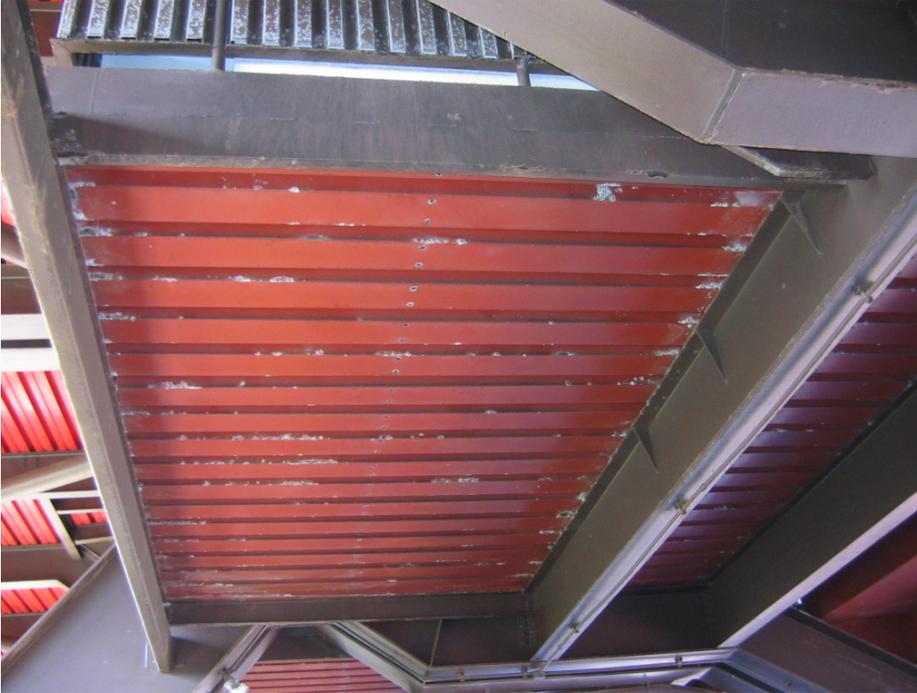
Figure S-37. Observed corrosion of metal deck behind the football pressbox

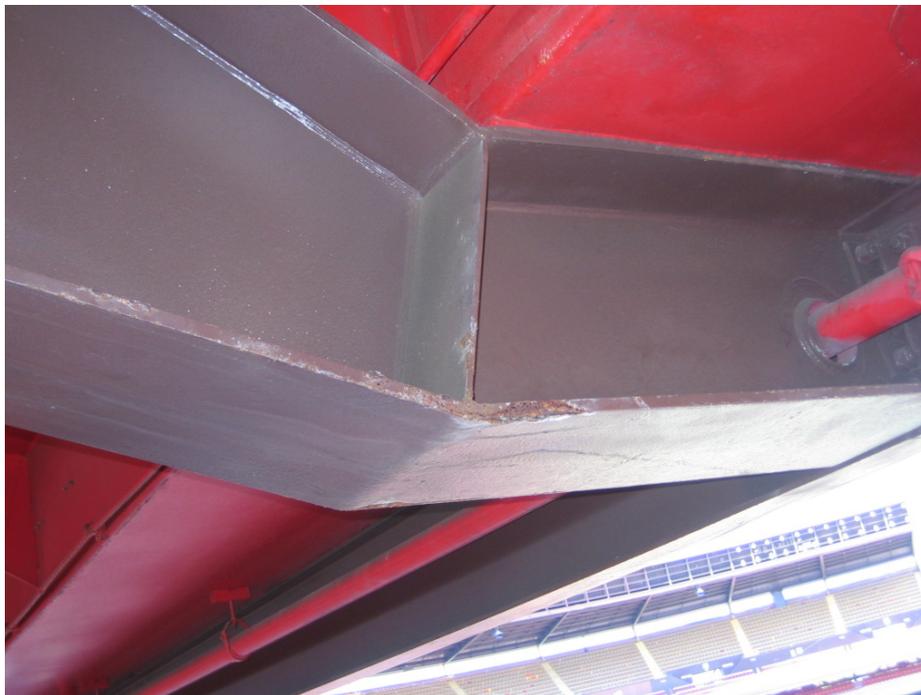
Figure S-41. Typical flange tip corrosion observed at the cantilevered portion of raker supporting the lower tier seating level

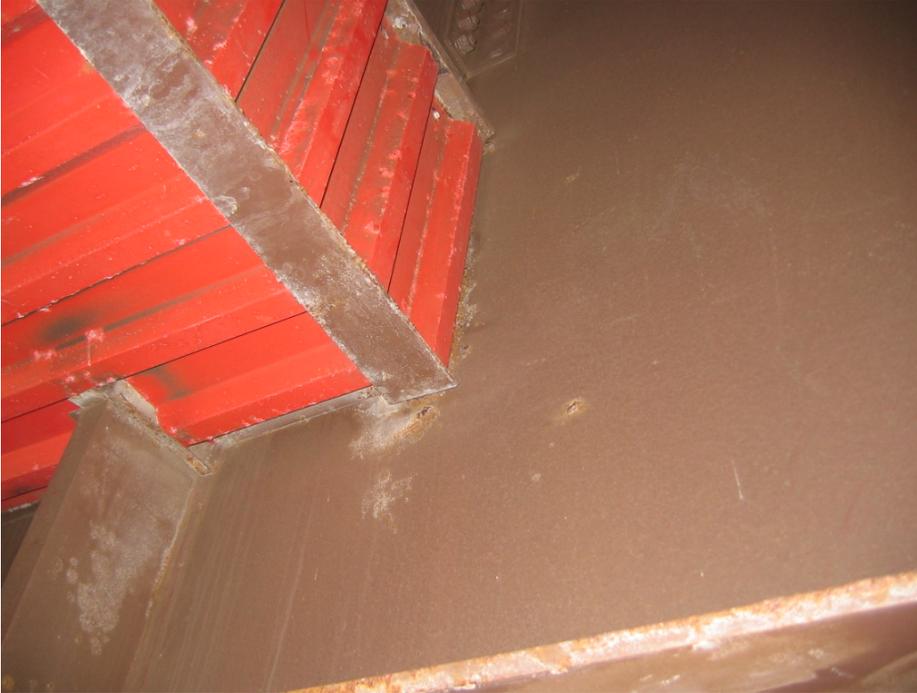
Figure S-42. Observed corrosion at intersection of pipe chase framing member and primary raker girder

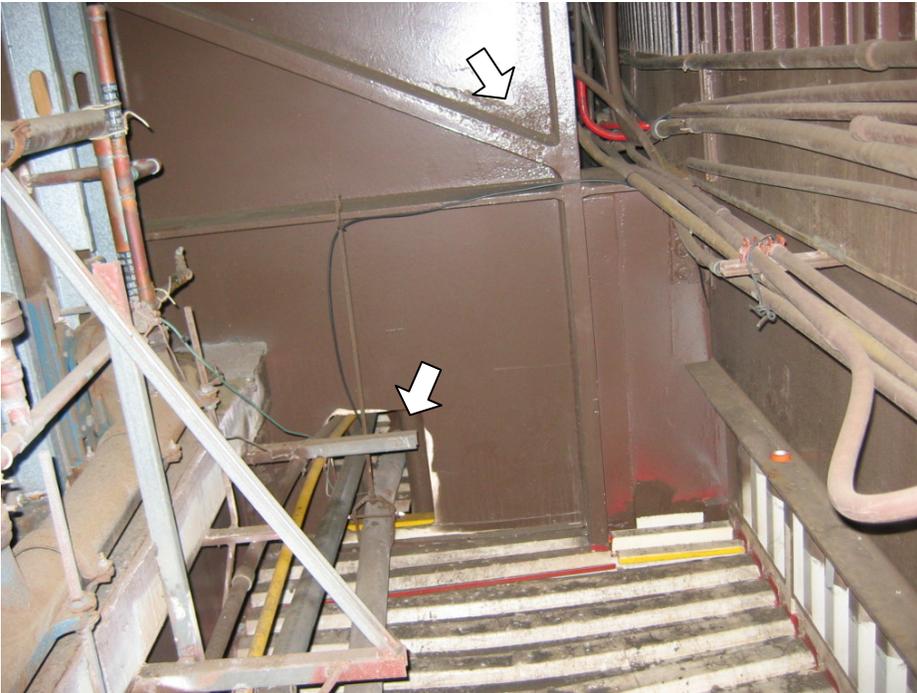
Figure S-43. View of primary raker girder within pipe chase, note pitting caused by prior web corrosion (upper arrow) and web cut-out (lower arrow)

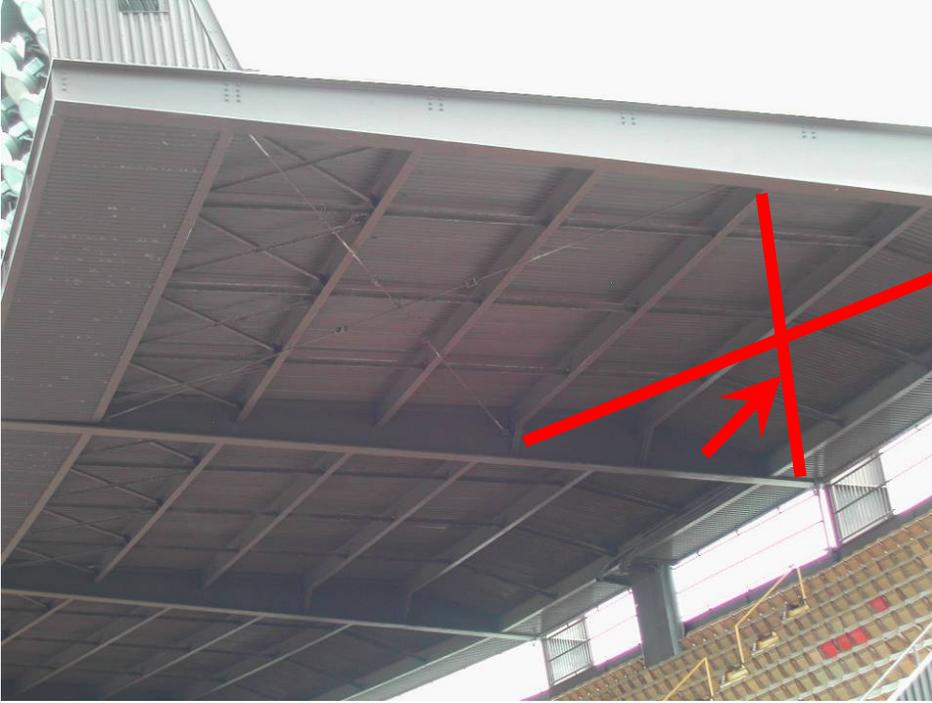
Figure S-54. Missing cross braces in the roof system framing

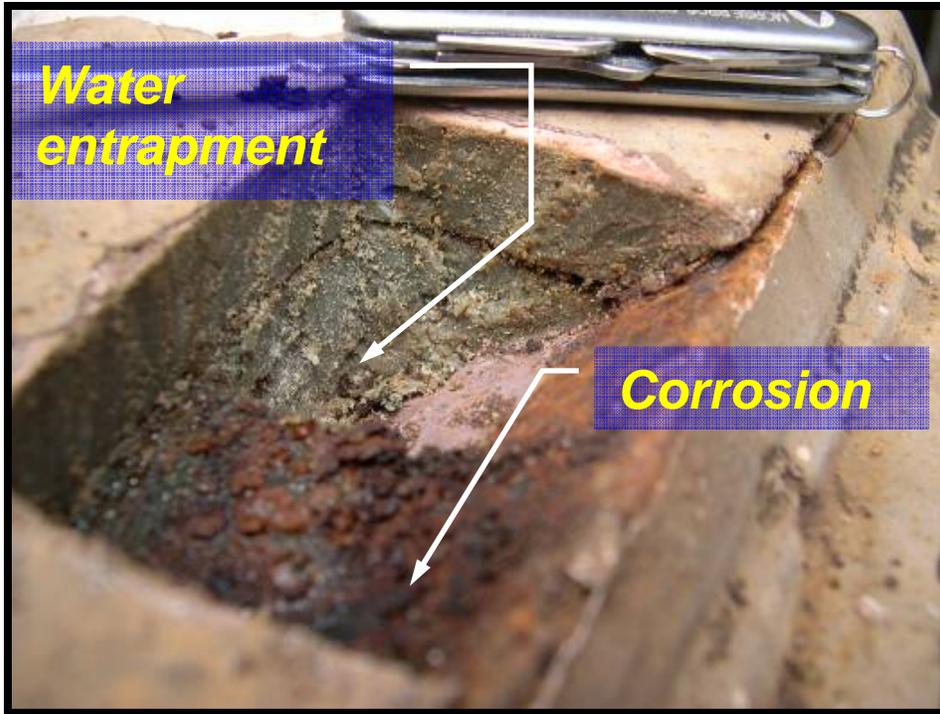
Figure S-67. Trapped water and corrosion observed beneath the filler material

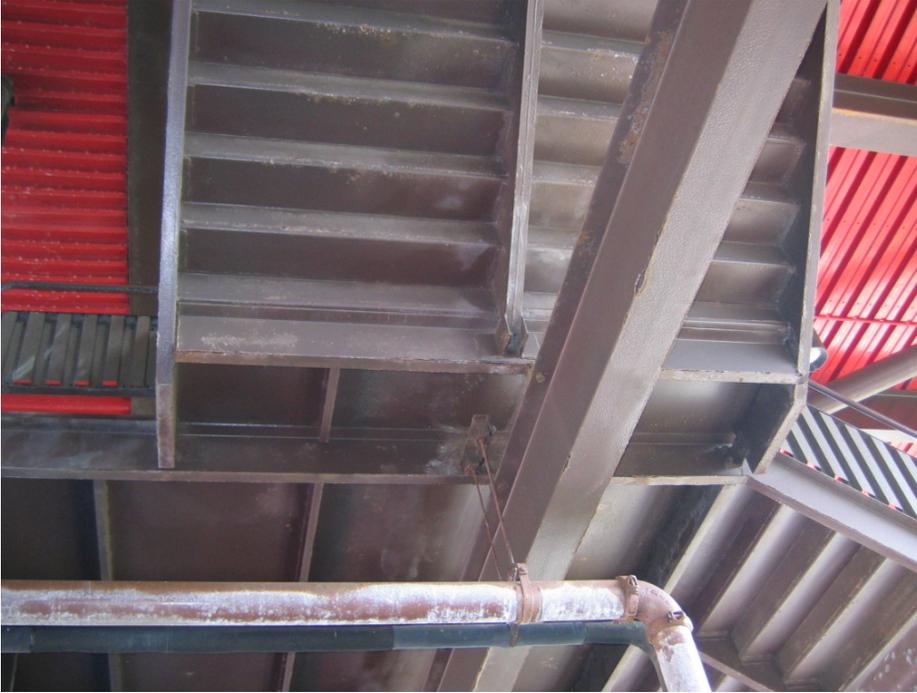
Figure S-73. Corrosion and coating failures observed on the stairwell framing

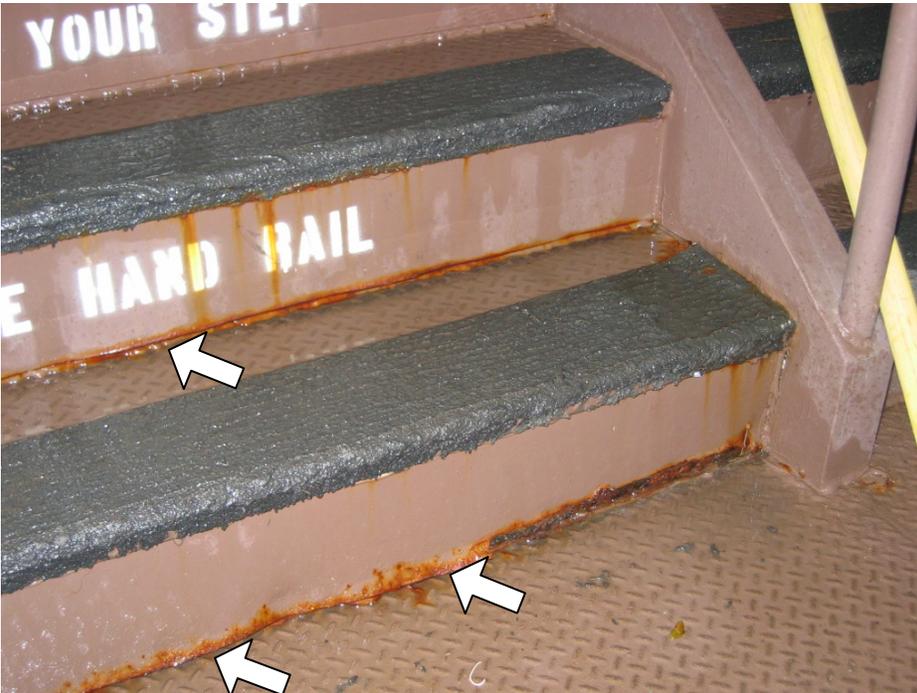
Figure S-74. Corrosion and pack rust has resulted in deformation of the riser plate

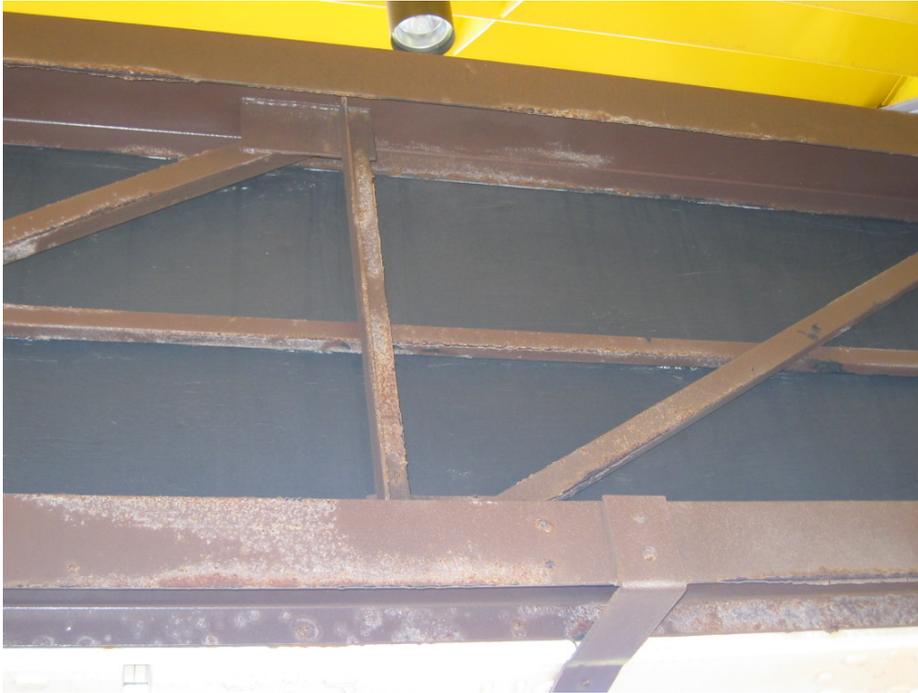
Figure S-78. Widespread corrosion of sign truss framing members

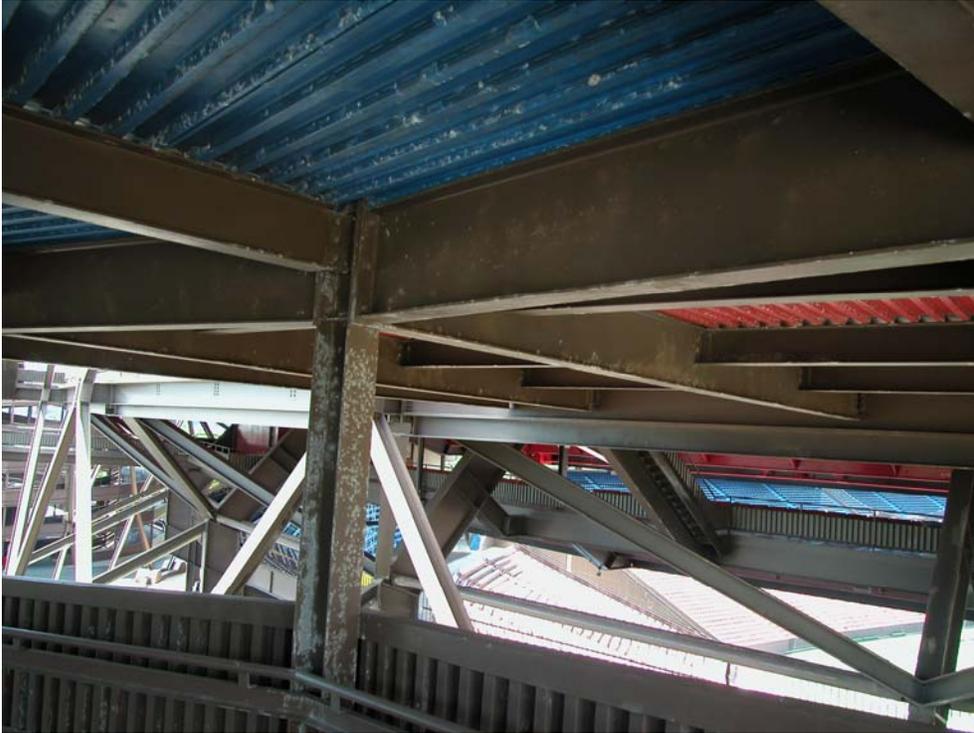
Figure S-80. Corrosion of the galvanized steel framing members

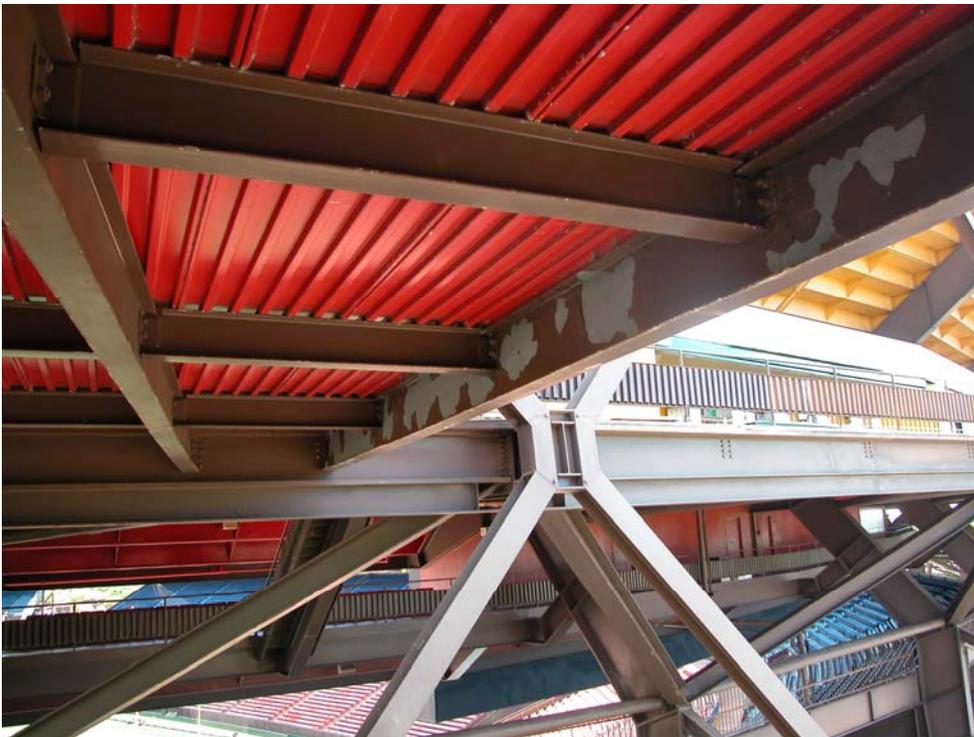
Figure S-81. Adhesion failure of the coating system on the beam element

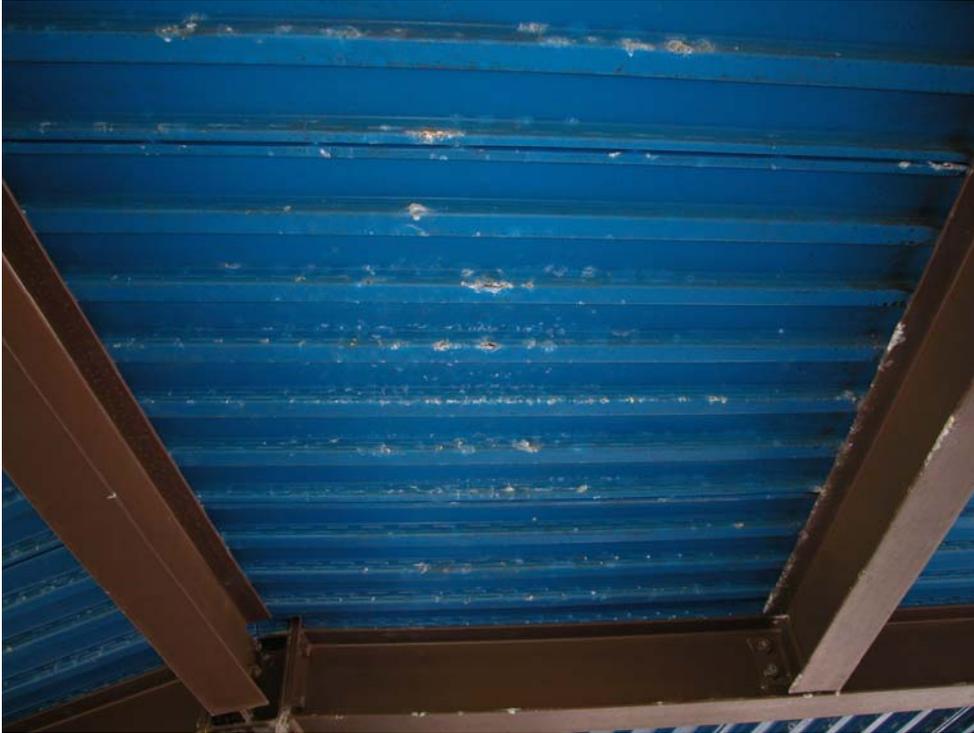
Figure S-82. Corrosion of the galvanized steel deck in the spiral ramp
