aloha stadium PLANNING STUDY FINAL REPORT - 12.22.05

Aloha Stadium Planning Study

Part I – Executive Summary

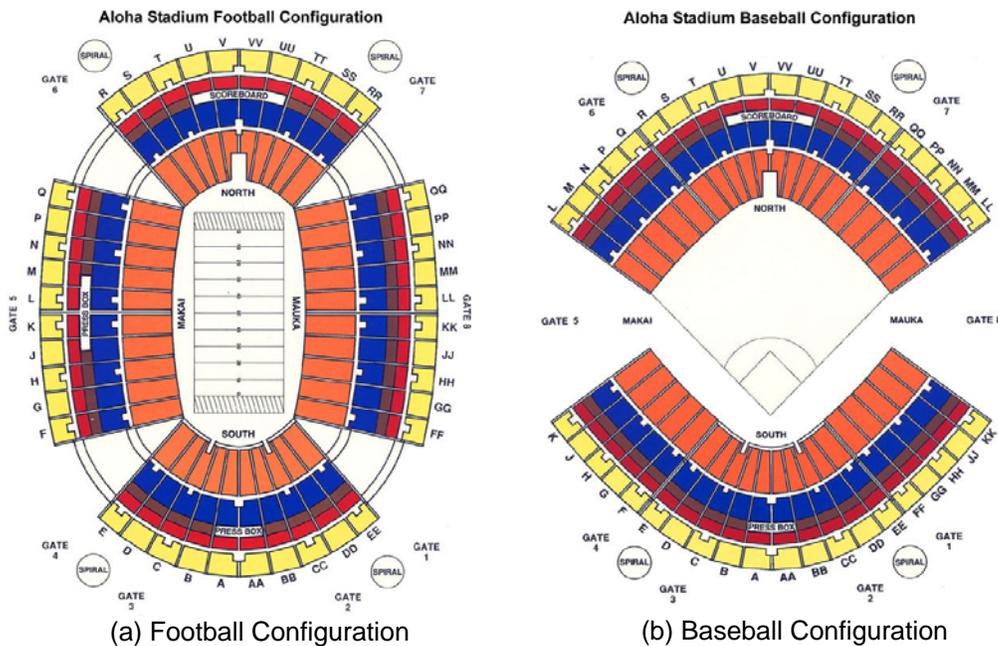
The facility contains approximately 50,000 seats primarily for the viewing of athletic events. One unique feature of the stadium is the ability to move four of the six total sections of seating stands to allow the stadium to be changed between either football configuration or baseball configuration. Plans showing the two configurations are given in Figure I-2.

Figure I-2. Expanded plans of Aloha Stadium: (a) Football configuration; (b) Baseball configuration.
