VOLUME 2: EXISTING CONDITIONS

aloha stadium PLANNING STUDY FINAL REPORT - 12.22.05

SECTION II: CONDITION SURVEY

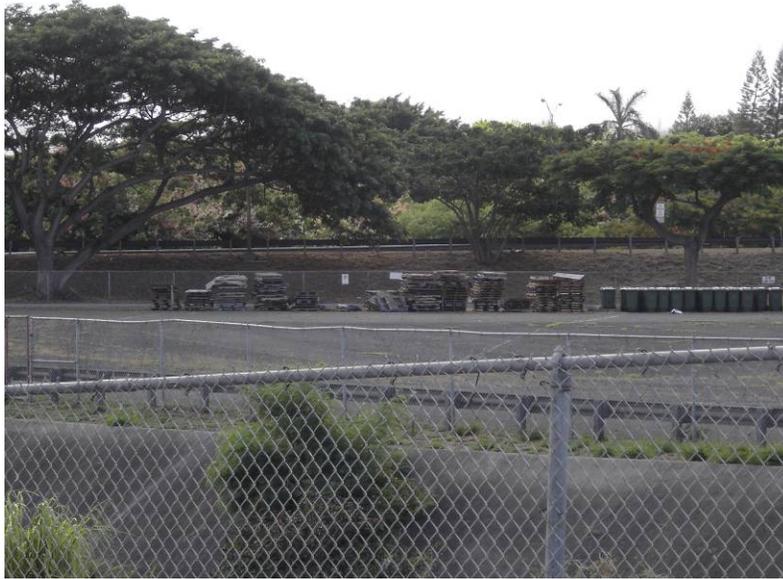
Pallets and rollaway trash cans are located against the fence in a parking area designated by the green signs next to the freeway. It is unsightly. **Recommend removing pallets and storing in an area out of sight of the public.**

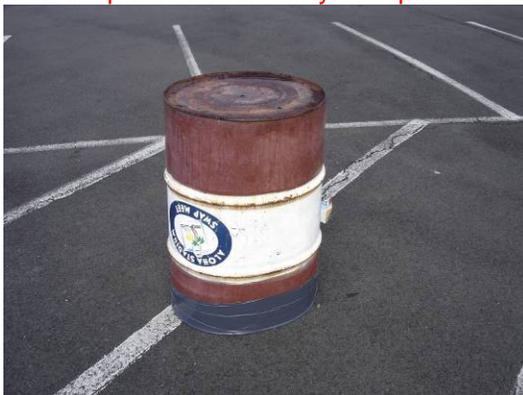
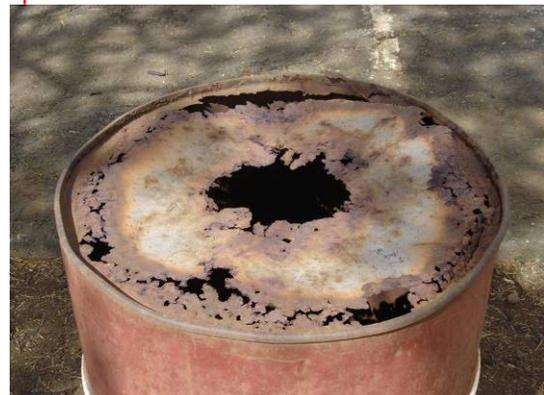
- A1. Steel 55 gallon trash drums in the parking lots are rusting and the bottoms are starting to rot. Need to be painted. Most of the trash drums are in this condition in the parking lot directly across from the main entrance. **Recommend the use of a 44 gallon Rubbermaid trash receptacle that is easily transported and emptied.**

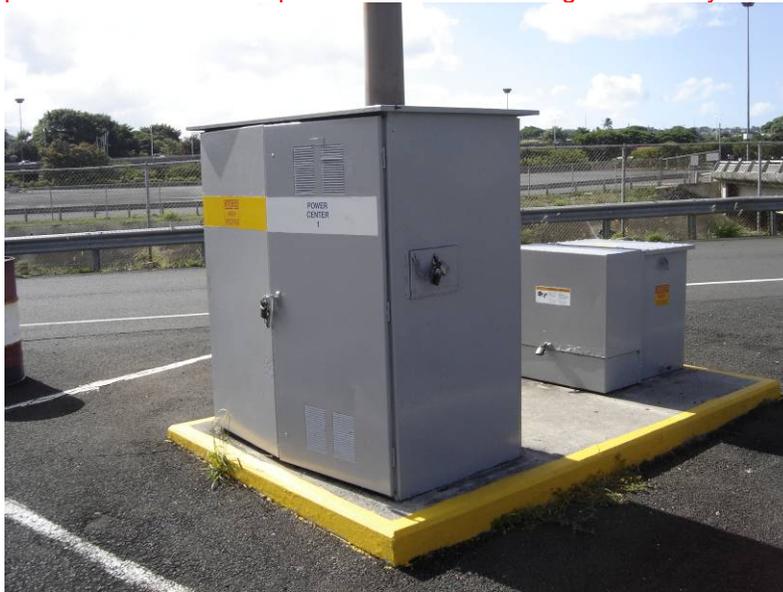
- A2. Transformer below the light pole no. 8 in the parking lot directly in front of the main entrance has the gate wide open within about 50 feet from this. **Recommend some of protective enclosure to prevent access or damage caused by vehicle intrusion.**

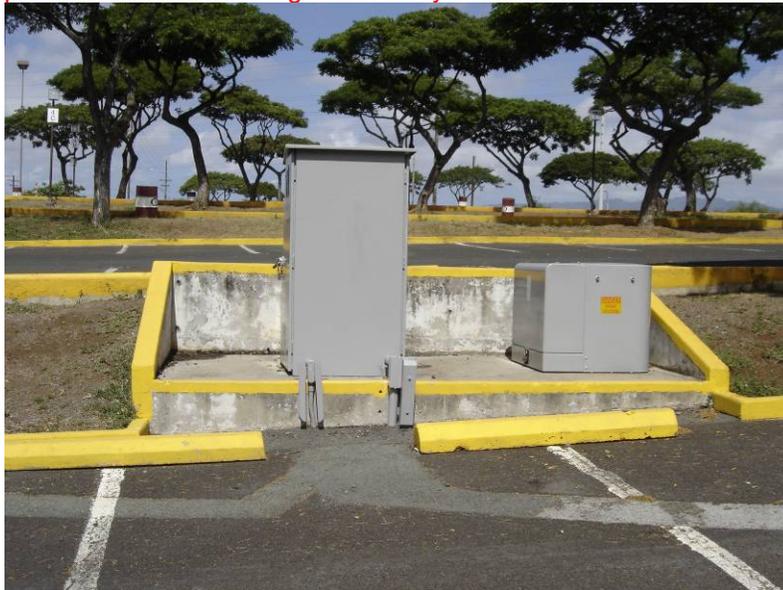
- A2. Transformers near Gate 5 have no protection. **Recommend a protective enclosure to prevent access or damage caused by vehicle intrusion.**

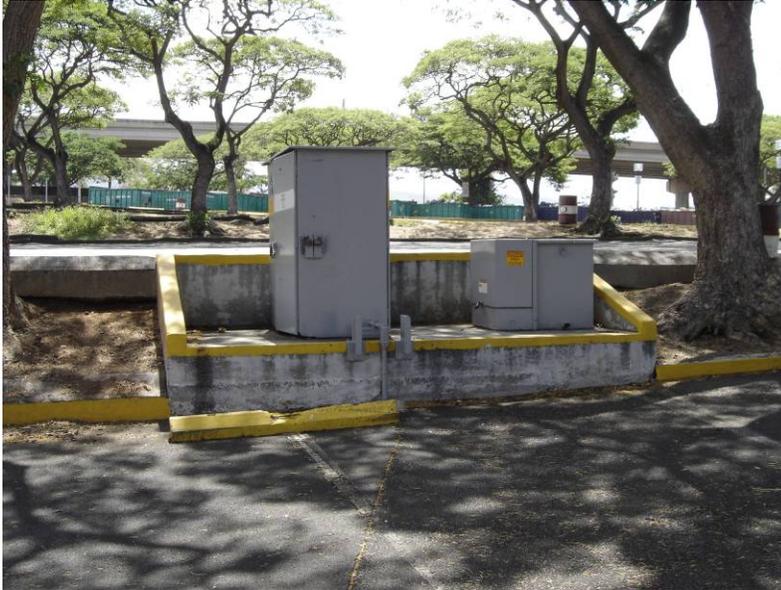
- A2. Transformer near Gate 8 is unprotected. Recommend a protective enclosure to prevent access or damage caused by vehicle intrusion.

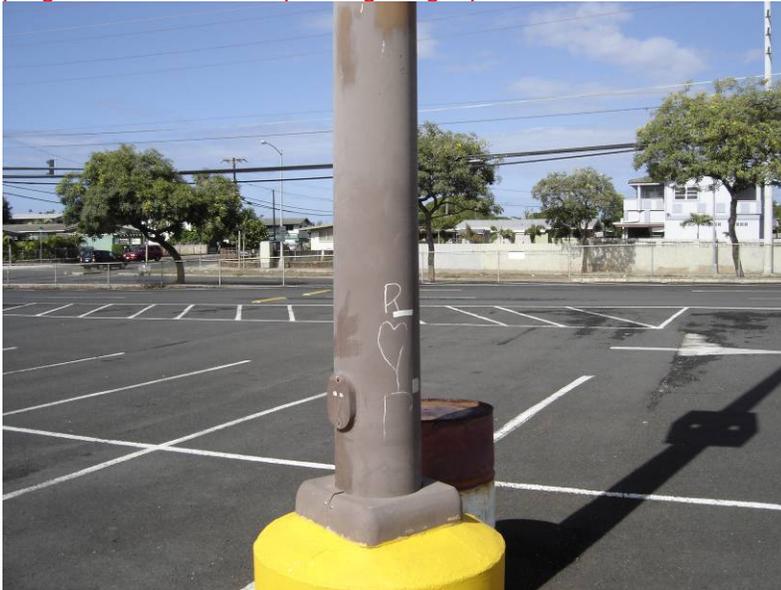
- A3. Light pole designated no. 7 in the parking lot showing signs of discoloration and graffiti is present. Light pole designated no. 4 across from main entrance is in the same condition. Pole is rusting and in need of painting. Recommend a regularly scheduled maintenance program to address the painting of light poles.

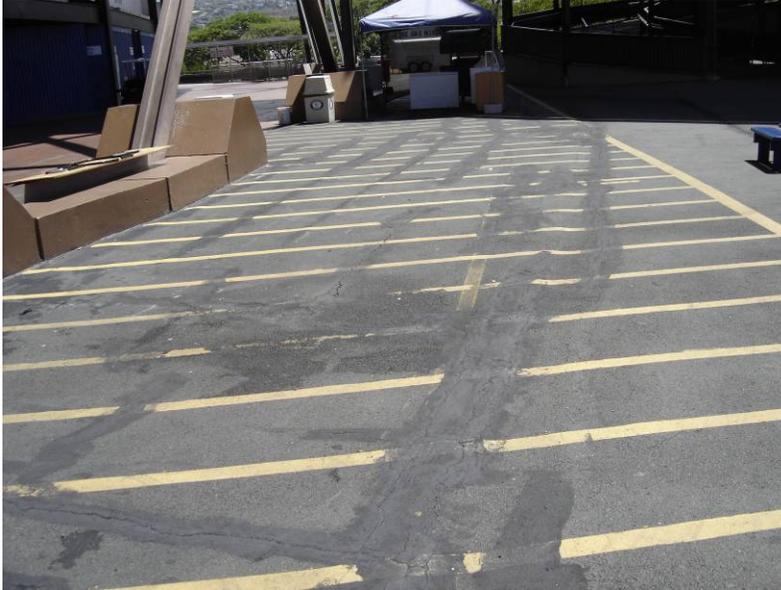
- A4. The asphalt concourse next to Gate 1 has had the cracking repaired. **Recommend the resurfacing of all asphalt paved areas.**

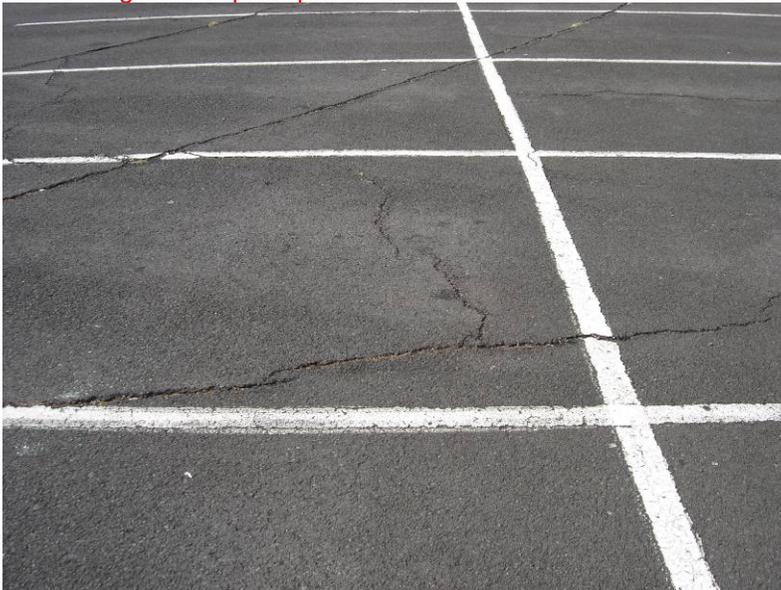
- A4. Evidence of cracking in the pavement and needs to be resurfaced. **Recommend the resurfacing of all asphalt paved areas.**

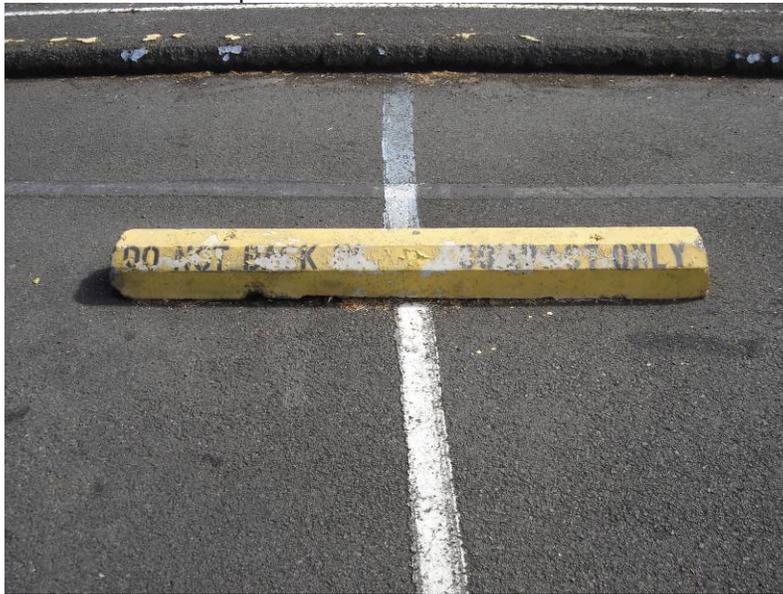
A4. Curbs need to be repainted.

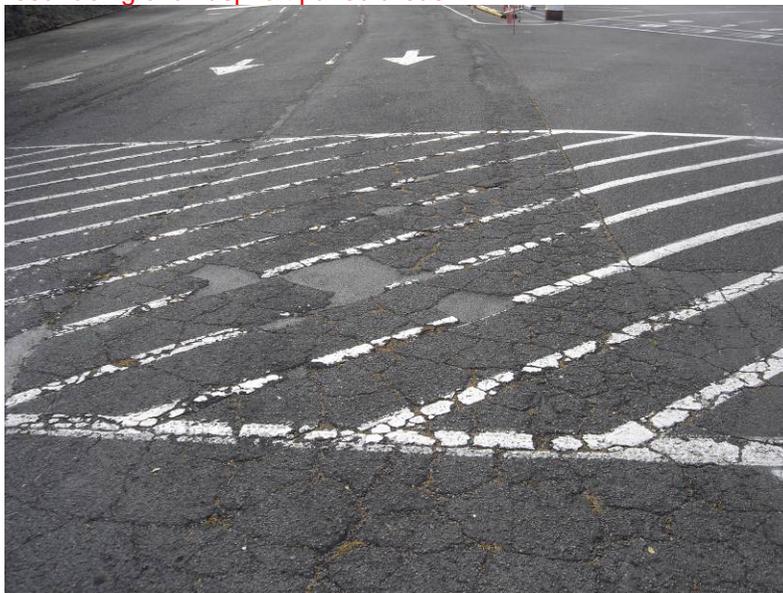
A4. Access road across from Section 4 - asphalt needs to be repaired. **Recommend the resurfacing of all asphalt paved areas.**

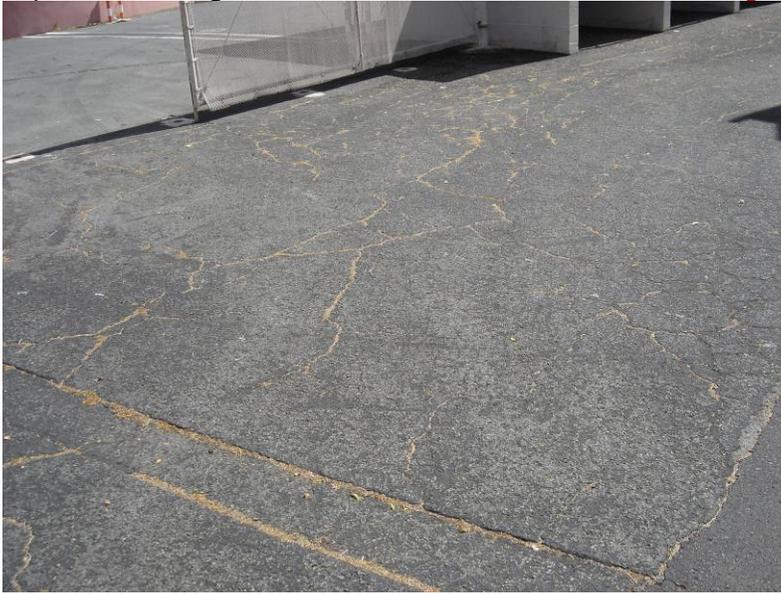
- A4. Asphalt is cracking outside Gate 4. **Recommend the resurfacing of all asphalt paved areas.**

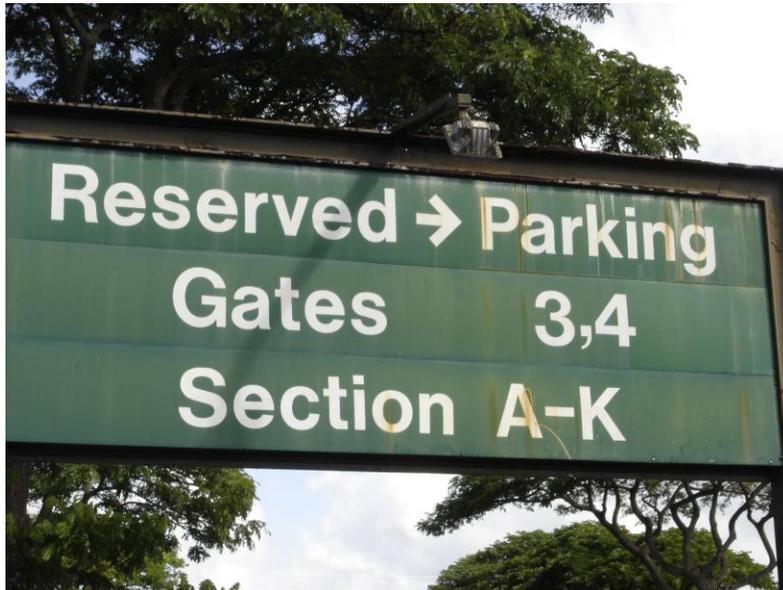
- A4. Asphalt on side of building near Sections 7 and 8 show the same wear pattern as parking lots.
- A5. Parking sign across from entrance off Salt Lake Road needs to be painted. **Recommend a regularly scheduled maintenance program to address the painting of signs and support structures.**

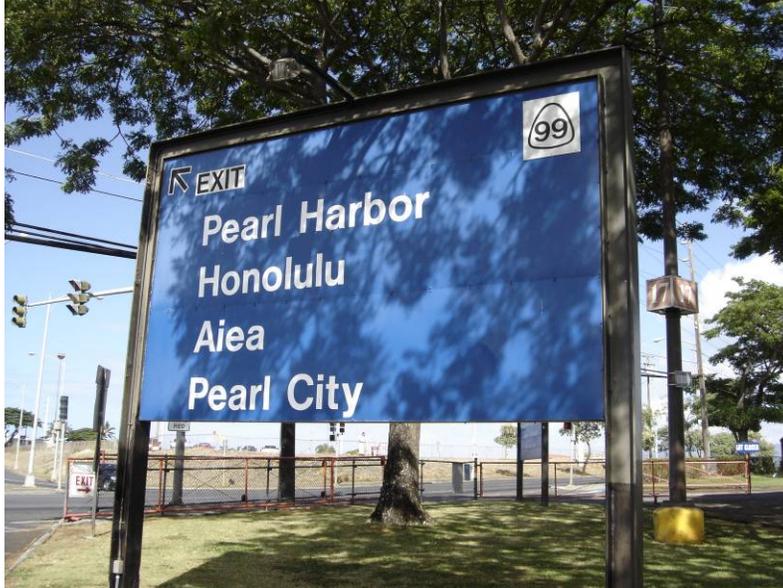
- A5. Exit sign leaving property to Salt Lake Road is in good shape and does not show signs of rusting. However, sign end support structure should be painted consistent with all other site signs to establish uniform images and condition.

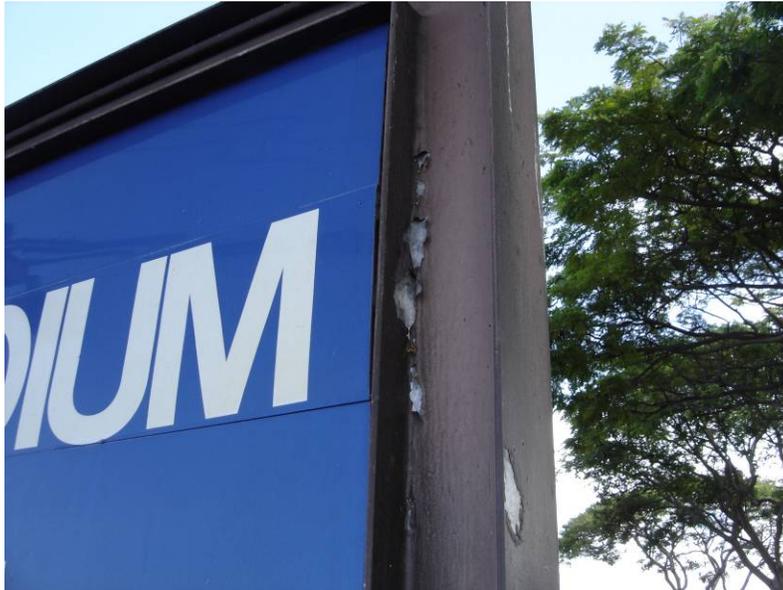
- A5. Main entrance sign showing evidence of rusting and needs to be repainted. **Recommend a regularly scheduled maintenance program to address the painting of signs and support structures.**

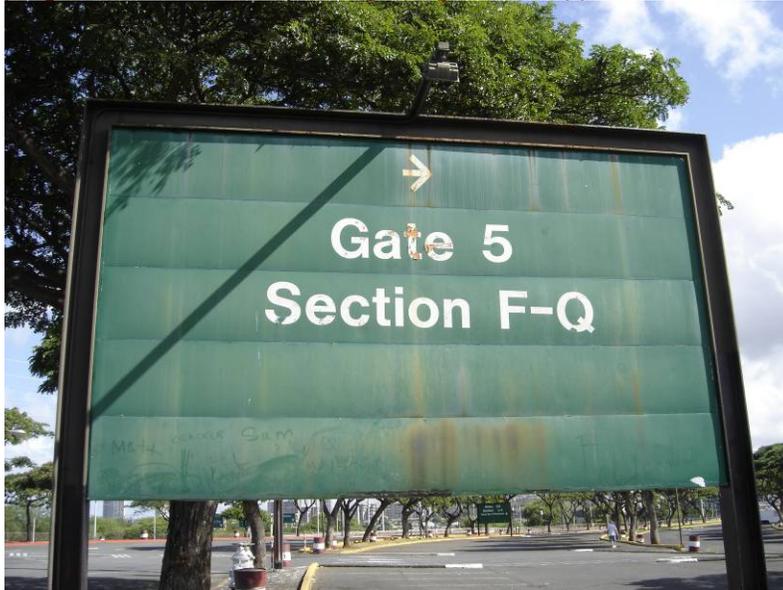
- A5. Gate 5 section sign in the parking lot across from entrance 5 - the paint is peeling off of the sign and support structure is rusting. Recommend a regularly scheduled maintenance program to address the painting of signs and support structures.

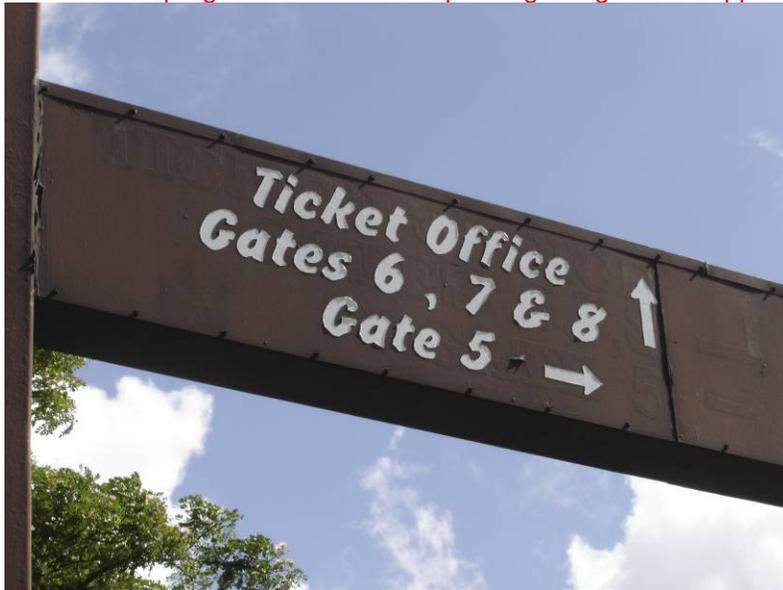
- A5. Sign across from Gate 5 - needs to be repainted. Recommend a regularly scheduled maintenance program to address the painting of signs and support structures.

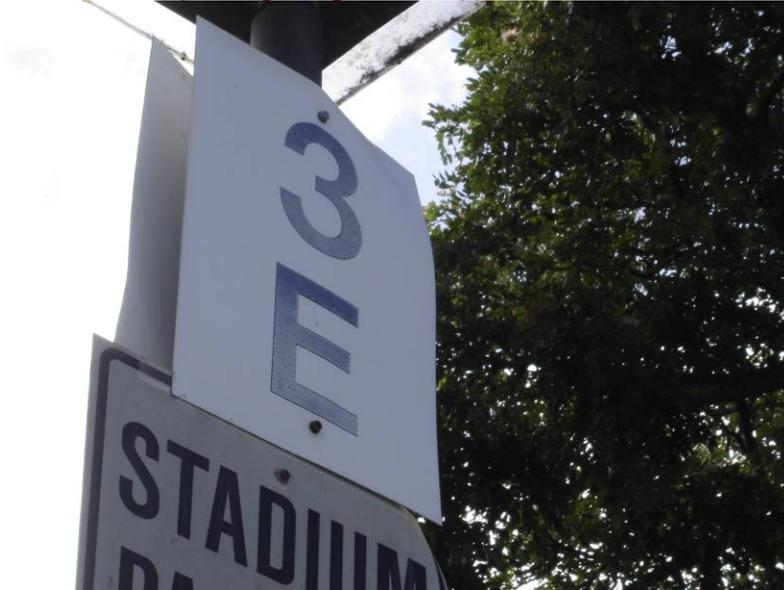
- A5. Near Gate 5 - sign on light pole is faded and needs to be replaced. Most of the lot signs need to be repainted or replaced. **Recommend a regularly scheduled maintenance program to address the painting of signs and support structures.**

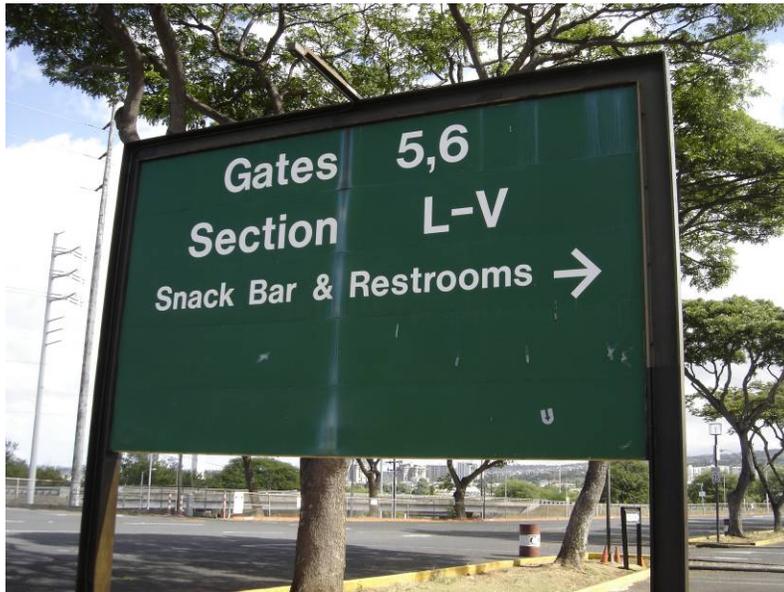
- A5. Sign designating Gates 5 and 6 - discolored and masking tape on the sign. **Recommend a regularly scheduled maintenance program to address the painting of signs and support structures.**

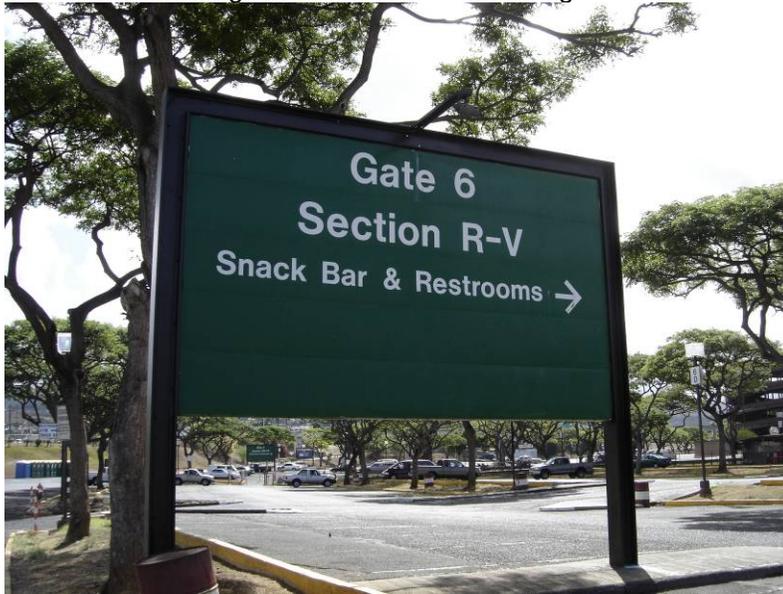
- A5. Gate 6 sign - the support frame and sign are in good shape and no need for repair except for some minor staining. However, sign end support structure should be painted consistent with all other site signs to establish uniform image and condition.

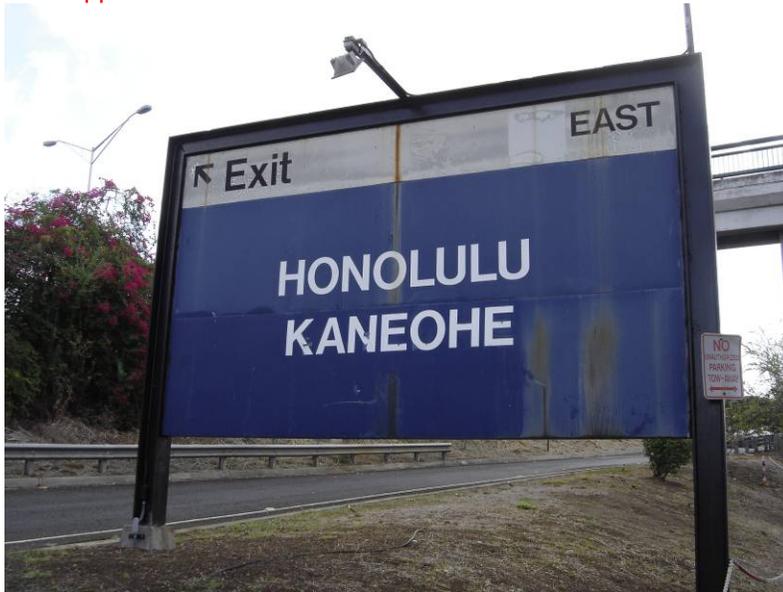
- A5. Exit sign from parking lot near Gate 7 - sign has rusted and letters are peeling. **Recommend a regularly scheduled maintenance program to address the painting of signs and support structures.**

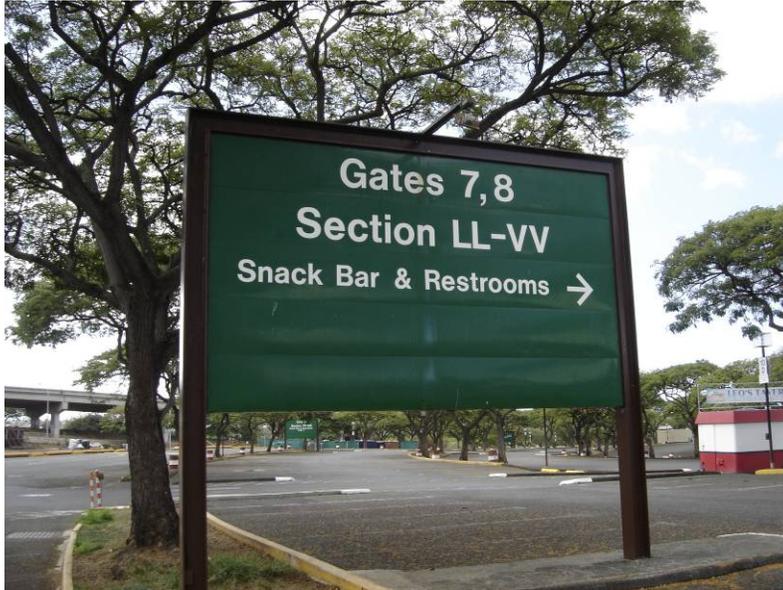
- A5. Signs at Gates 7 and 8 - it appears that the support structure has been painted recently. However, sign end support structure should be painted consistent with all other site signs to establish uniform image and condition.

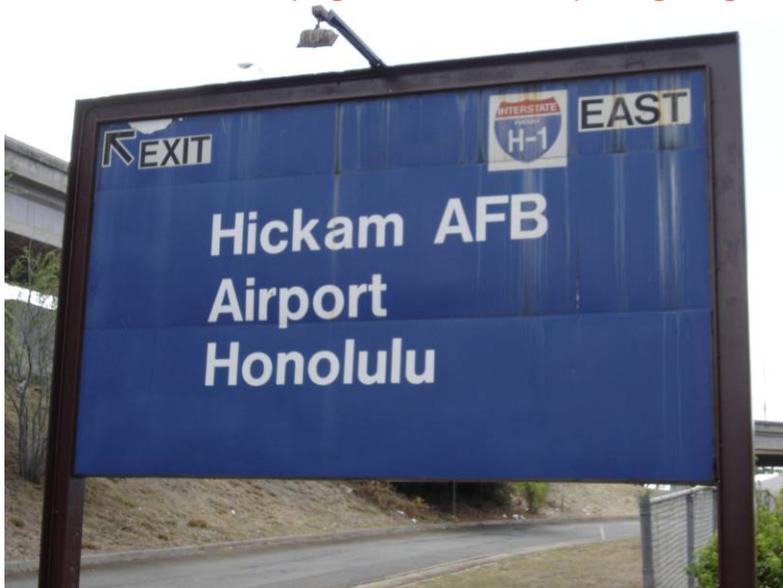
- A5. Exit sign from stadium complex is peeling and significant staining. Recommend a regularly scheduled maintenance program to address the painting of signs and support structures.

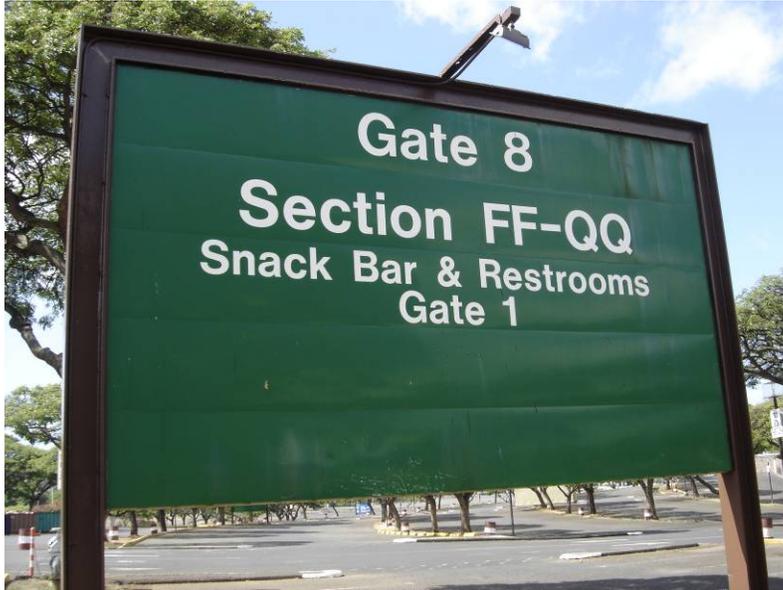
- A5. Directional signage at Gate 8 has minor rusting as well as the support structure. Recommend a regularly scheduled maintenance program to address the painting of signs and support structures.

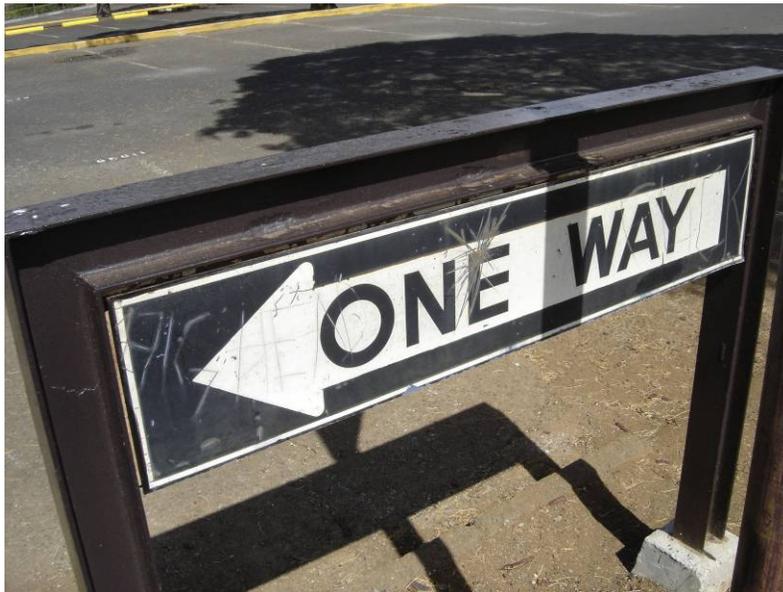
- A5. One way sign next to the light pole designated parking area 11 is faded. Recommend a regularly scheduled maintenance program to address the painting of signs and support structures.

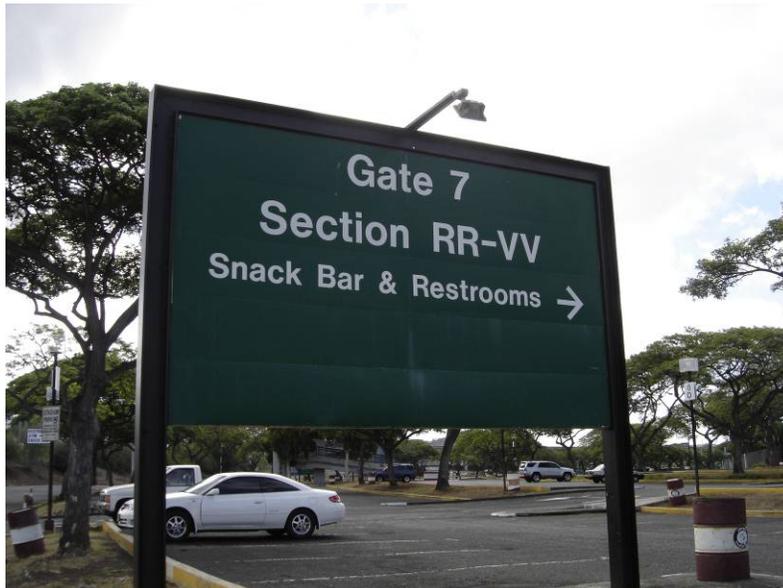
- A5. Sign designating Gate 7 is in good shape with minor staining. However, sign end support structure should be painted consistent with all other site signs to establish uniform image and condition.

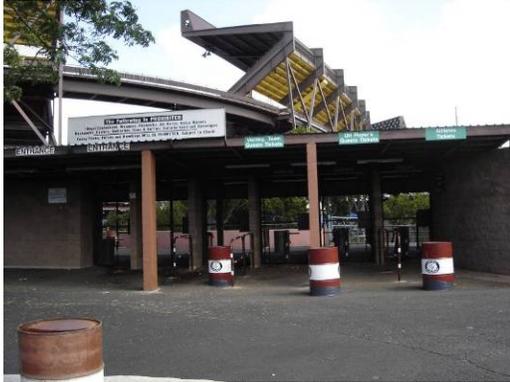
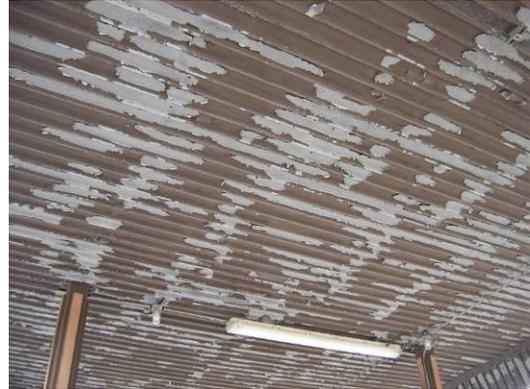
- A6. Underneath the roof that is access point to the parking lot - all the paint is peeling and needs to be repainted. **Recommend a regularly scheduled maintenance program to address the painting of roofs of parking overhangs.**

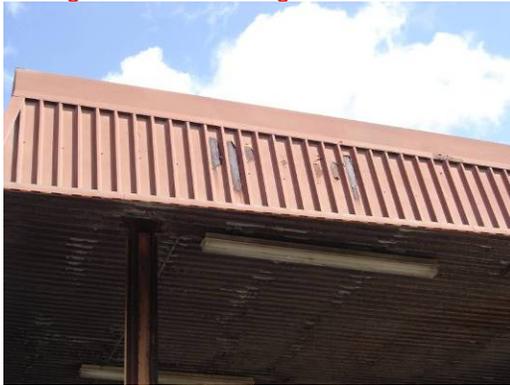
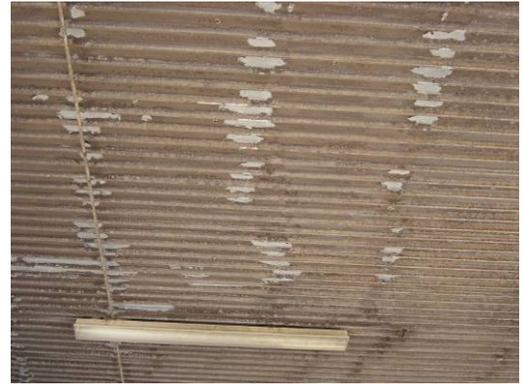
- A6. Entry building at parking lot entrance across from Gates 6 and 7 has a metal roof soffit with peeling paint. The roof canopy is peeling significantly. **Recommend repainting all parking lot building entrance buildings.**

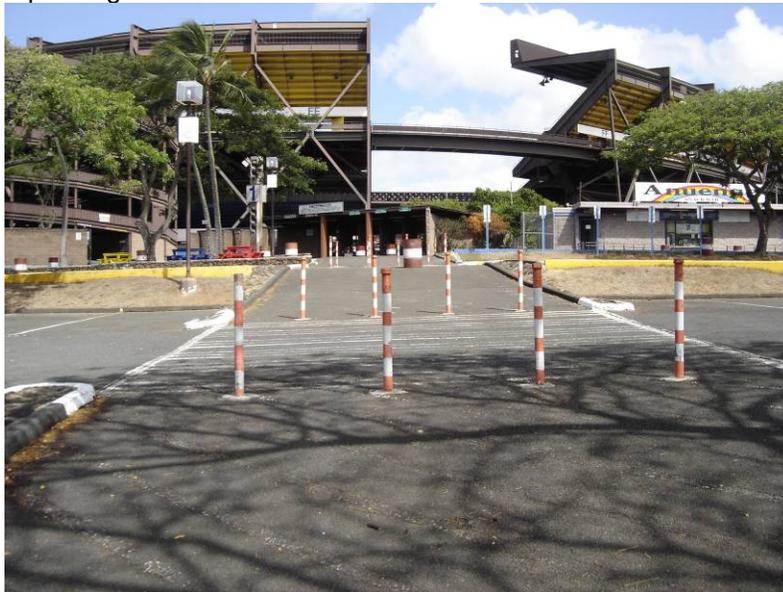
- A7. Gate 1 area parkway leading to gate has ample vehicle intrusion bollards. Bollards need repainting.

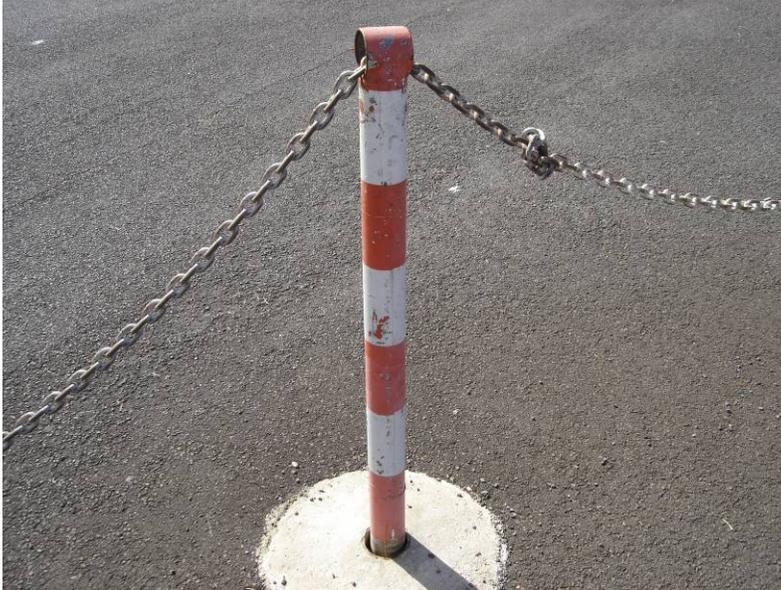
- A7. Parking lot next to entrance no. 5 - bollards have been chipped and worn and need to be repainted. Recommend a regularly scheduled maintenance program to address the painting and refurbishment of bollards.

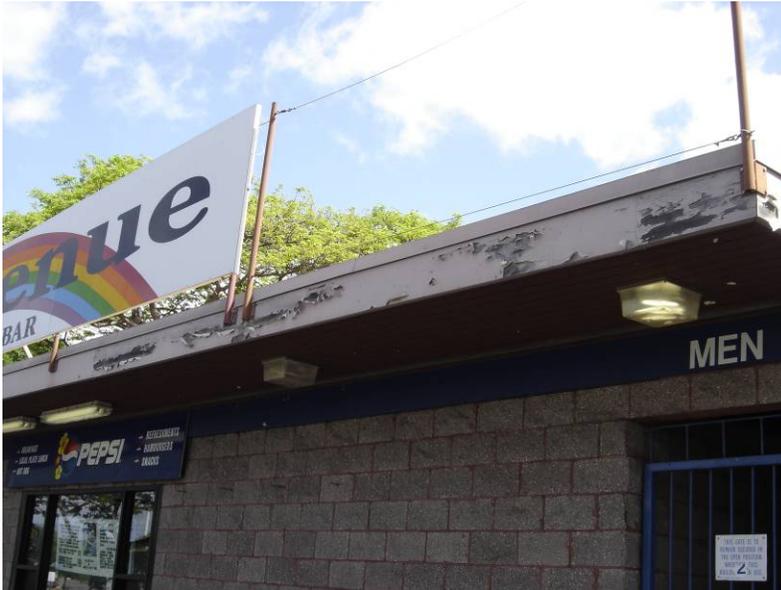
- A8. The concession stand next to Gate 4 has peeling paint on the soffit. Recommend a regularly scheduled maintenance program to address the painting of exterior building structures.

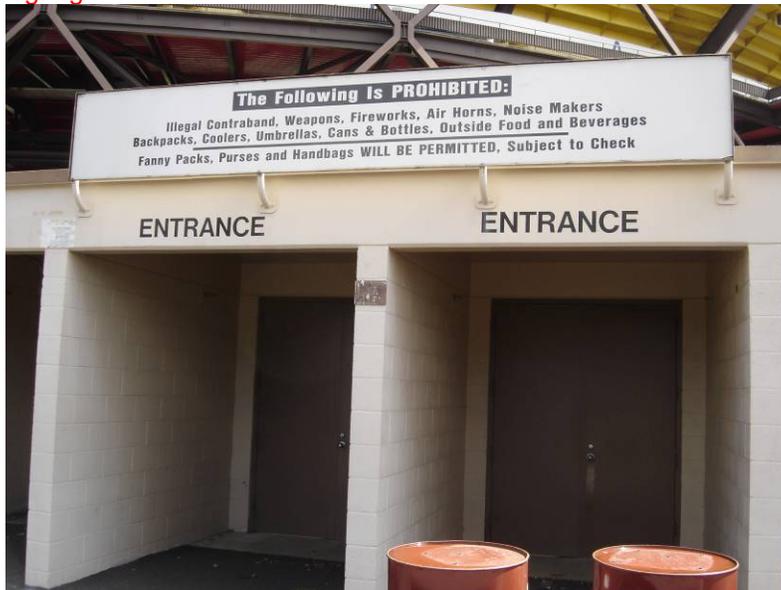
- A10. Gate 3 signage is clear and concise, however should be replaced as part of overall site signage refurbishment.

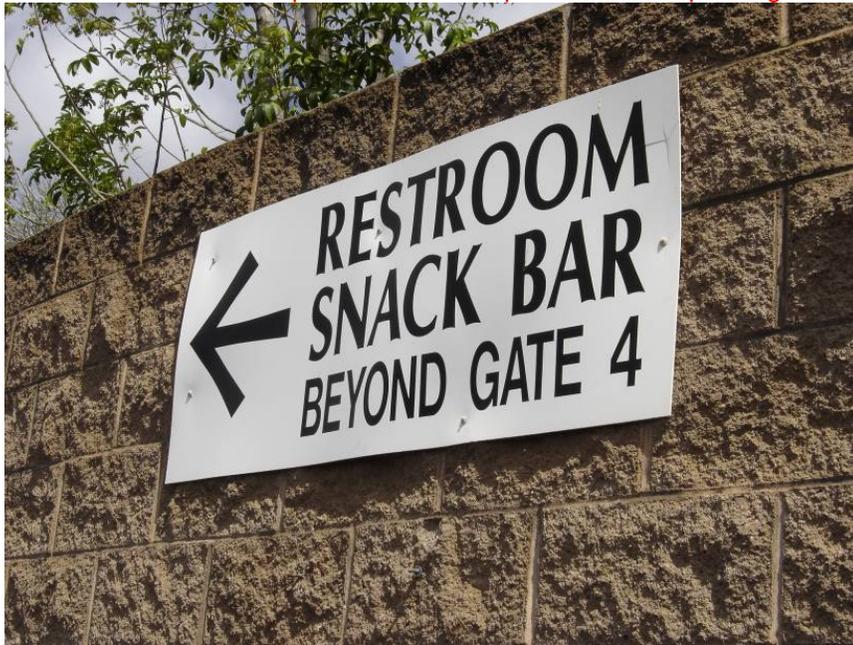
- A10. Sign on the wall next to Gate 4 is bent and in need of replacing. **Recommend a regularly scheduled maintenance plan to address replacement or repainting of directional signage.**

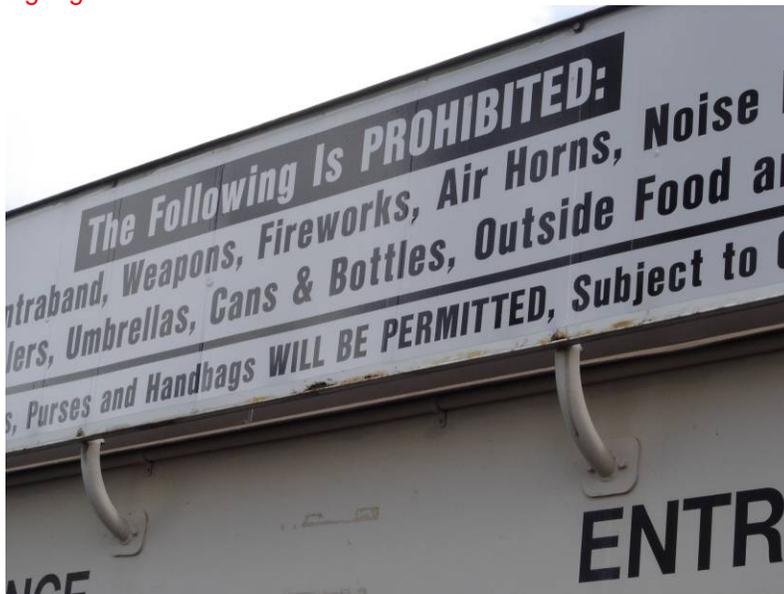
- A10. Gate 4 prohibited items signage exhibiting signs of rusting at the bottom. **Recommend a regularly scheduled maintenance plan to address replacement or repainting of exterior signage.**

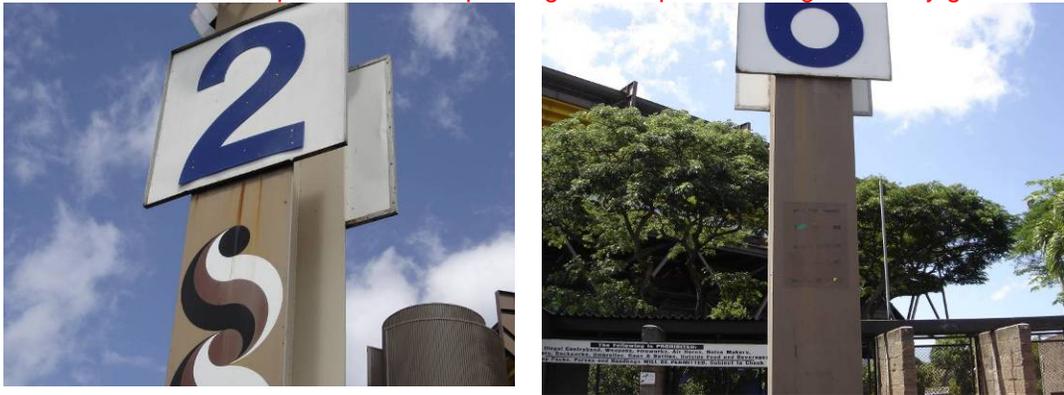
- A11. Gate 2 and Gate 6 steel posts exhibiting signs of corrosion. Recommend a regularly scheduled maintenance plan to address painting of steel posts and signs at entry gates.

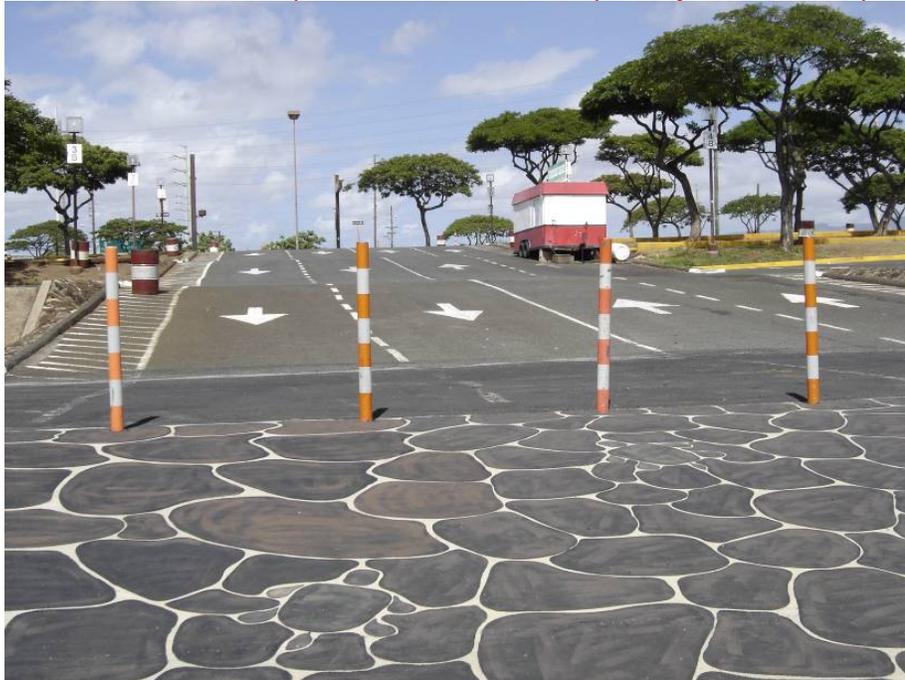
- A12. Gate 5 approach has one level of vehicle intrusion protection. Recommend increasing the level of vehicle intrusion protection at Gates 5 & 8 possibly with concrete planters.

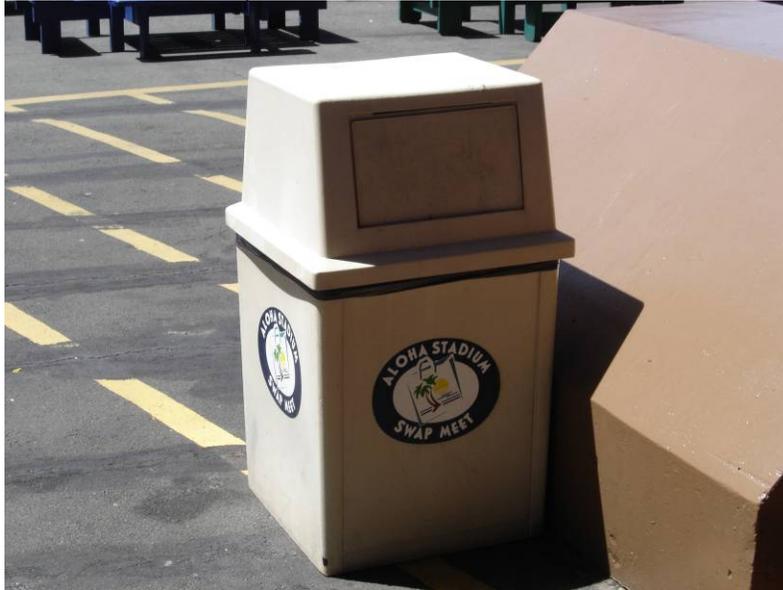
- A15. Primary trash can on main lower level concourse. Trash cans with spring hinged doors are not considered as a “best practice.” Recommend replacing trash can top with a top that has sides that are “open.”

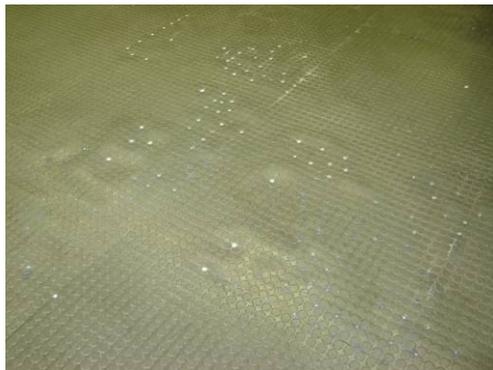
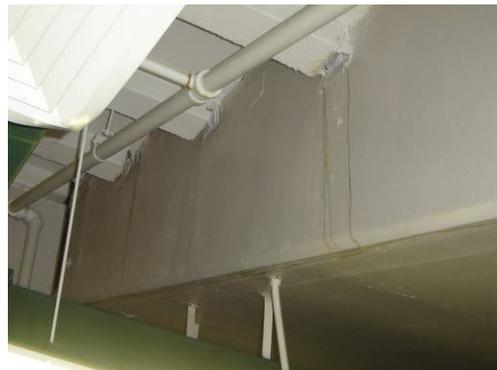
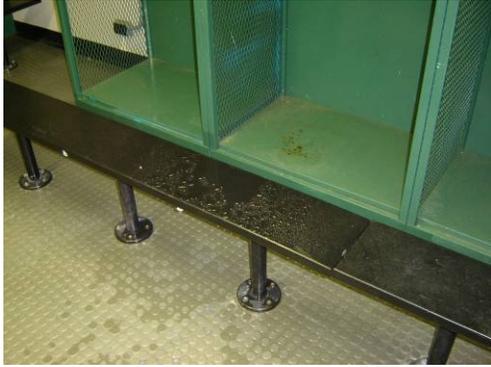
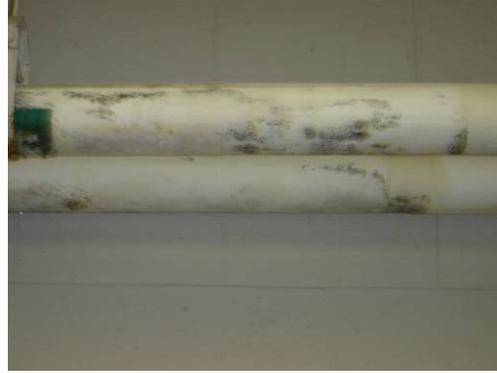
C1. Team locker facilities – There are two large locker rooms at the event level of the stadium. Both locker rooms have toilets, showers, and coaches offices associated with each. The condition of the visitor locker room (on east side of level) is in poor condition. Water has leaked through the precast seating bowl above and has damaged the rubber flooring, pipe insulation, paint, and several other items. It appears this water is also causing mold to grow in certain places which could become a serious health concern if not corrected. Leaking pipes are damaging pipe insulation. **Recommendation – Stop water from entering space by replacing the sealant joints in the precast seating areas above, adding a subroof system, and removing the old coating system on concrete treads and risers and replacing with elastomeric waterproof traffic coating. Traffic coating and precast joint replacement is also necessary to protect the condition of the bowl and is discussed in greater detail in Section D, Seating Bowl. Hire an industrial hygienist to confirm the presence of mold and offer advice of how to eliminate it.**

C2. **Remove and repair any finishes including painting of walls and ceilings damaged by water or showing signs of mold.**

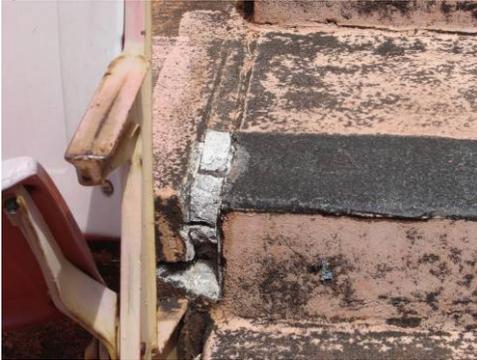
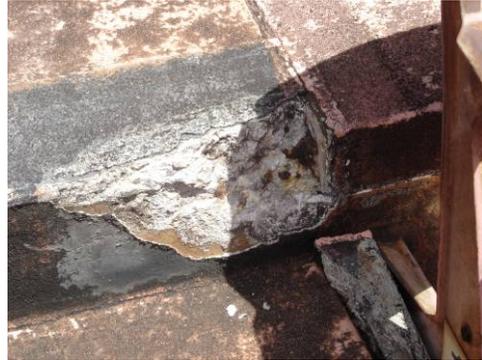
- D1. Section R row 18 seat 19 - concrete joints are delaminating. There are several areas where this is evident. **Recommend a review of maintenance procedures to address broken concrete in fixed seating. Repair concrete prior to elastomeric waterproof traffic topping replacement.**

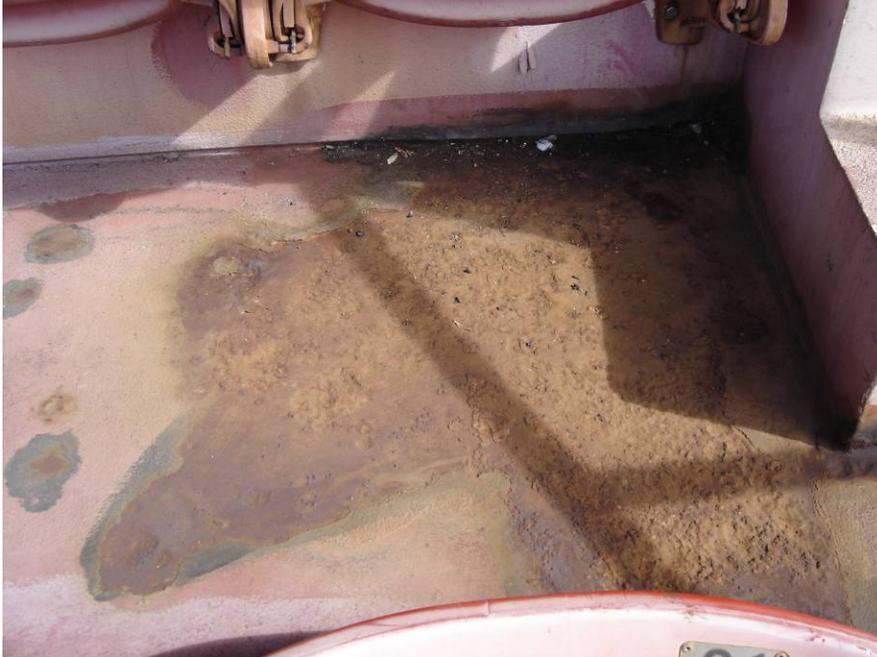
- D1. Section U seat 21 row 3 – floor coating at the base has come up and has exposed the concrete and is beginning to weather. This photo illustrates a common condition on the Loge Level requiring reapplication of the elastomeric waterproof traffic coating.

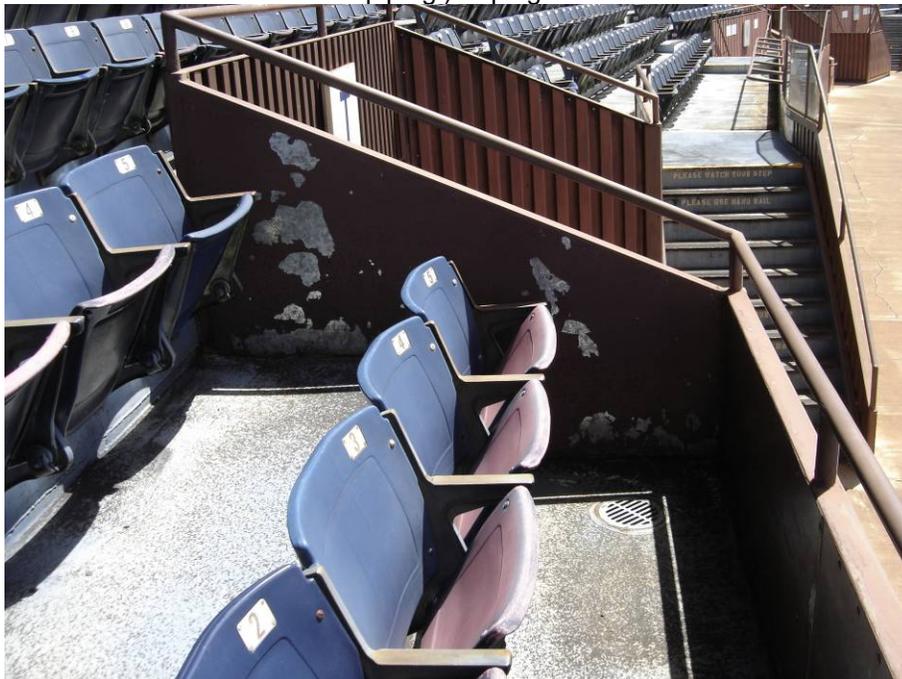
- D3. Section S row 31. The paint has come off the vomitory bulkhead wall and is in need of repainting. Recommendation: Recoat utilities and other nonstructural components at the same time structural steel is recoated. (Refer to Plumbing section of report which addresses the condition of the piping.) Piping will need to be cleaned and repainted.

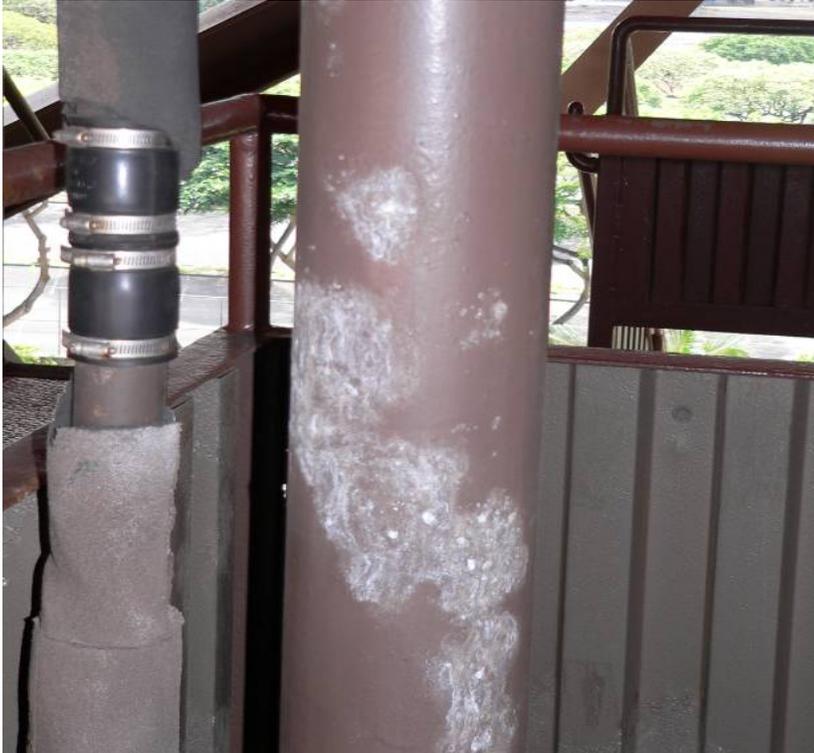
Roof drain leaders show signs of corrosion.

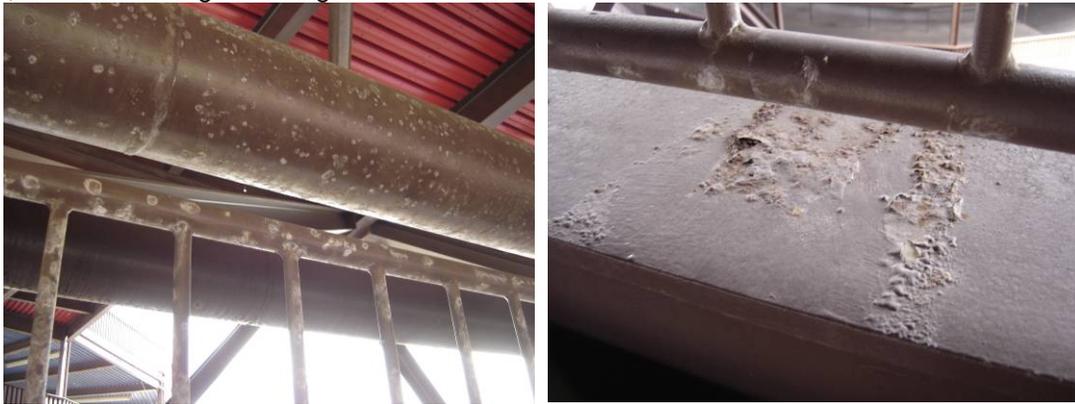
Section S, Row 46 – railings showing evidence of oxidation.
