VOLUME 2: EXISTING CONDITIONS

aloha stadium PLANNING STUDY FINAL REPORT - 12.22.05

SECTION II: CONDITION SURVEY

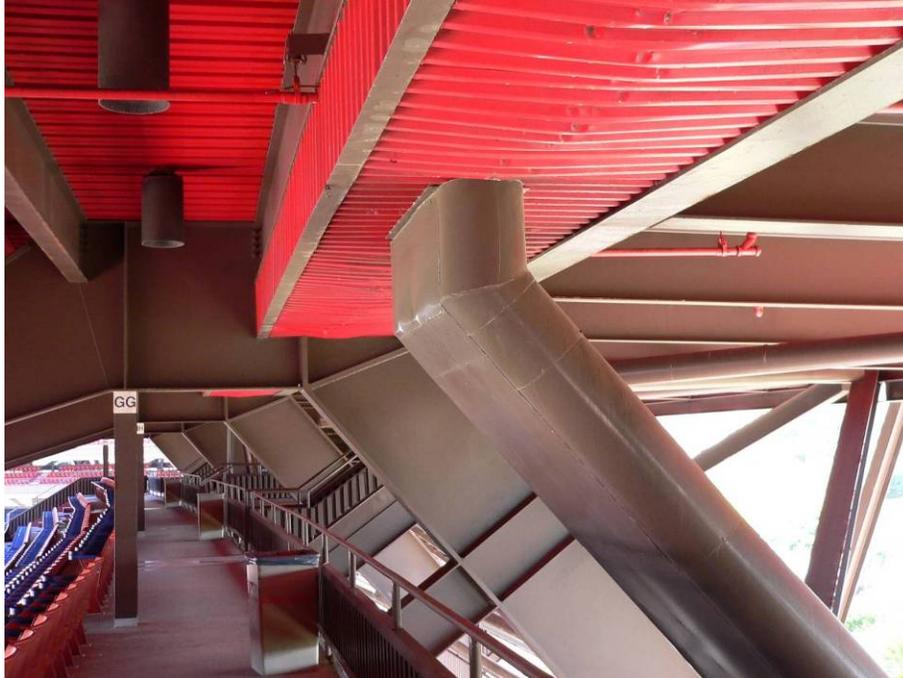
D4. A utility chase runs above the cross aisle and is enclosed with painted metal deck. In several areas, particularly the northeast moveable stands, the horizontal deck is significantly dented apparently due to damage caused by workers bearing weight on the surface from above. Recommendation: Remove and replace painted metal deck.

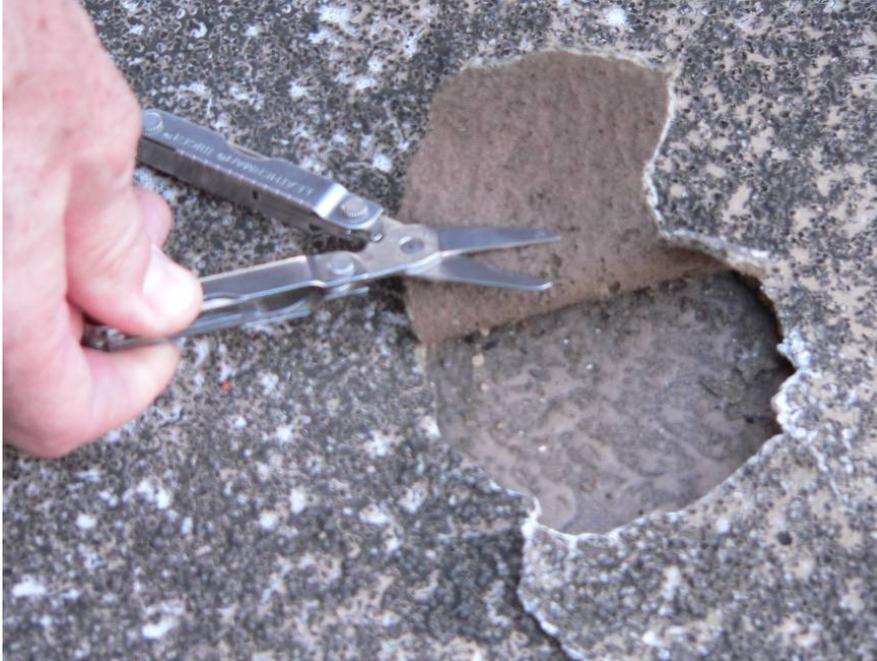
- D1. Treads and Risers are steel plate with elastomeric waterproof membrane traffic coating. The membrane is failing, particularly in the more exposed rows due to greater sun exposure. Photo below shows delamination of the last membrane from what is assumed to be the original coating. Recommendation: Remove existing coating and reapply new elastomeric waterproof membrane in conjunction with seat replacement.

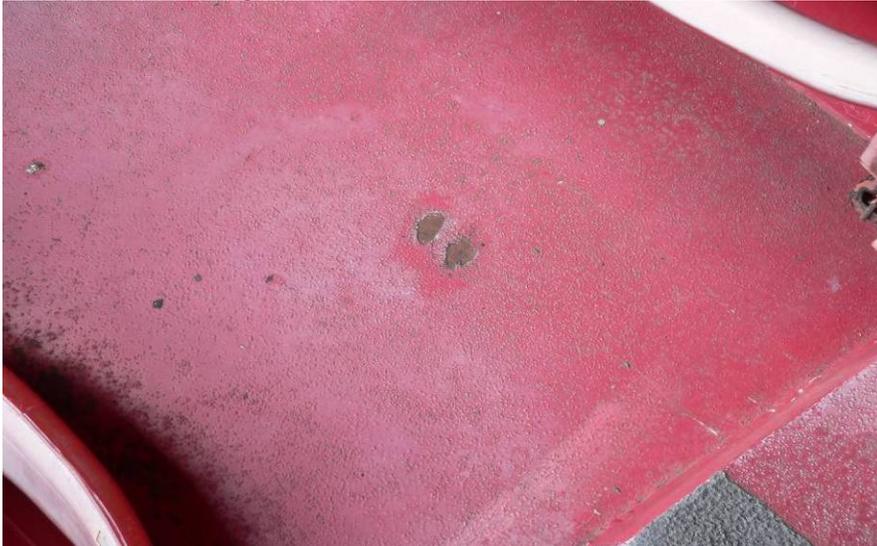
Lower section below cross aisle has small amounts of exposed bare steel. Balance of topping is very thin and needs recoating.

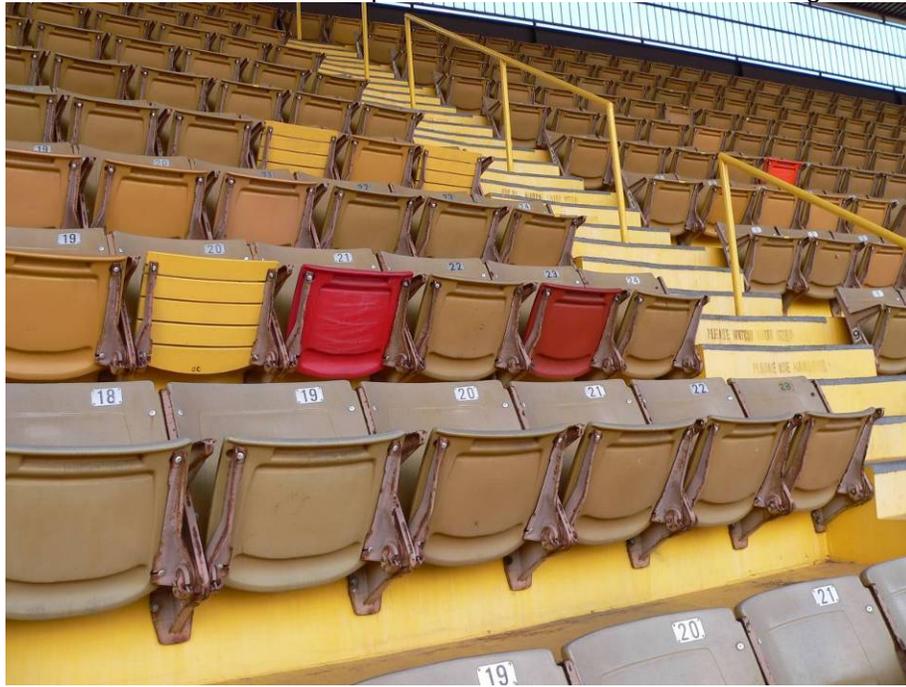
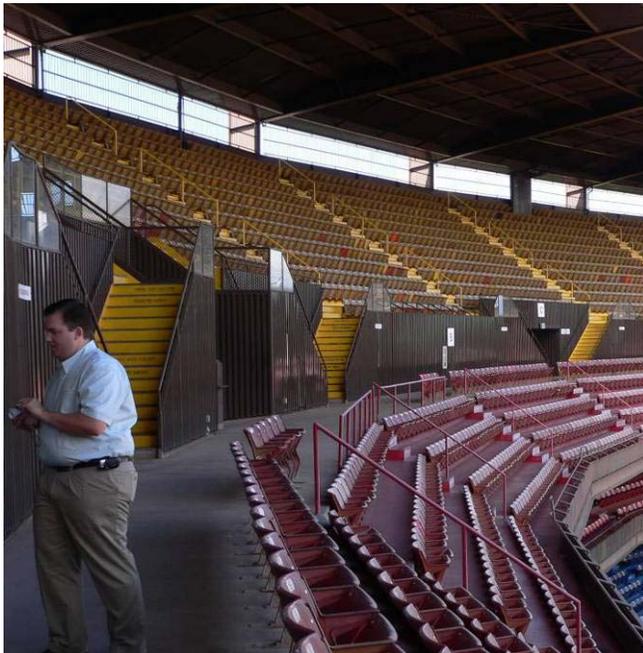
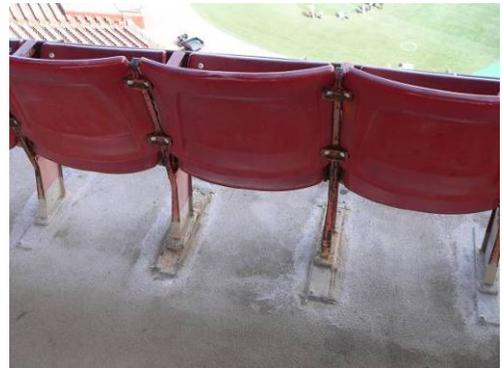
- D2. Seats are in the middle range of deterioration on this level and need to be replaced due to extent of corrosion on seat standards, fading of seats and backs, and loss of spring action on seats. Several seat bottoms have been replaced with an ad-hoc supply of "found" seat bottoms. Recommendation: Replace all seats on this level and throughout the stadium.

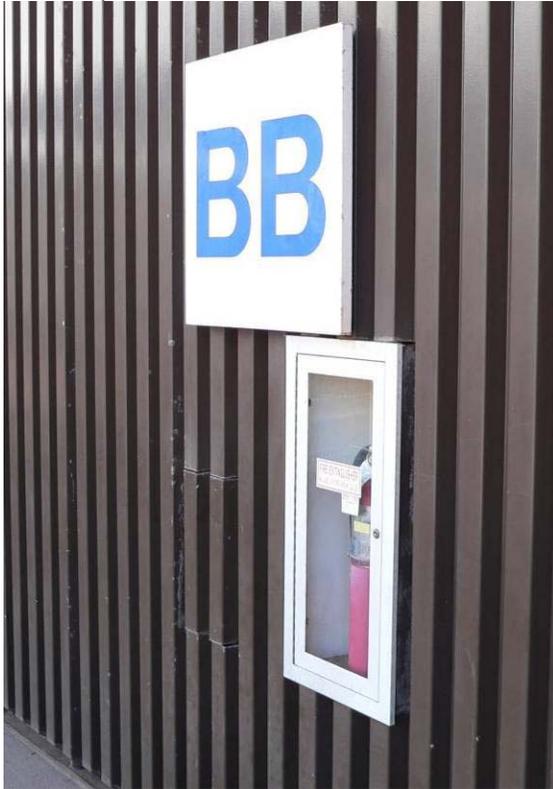
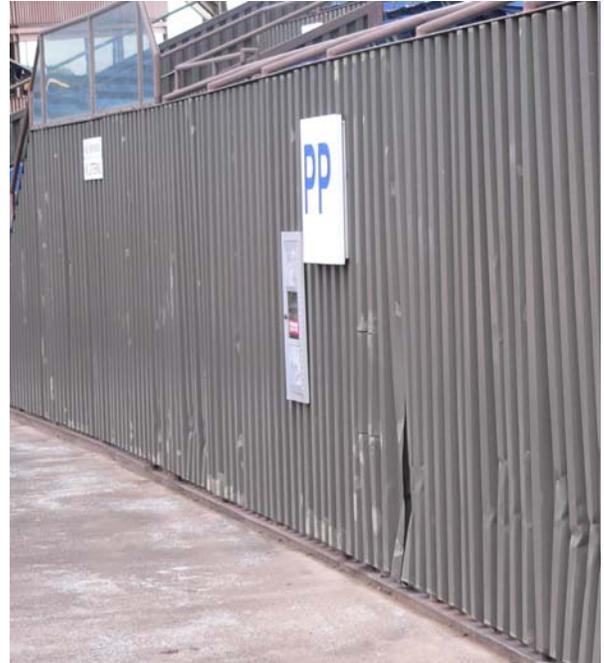
- D6. Cross Aisles – The metal siding forming the bulkhead in front of the upper bowl and forming one side of the cross aisle has some corrosion and in the north east moveable stands section is significantly dented. Recommendation: Replace damaged wall panels. Recoat all wall panels.

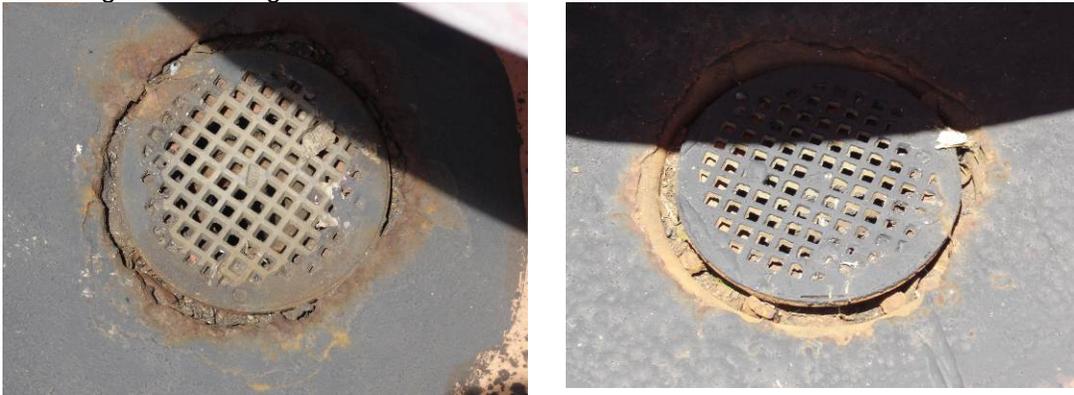
- D7. Floor drain at Section M, Row P, as well as other areas within the moveable seating sections, show signs of significant corrosion. Replace corroded drain bodies prior to installing traffic coating.

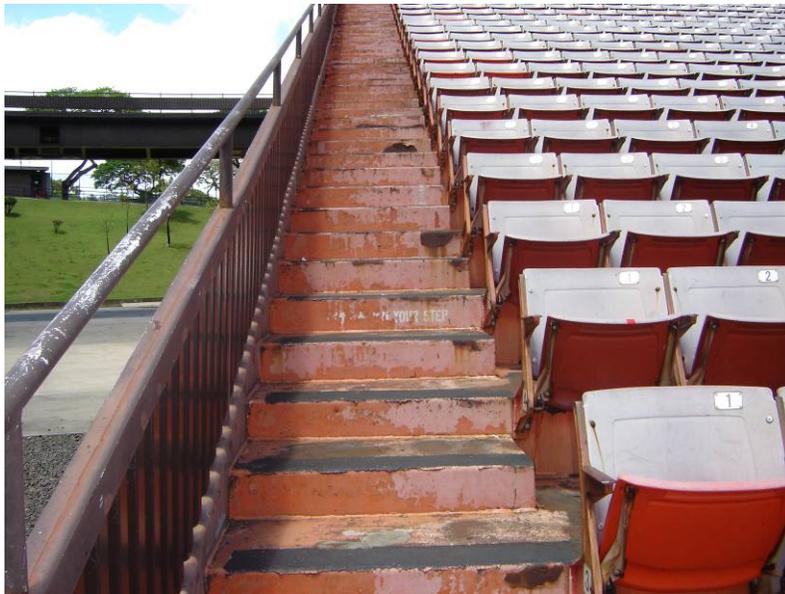
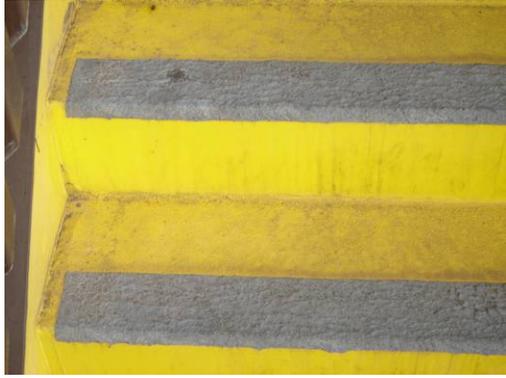
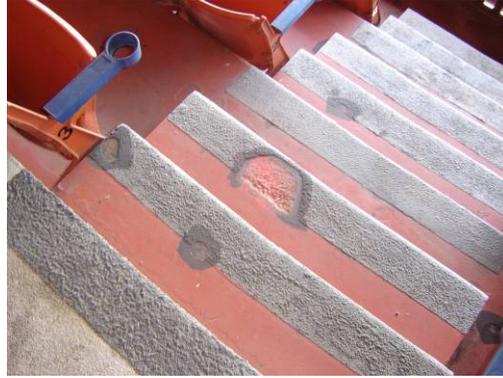
- D1. Stairs – In both the lower and upper field seating areas there are aisle steps located between sections. In the lower field seating bowl the width of the aisle steps vary from 4'-7" wide at the top of the section to 3'-6" wide at the bottom of the section. In the upper field seating bowl, the width of the aisle steps vary from 3'-6" wide at the top of the section to 4'-3" wide at the bottom of the section. This change in width relates to the increased capacity of the aisle steps as they get closer to the lower level concourse. There are also 5'-0" wide accelerated aisle steps leading from the cross aisle up to each aisle of the upper field seating areas. The aisle steps in the lower bowl seating areas match the same construction as the treads and risers that they are located in, so the overall condition of them is very similar to the tread and riser condition. The failure of the coating system is the biggest issue at this time and is consistent with the type of failures occurring on the seating bowl treads and risers. The condition of the stair nosing material on the aisle steps in the lower seating bowl however is still in good condition in most locations. There are a few isolated locations where the coating has been chipped or damaged. **Recommendation – Removing existing coating system and replacing with elastomeric waterproof traffic coating system on the aisle steps throughout the stadium when the rest of the coating system on the seating bowl is replaced. Continue to spot repair stair nosing material where necessary.**

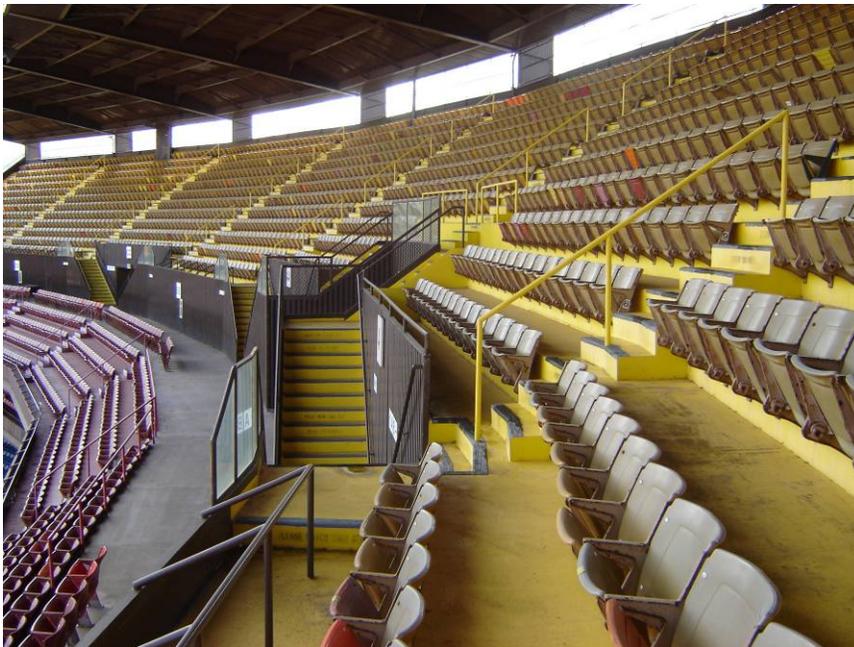
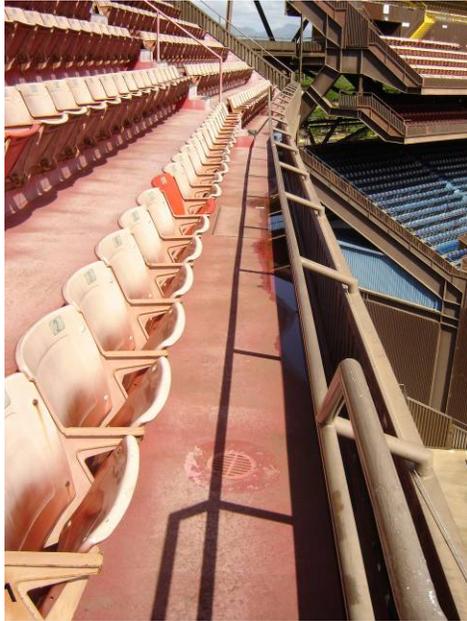
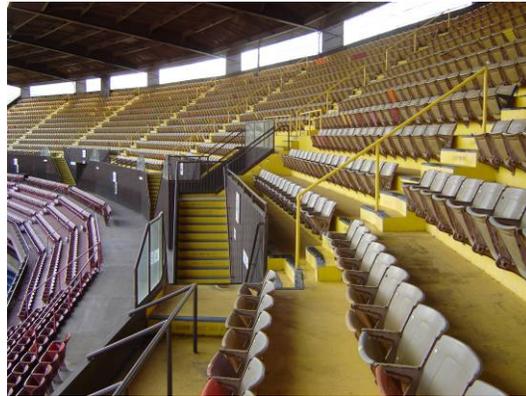
D8. Railings – Most of the railings in the seating bowl appear to comply with current code requirements. All of the rails are painted steel. The coating is currently acceptable however these rails will need to be repainted in the near future. There is some glass infill on the guardrails around the vomitories at the upper tier seating and upper field level seating sections. In the upper tier seating sections of the upper deck the height of the guardrails at the landings is 3'-5" instead of the required 3'-6". Also, the guardrails are not as long as the width of the aisle steps above. They begin to slope down with the stairs 2 to 3 inches before they should. This condition also occurs at the upper field seating vomitories. At the vomitories at the upper tier and upper field level seating sections there is no railing at guardrail height (3'-6") down the side of the stair adjacent to the cross aisle. The single rail that is mounted there is at handrail height (2'-10") and does not meet guardrail code requirements. At the front of all of the seating decks the rails that are installed appear to meet current code requirements however some of them have a very strange configuration for sightline reasons. Only the seating in the upper deck (lower and upper tier seating sections) has a center aisle rail installed. We would recommend installing a center aisle rail at the other seating bowls for safety. The center aisle rails that are installed do not have a second horizontal rail 12" below the top rail. **Recommendation – Correct heights of rails where they are low or not long enough to meet current codes. Install guard rail on sides of accelerated stairs next to cross aisles. Install center aisle rails at lower and upper field level sections as well as box seat sections. Recoat railings at all locations when seating bowl is recoated.**

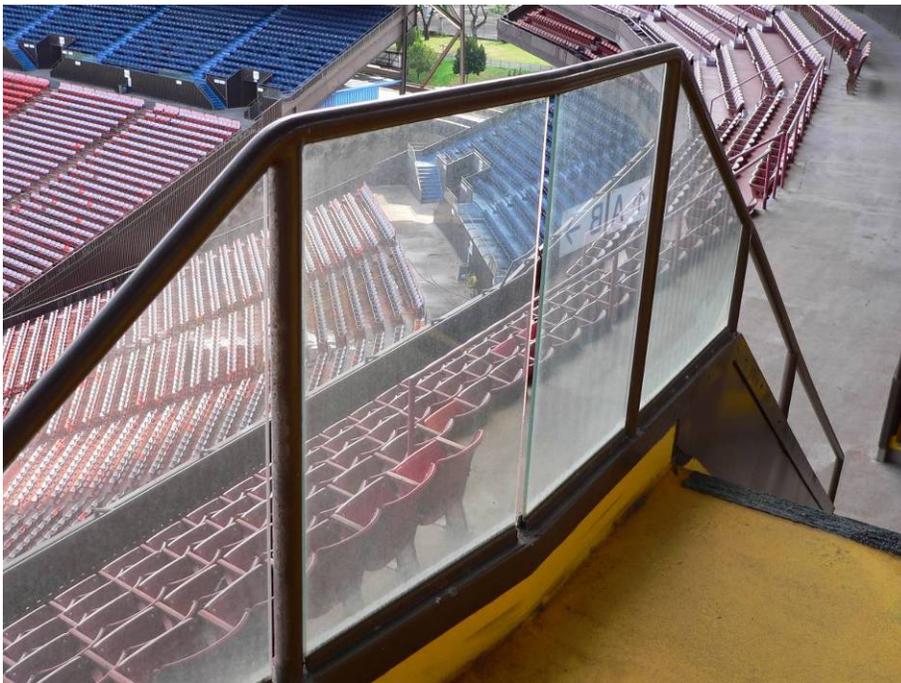
- D8. Railings – Stair landings utilize glass panels. Panels are approximately 42” in height at landings, but open side of stair does not meet 42” high guardrail code requirement. Glass should be confirmed that it is tempered or laminated for safety reasons. All railings should be recoated. Side railings should be corrected to provide required guardrail protection.

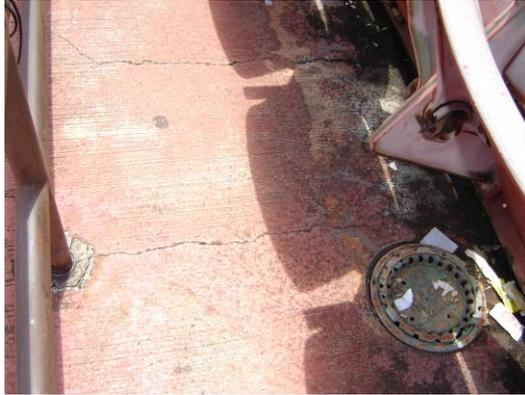
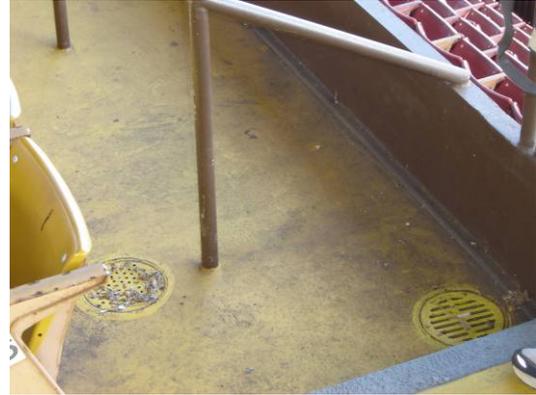
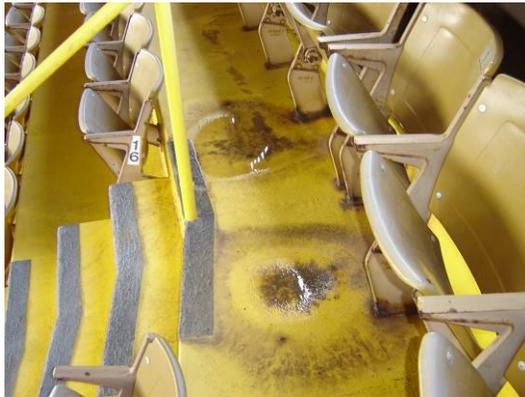
D8. Drainage - The intent of the original seating bowl drainage system was for the treads and risers (both concrete and steel) to be sloped towards the front row of each seating section where drains are located. This drainage system appears to work well in the north and south areas of the lower field seating sections where the seating bowl is precast concrete. The only problem observed at these locations were the drains being filled with trash and other debris. At the east and west lower field seating sections as well as the entire upper field seating bowl the drainage system does not work as well. At all of these locations the seating bowl is constructed of steel treads and risers. There were many locations observed where the water ponds on the seating bowl treads instead of running down to the next row. It appears that this ponding of water has accelerated the deterioration of the steel coating system in those areas. It is evident that this has been a problem for some time as additional drains have been added in random locations to provide spot drainage for ponding water. While this does solve the problem at an individual location we believe it is a costly solution to try to do this everywhere. **Recommendation – Eliminate areas in seating bowl where water ponds and does not drain properly prior to applying traffic coating. Clean out trash and debris from existing drains.**

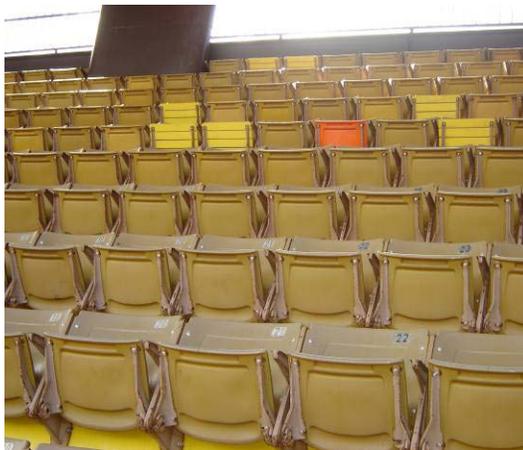
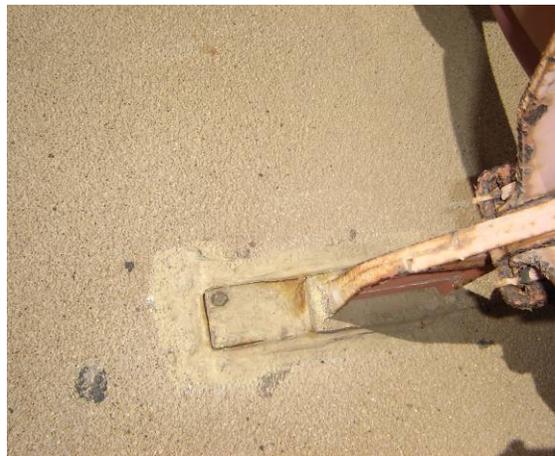
- D2. Seats / bleachers – The seating at all locations of the stadium is in poor shape and in need of replacement. The majority of the seating standards and hinge arm assemblies are showing significant rust. Most of the anchorage into the seating treads and risers appeared sturdy and most of the hinge arm assemblies appear to still function properly. The plastic seat backs and bottoms are severely faded and there are many locations where they have been replaced with a piece that is a different color, been painted to match, or a piece that is wooden instead of plastic. The seating in the lower and upper field seating areas are 21 inches wide which is wider than the current standard of 19” in most modern stadium general seating areas. **Recommendation – Replace entire seating system.**

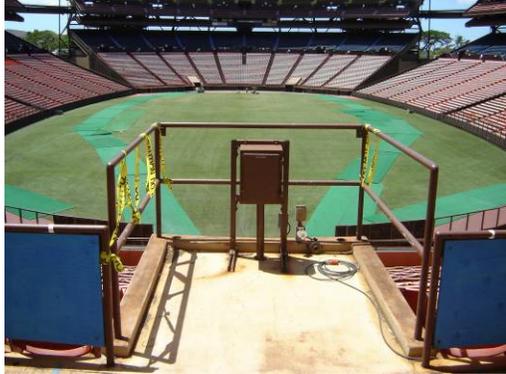
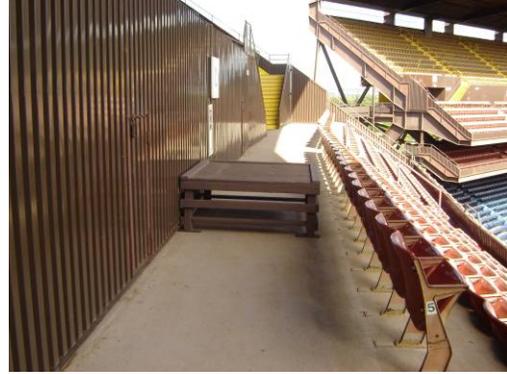
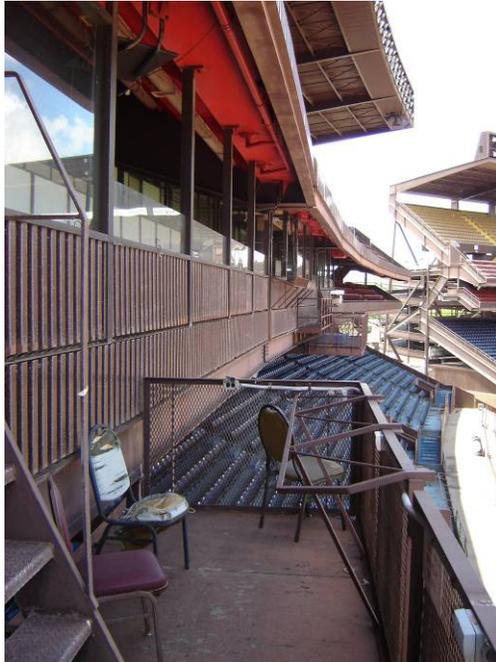
- D6. Television camera locations – There are three fixed television camera locations located at the top of the lower field seating bowl. One is located at the center of the north endzone and the other two are at the southeast and southwest corners of the stadium. The platforms are sized for a single camera position and there is an A/V and power connection at each location. At the upper deck there are a few movable wooden platforms at the cross aisles that are used as camera platforms. There does not appear to be any dedicated power or A/V connection boxes for the moveable platforms. There are two additional camera platforms at the west side in front of the football press box. **Recommendation – Install additional permanent camera platforms with dedicated power and A/V connections to accommodate television and coaching staff needs.**

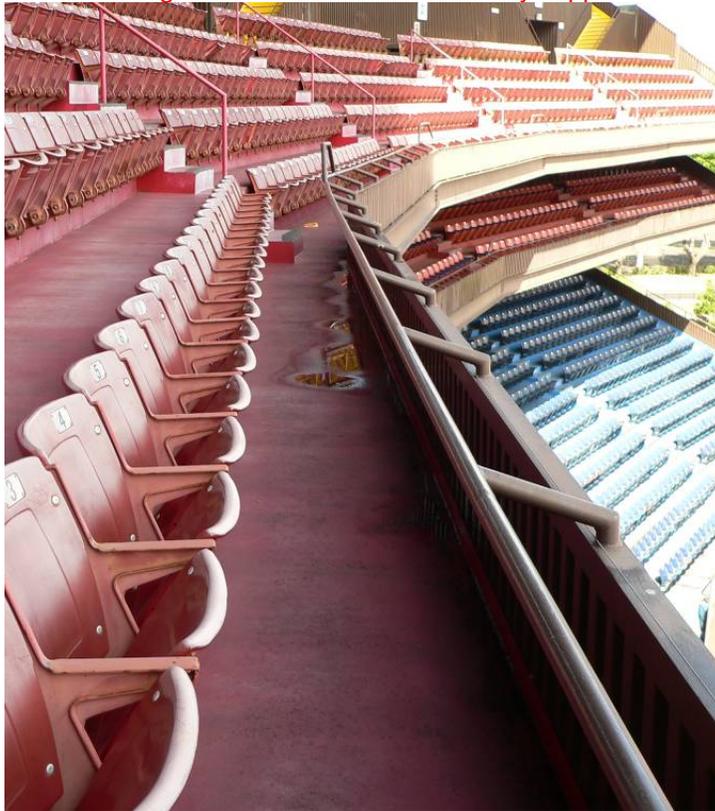
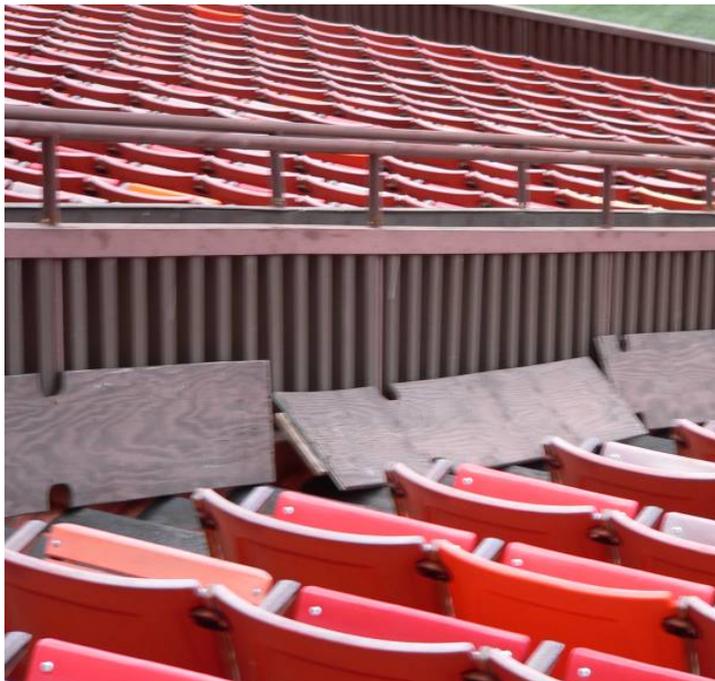
- D9. Railings – The railings at the front of the upper bowl and loge flex substantially when leaned on. This increases the perception of structural instability. Filler between moveable stands when they are in the football position are painted plywood panels. **Recommendation - Stiffen railing with the addition of secondary supports.**

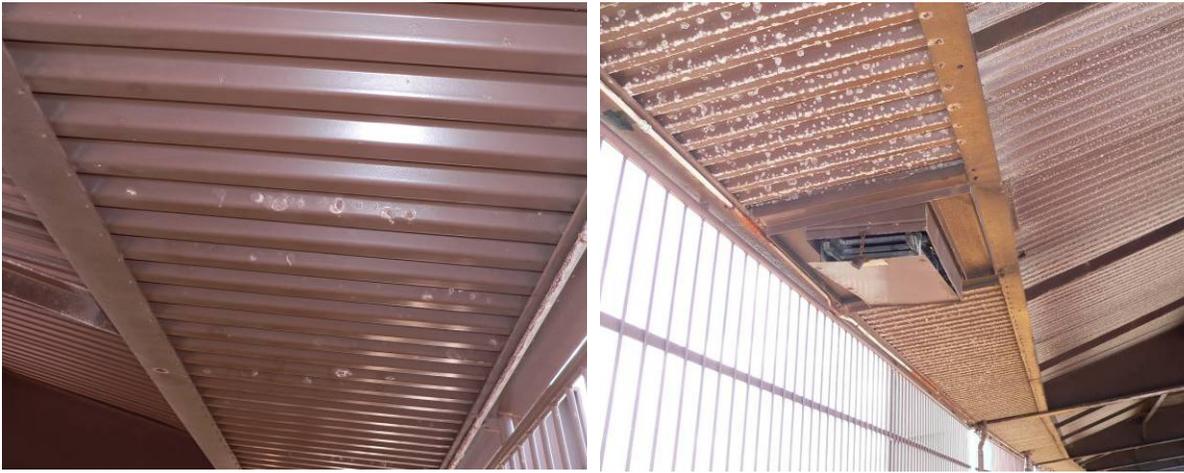
Roof gutter and canopy has significant corrosion. Roof access ladder needs repair. Ceiling at the back of the bowl is corroded.

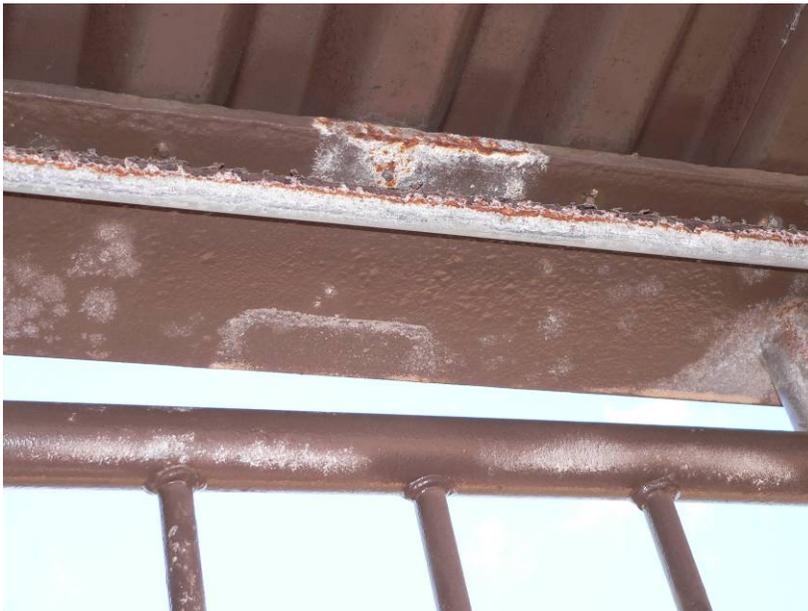
Railing at back of bowl is corroded along with gutter framing.

- E1. Replace steel decking at canopy. Recommendation – Recoat all exposed steel structural members including girders, gutter decking and railing at the back of the bowl.

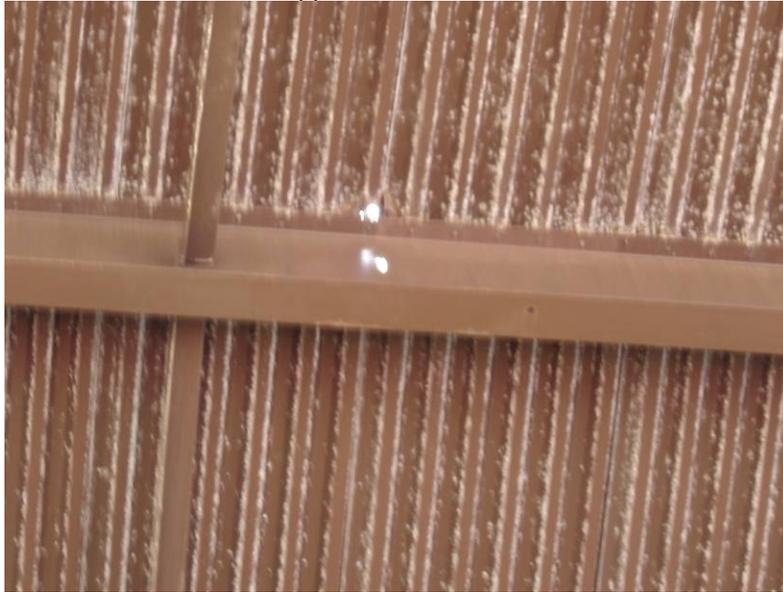
E2. At the South end of the upper bowl there is a hole in the metal roof panel.

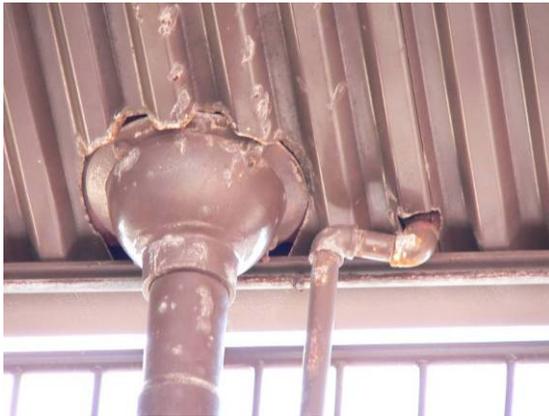
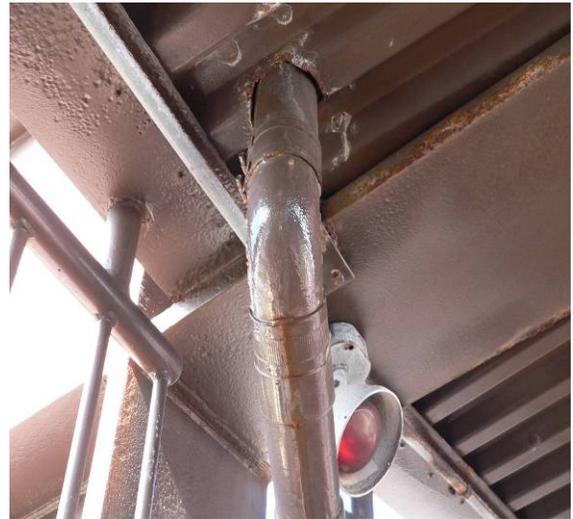
E3. Roof drain bodies, piping and adjacent vents are corroded with surrounding decking severely corroded. **Recommendation: Replace all roof drains and piping. Repair metal decking with steel plate around drains. Recoat all exposed steel including railings.**

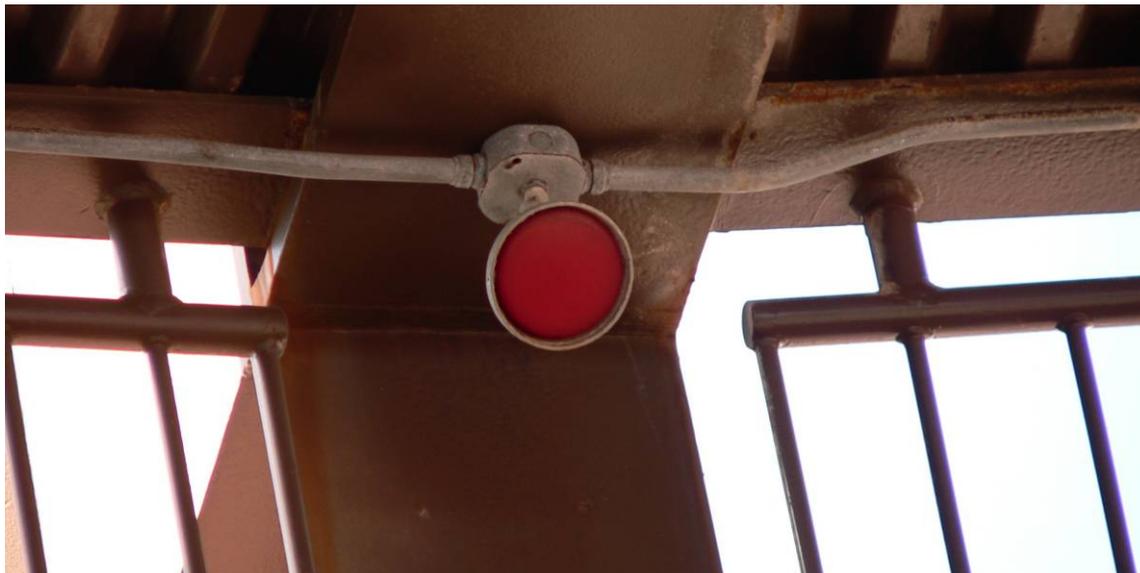
Emergency exit red lights are located above the aisles in the seating bowl which is not a typical requirement in outdoor seating bowls.

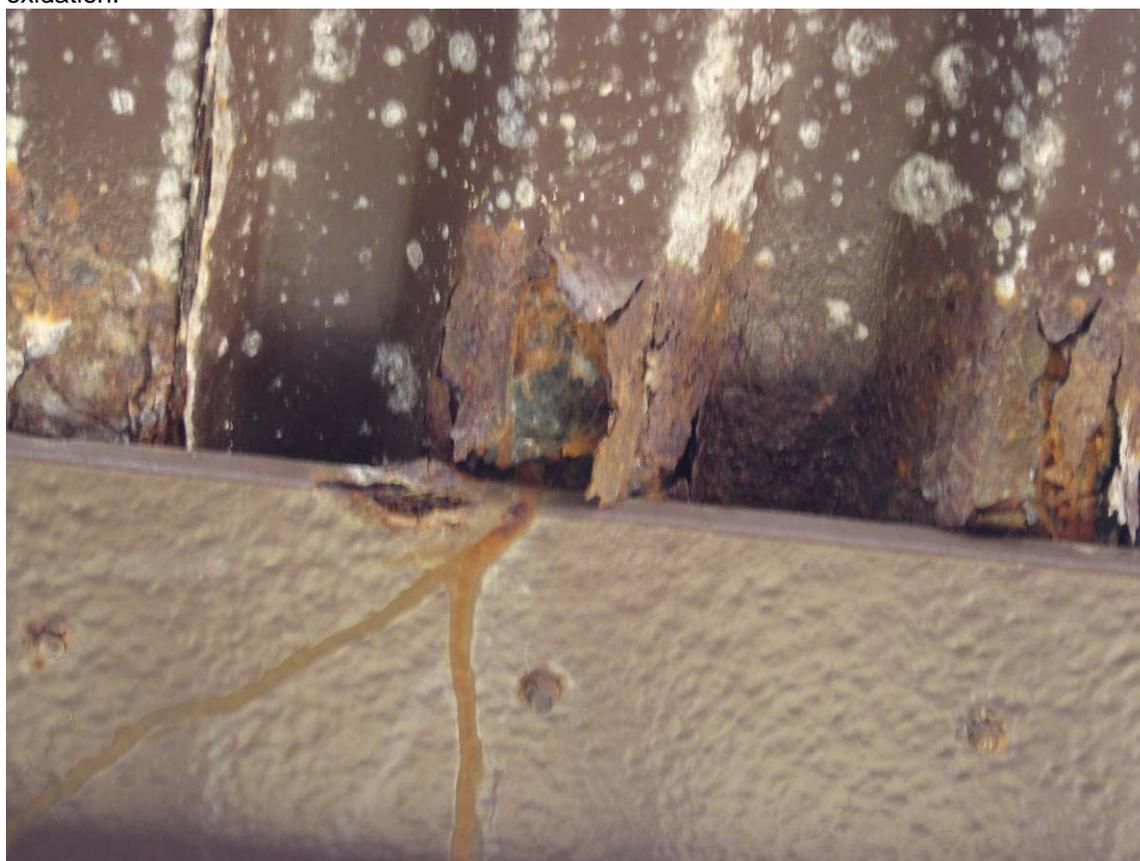
Upper level South end – roof paneling at the top row of seating area showing extreme evidence of oxidation.

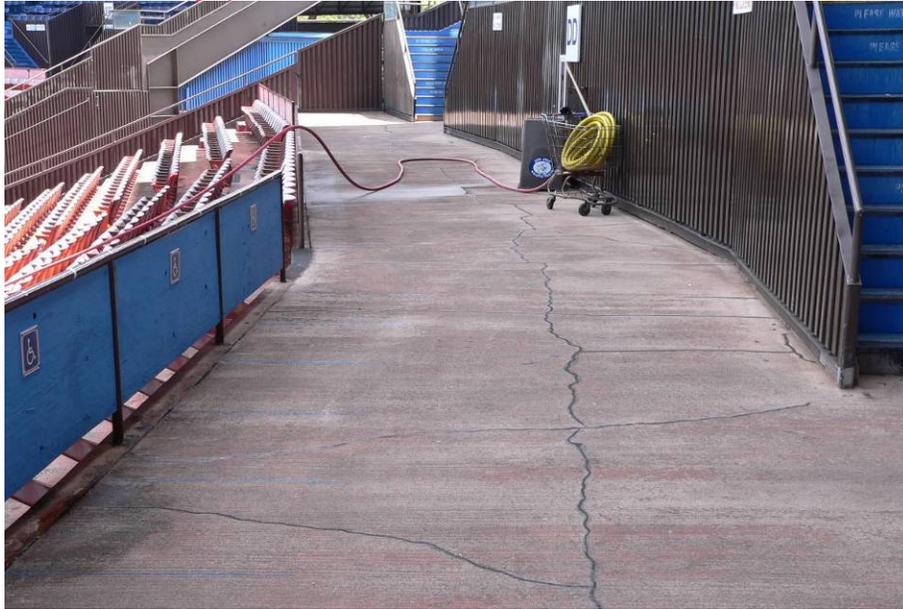
- F1. Concrete slab condition – The lower concourse slab and coating system appears to be in good condition unlike the seating bowl. There are some areas where cracks have appeared that need to be addressed. There are no concourse drains so all drainage is accomplished by sheet draining the water to the outside edge of the concourse. There is minimal slope on this concourse slab to accomplish this. **Recommendation –Repair cracks in concrete in concourse with epoxy non-shrink grout. These repairs should be made prior to replacing the traffic coating system on all concourse slabs.**

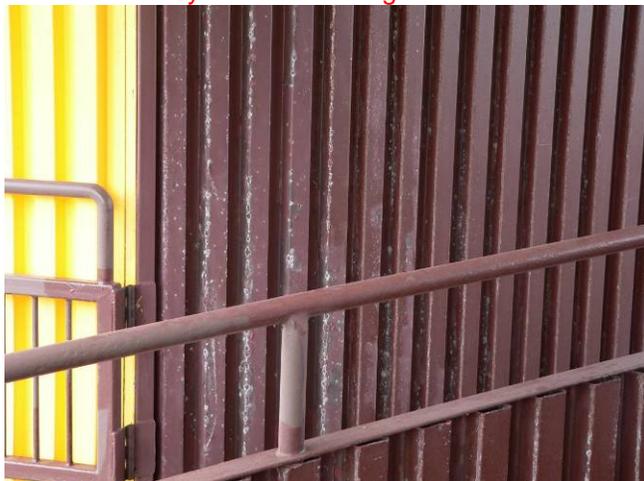
- F2. Vomitory walls and railings show advanced weathering. Walls on the windward side of the stadium are particularly corroded due to the prevailing salt laden winds. **Recommendation - Recoat Vomitory walls and railings.**

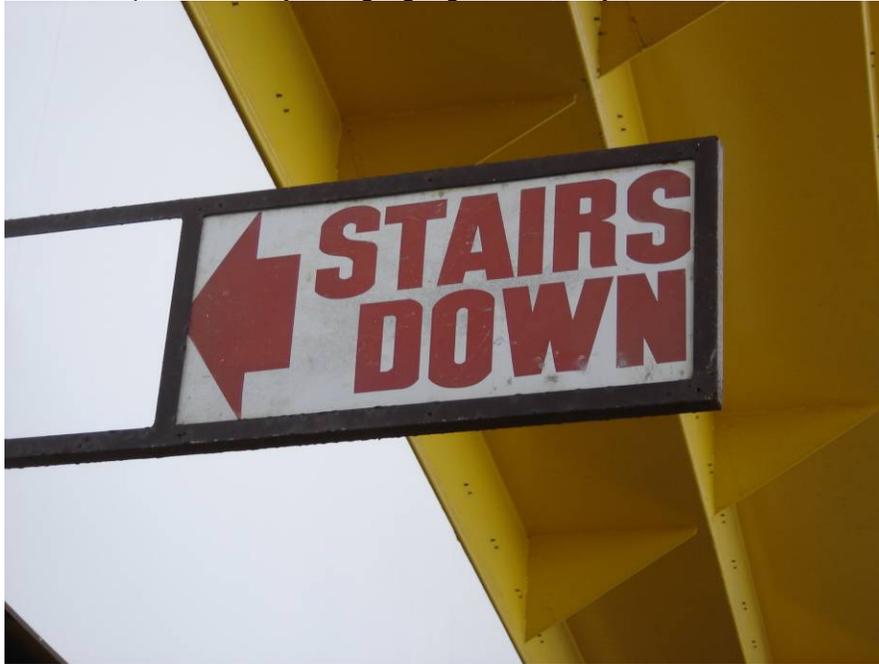
Outside Section M picture of wayfinding signage is dull, dirty and in need of enhancement.

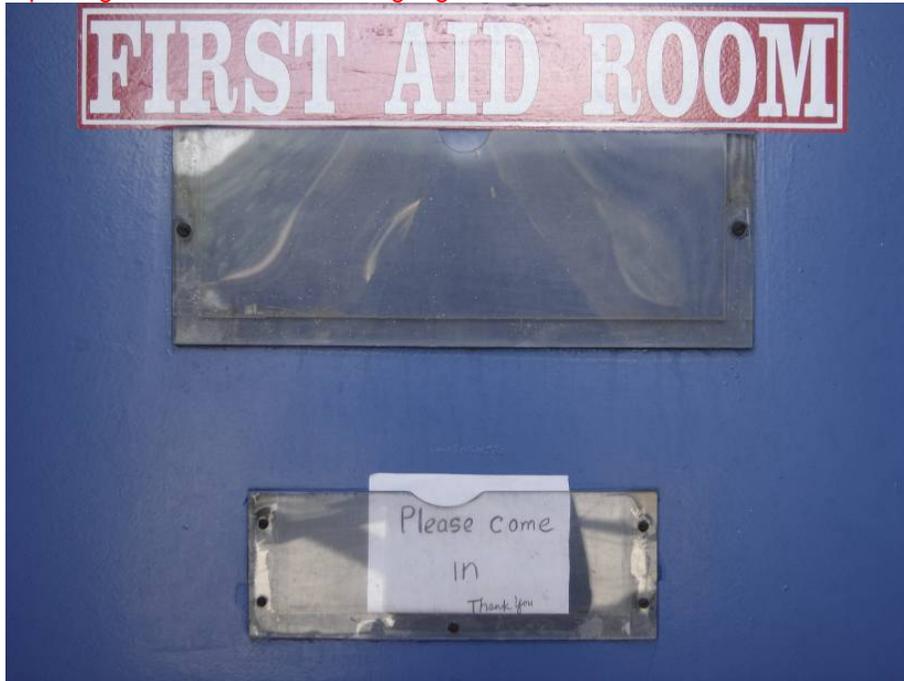
- F4. First aid room on main concourse with a folded paper sign welcoming guests. **Recommend replacing broken and outdated signage on doors.**

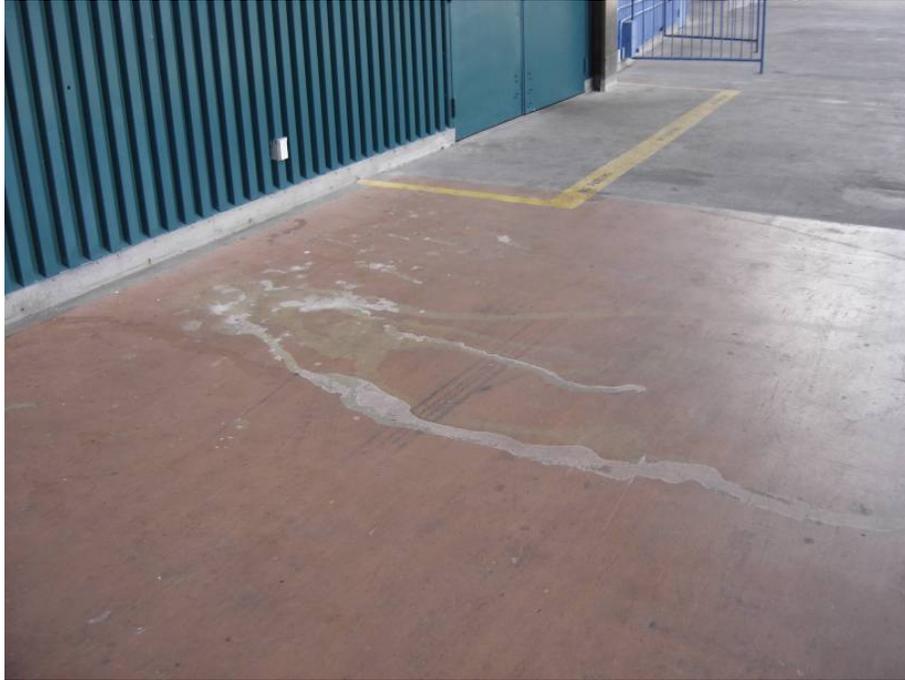
Main concourse outside of the Hawaiian Isle concession stand has significant staining and should be power washed. Recoat over any stains that normal washing and cleaning will not remove.

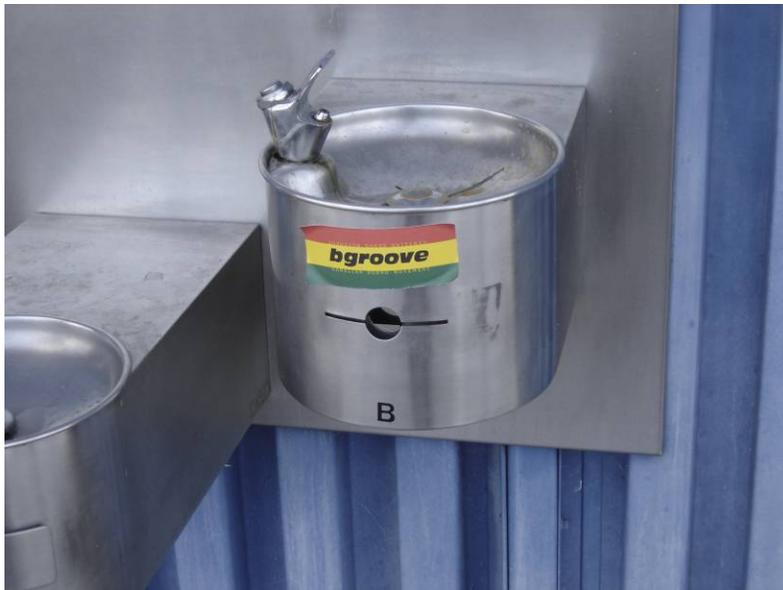
F5. Main concourse outside Women's restroom, Section A - water fountain has a missing push button. **Recommend a regularly scheduled maintenance program to address replacing hardware on water fountains.**

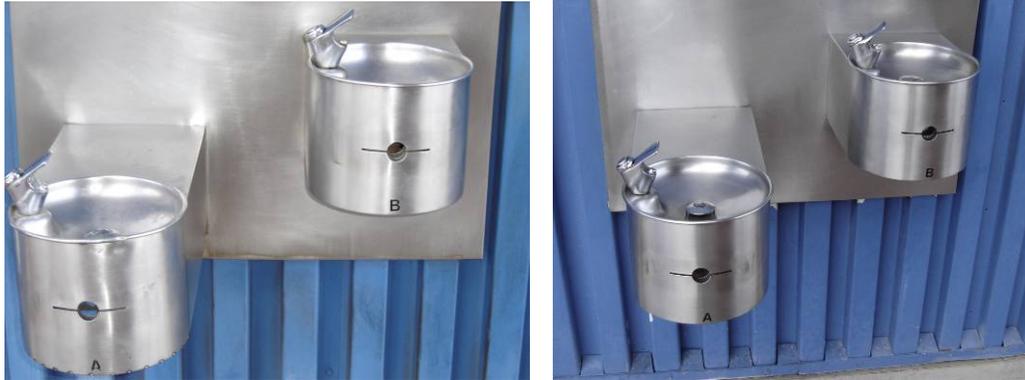
- F5. Water fountains outside section SS missing push buttons. Recommend a regularly scheduled maintenance program to address replacing hardware on water fountains.

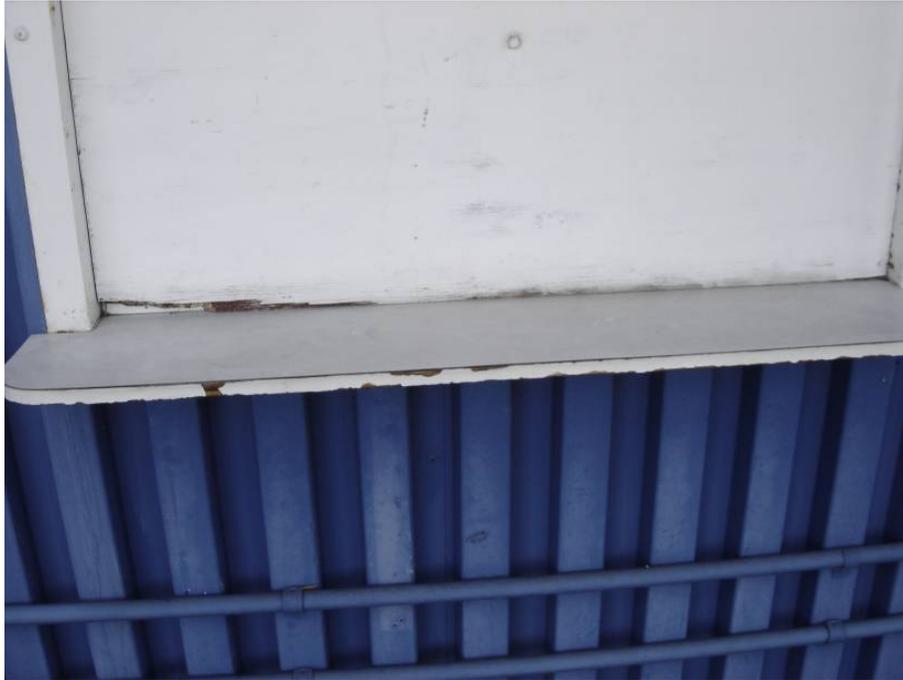
- F6. Counter to information booth on the main concourse is in need of repair. Exposed exterior conditions create a harsh environment for what is traditionally interior materials. Recommend a regularly scheduled maintenance program to address replacement of delaminated counters.

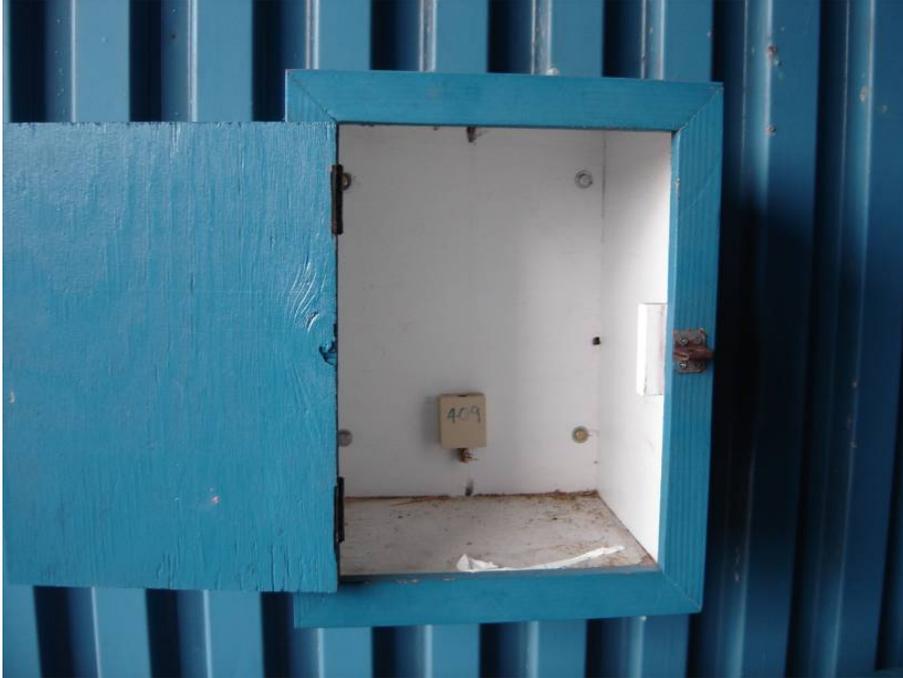
- F7. The “usher phone” is missing from box on main concourse. Recommend a regularly scheduled maintenance program to address the replacement of missing and damaged equipment.

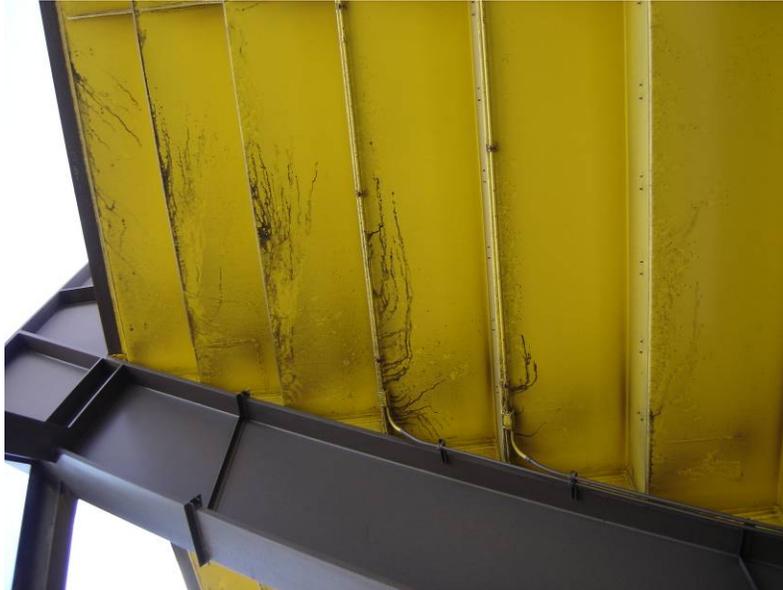
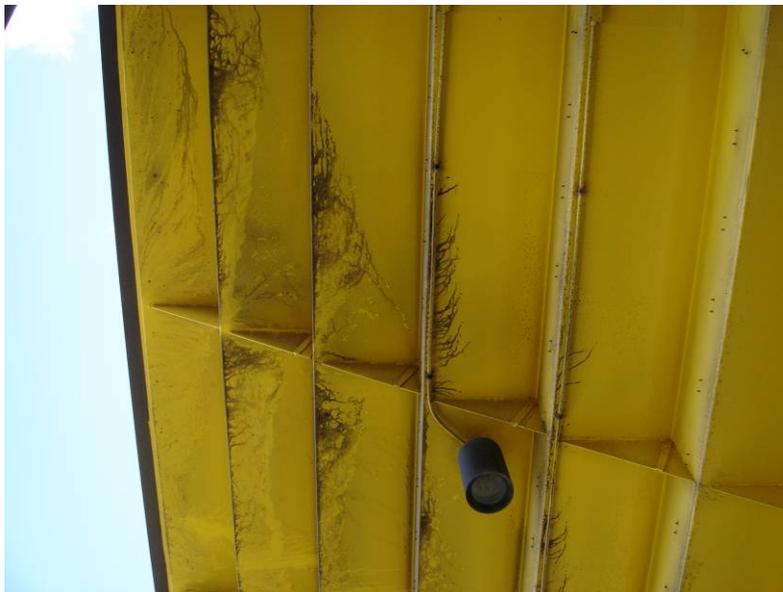
- F8. Concrete fill on steel deck is protected by an elastomeric waterproof membrane which is nearing the end of its useful life. **Recommendation – Remove old coating and apply new elastomeric waterproof traffic coating over concourse.**
- F9. Upper concourse outside section DD - noticed some discoloration of the upper bowl metal raker beams. **Recommend a regularly scheduled cleaning program to address dirt build up on the rakers .**
