VOLUME 2: EXISTING CONDITIONS

aloha stadium PLANNING STUDY FINAL REPORT - 12.22.05

SECTION II: CONDITION SURVEY

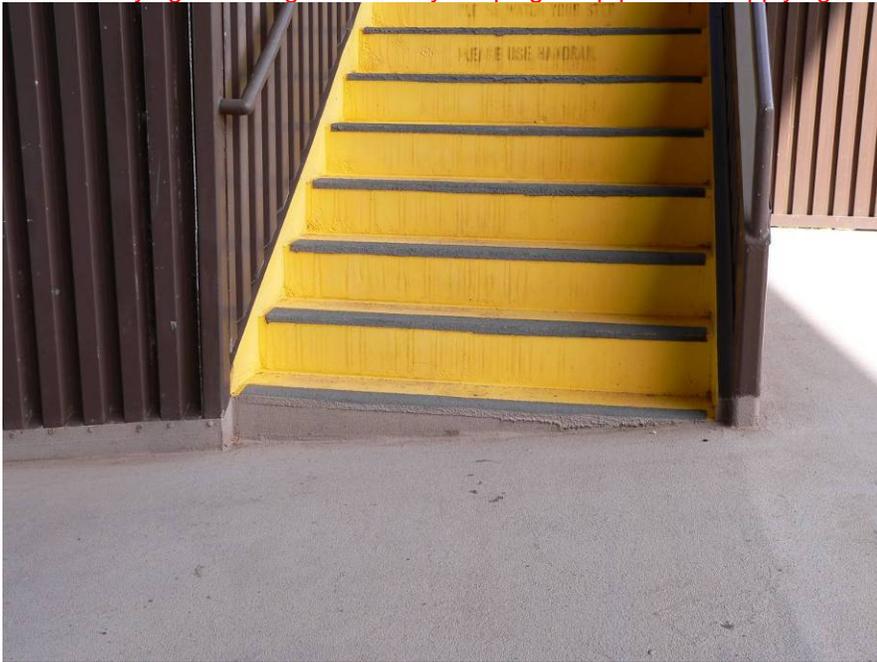
- F9. Vomitories – The sloped condition at the upper bowl vomitories creates an unsafe condition in front of the aisle steps leading to the upper level seats. The slope also exceeds the maximum allowable slope of 1:12 stipulated in the ADA guidelines. **Recommendation – Correct varying riser height at stair by warping ramp prior to reapplying traffic coating.**

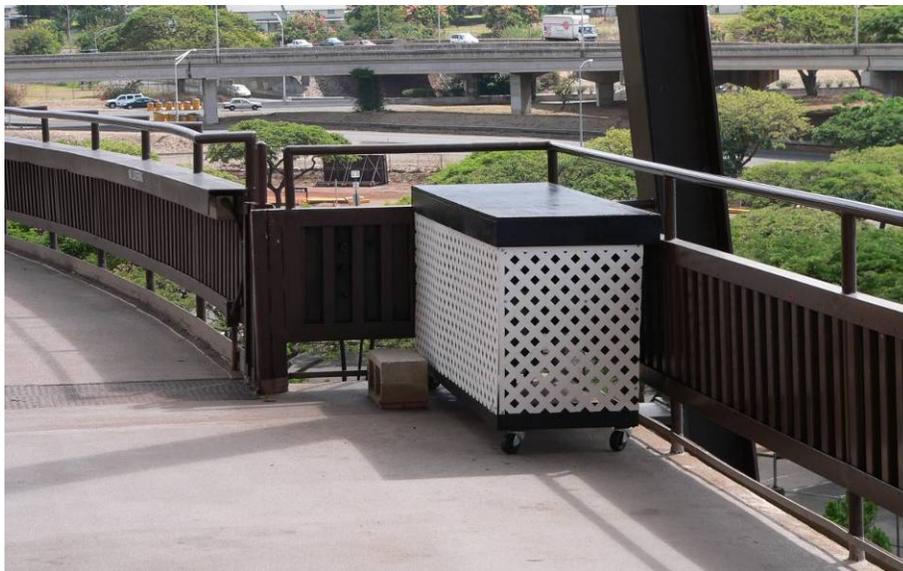
- F10. Main and Upper Concourse Corner Bridges – The width of the bridges constrict travel and they are very bouncy when walked on. The railings flex excessively when leaned on. Although the current design may be adequate for safety, it likely contributes to a perception of instability for patrons. **Recommendation: Perform additional structural analysis on bridges and rails to confirm they are safe. Also stiffen bridge guardrail with the use of secondary support members.**

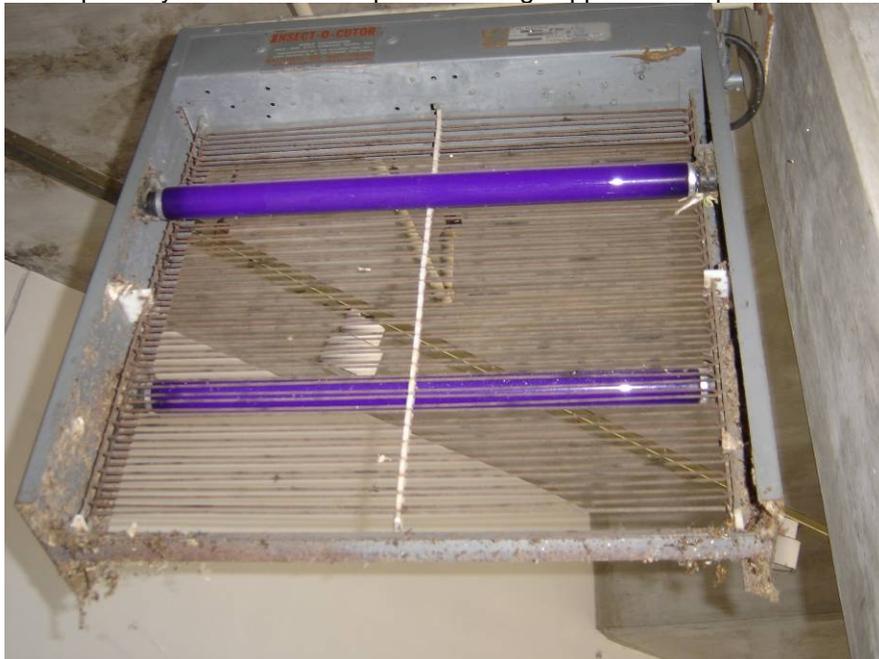
Security checkpoint by main entrance - picture of bug zapper in disrepair.

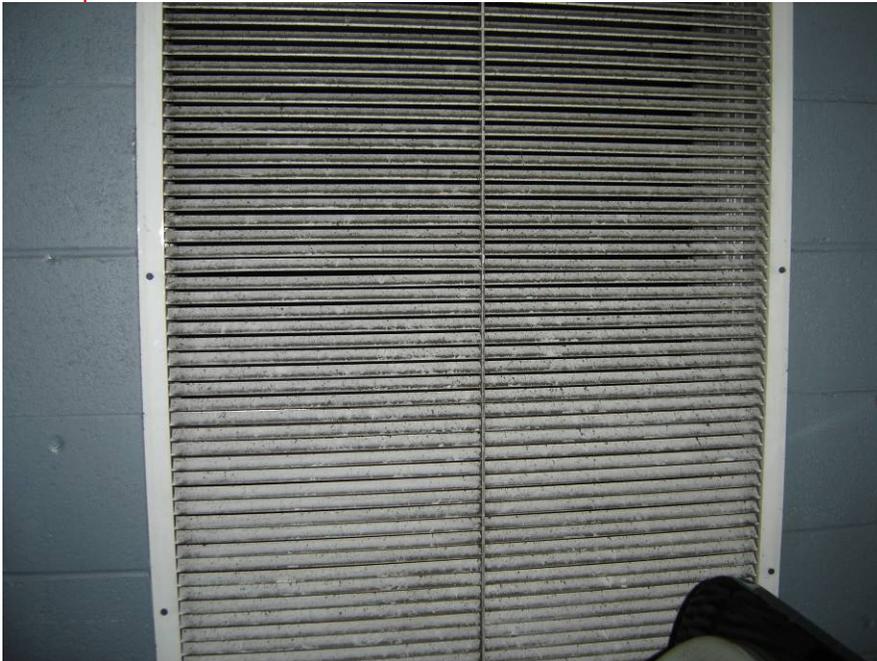
Return air vent on the service level outside the freight elevator is dirty. **Recommend a review of cleaning procedures to address dust and dirt on return air vents on a regular basis. Refer to Mechanical Report for detailed related recommendations.**

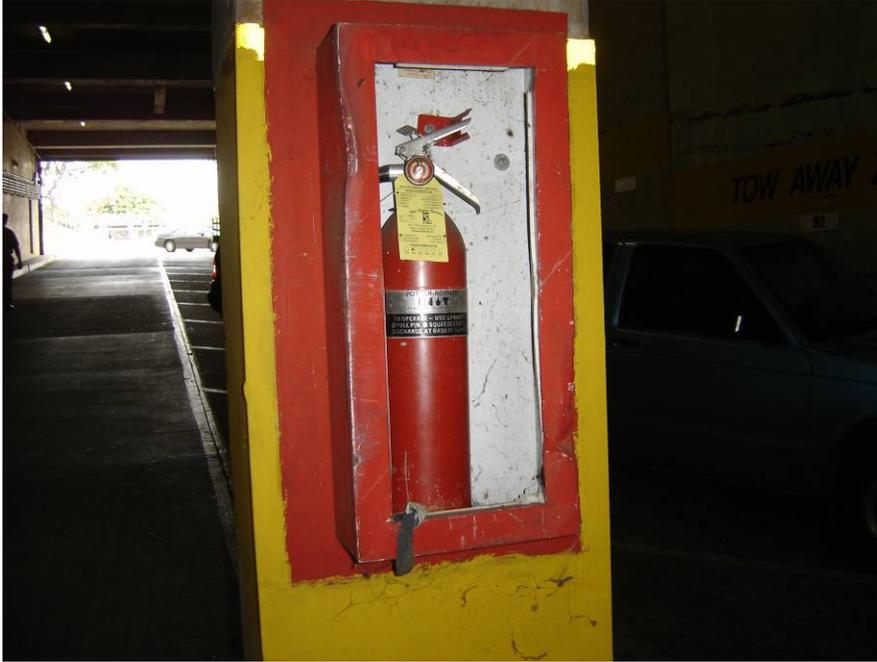
- F11. Fire extinguisher in the box - the glass has been broken, it is dirty. Recommend a review of maintenance procedures to address missing glass and cleaning procedures for build up dirt on the box.

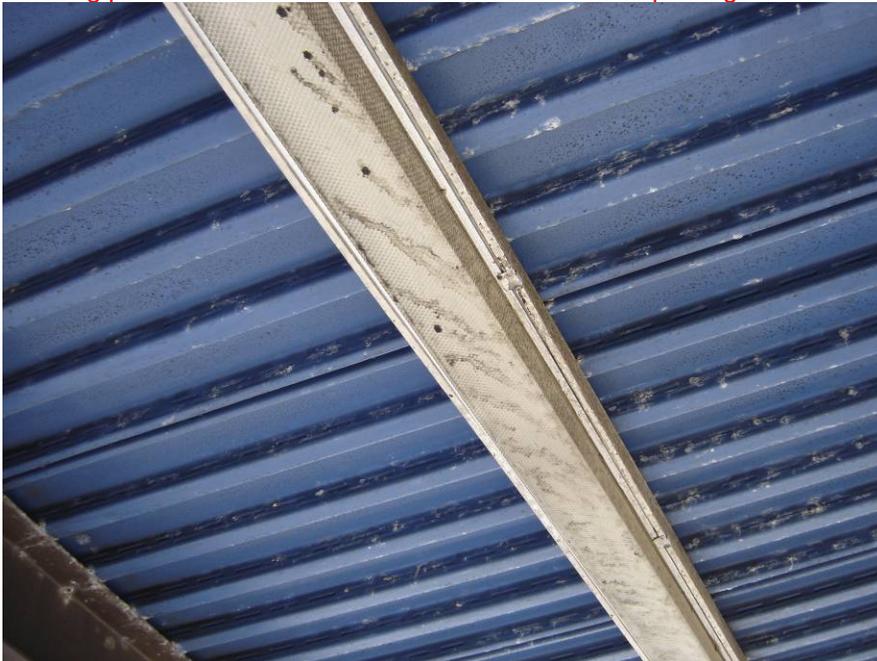
- F12. Light on upper deck has a significant amount of dirt buildup. Recommend a review of cleaning procedures to address dirt and cobweb build up on light fixtures.

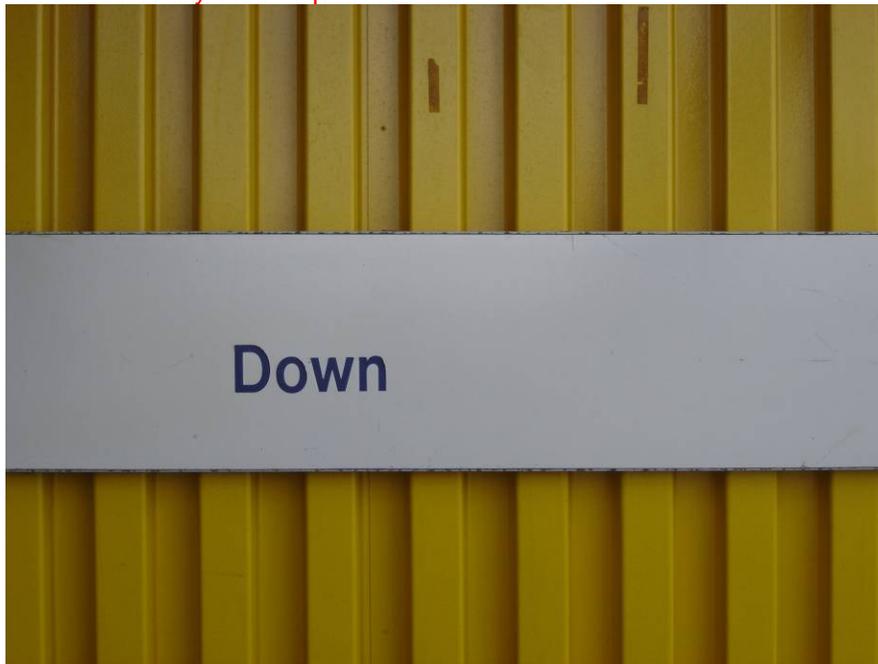
- F13. Sign outside section M. It should be noted that this is a rated exit and there is no illuminated exit sign at this location. **Recommendation – Add illuminated exit signs meeting current life safety code requirements.**

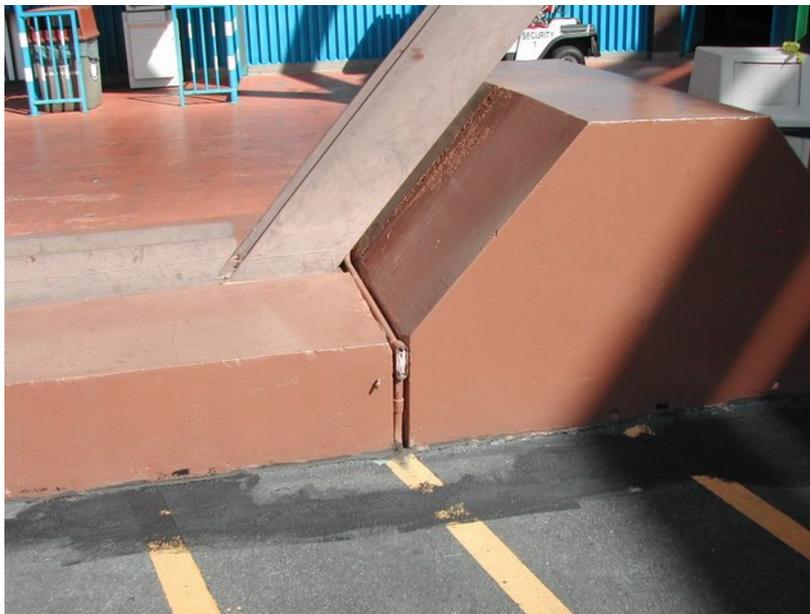
- F14. The south concourse areas over the offices show cracks in the asphalt and unsealed penetrations near the steel columns both of which are causing leaking below. **Recommendation – Remove existing asphalt and waterproofing membrane over offices, reapply a new fluid applied membrane system and seal around all penetrations, and reapply new asphalt in this area.**

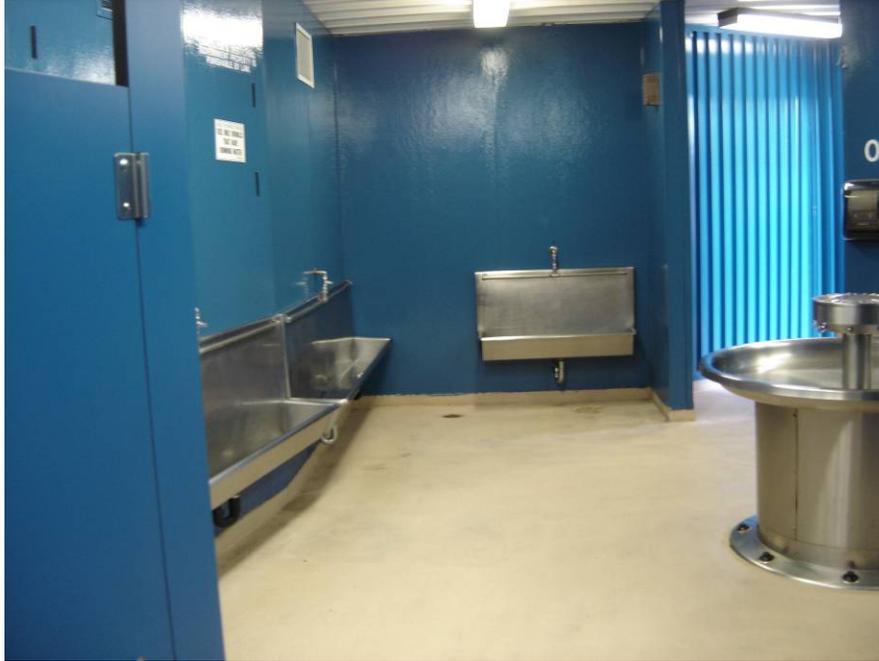
Men's restroom outside of Section AA is in good condition. Recommend a review of the floor coating system and repair any damaged areas and unsealed penetrations. Increase normal maintenance program to make these repairs.

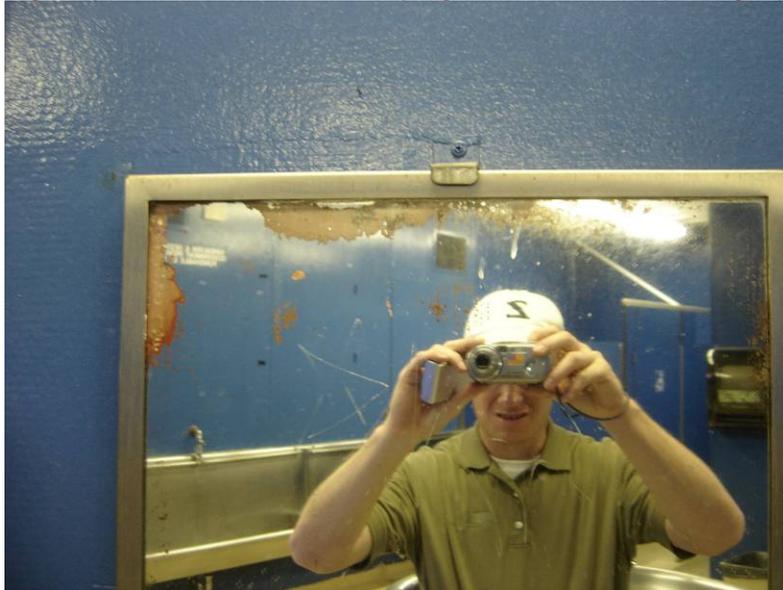
G2. Men's restroom outside section SS - mirror has been damaged by water. Recommend a regularly scheduled maintenance program to address replacing equipment in rest rooms.

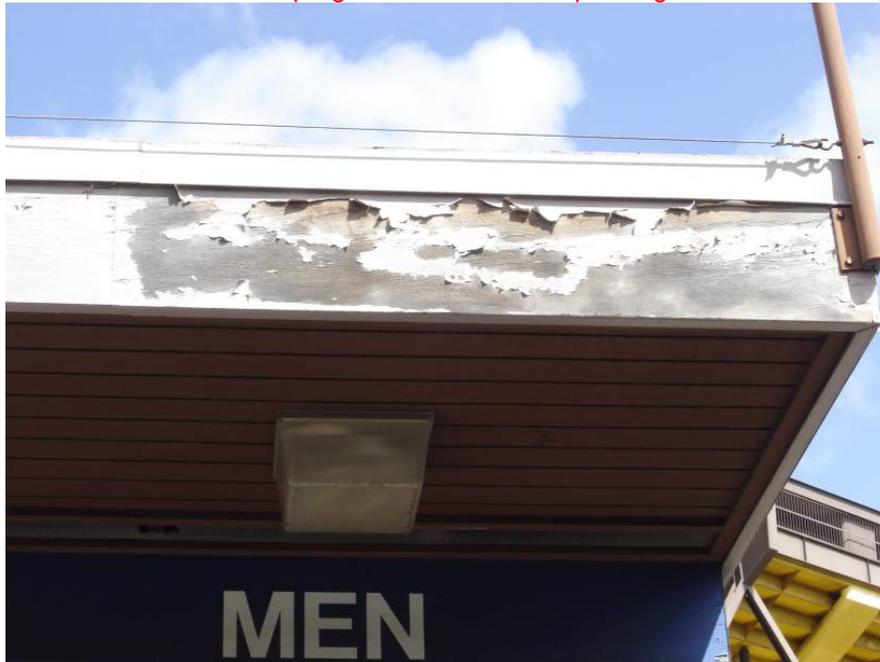
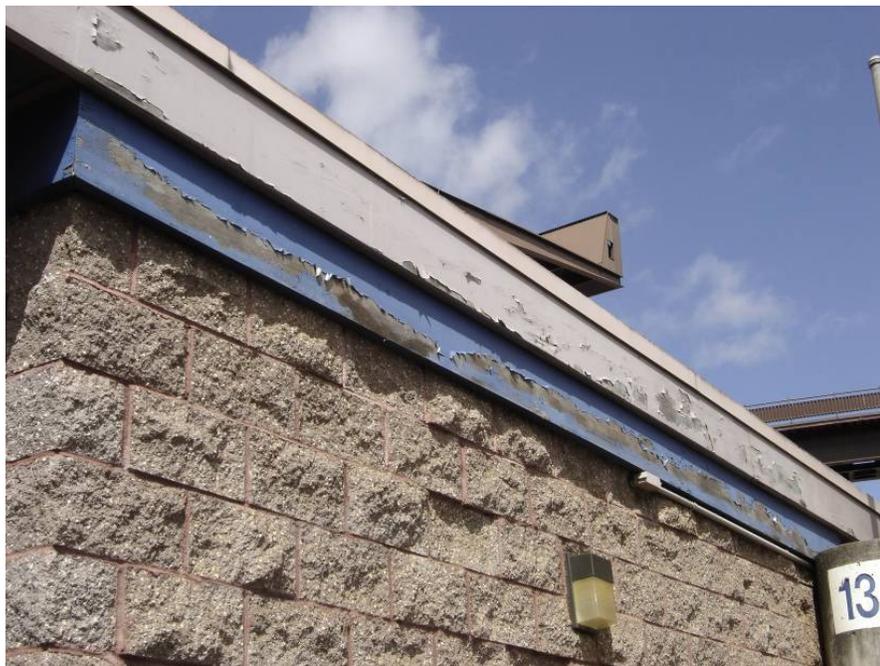
- H1. Concession stand next to Gate 1 with peeling paint on soffit. **Recommend a regularly scheduled maintenance program to address the painting of exterior building structures.**

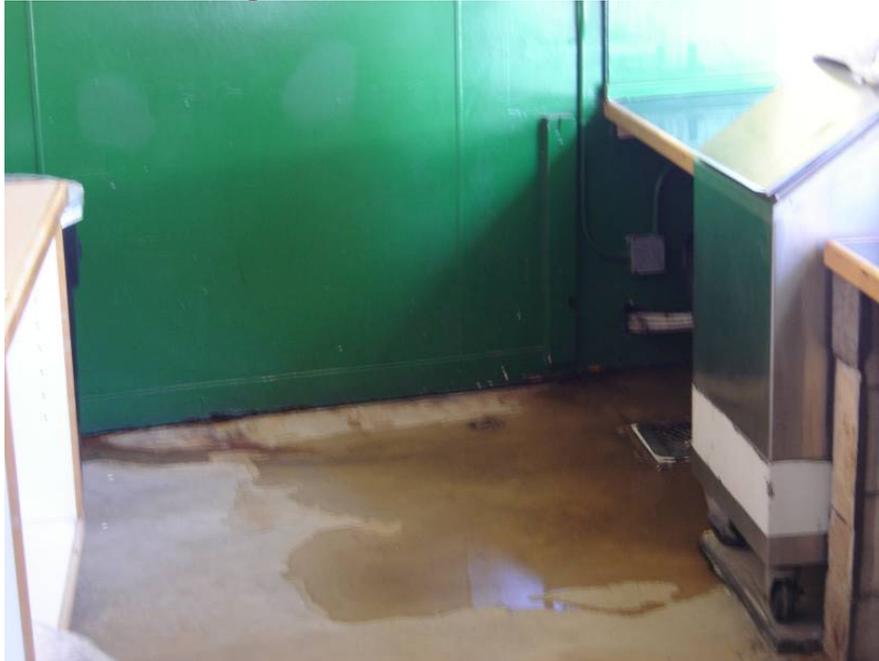
- H2. Concession stand on the main concourse across from Gate 1 has a floor drain not flush with the floor so water cannot drain. This condition may possibly violate a state health code. **Recommend lowering floor drain to allow flow to the drain.**

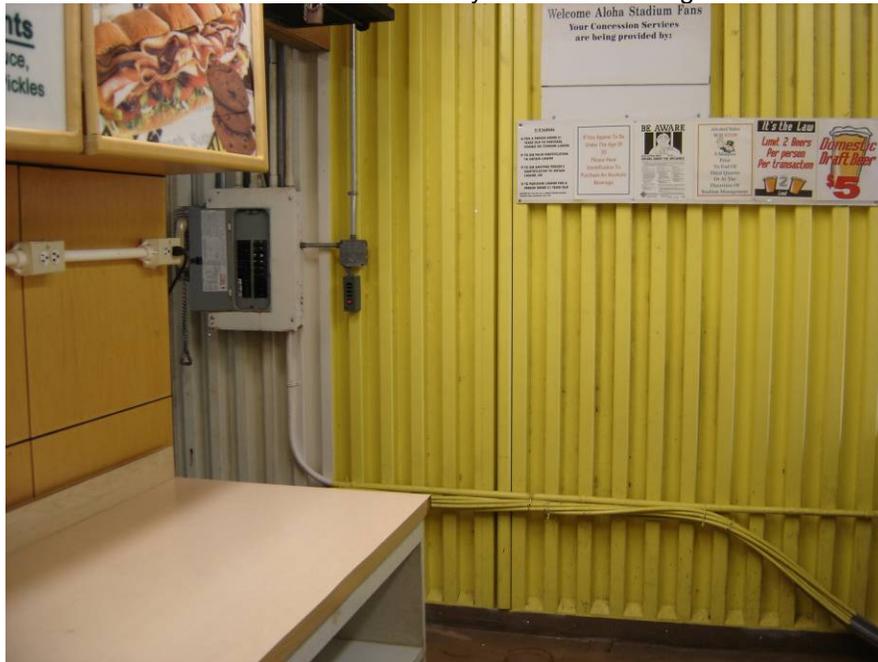
Subway concession stand on main concourse by section KK is in good condition.

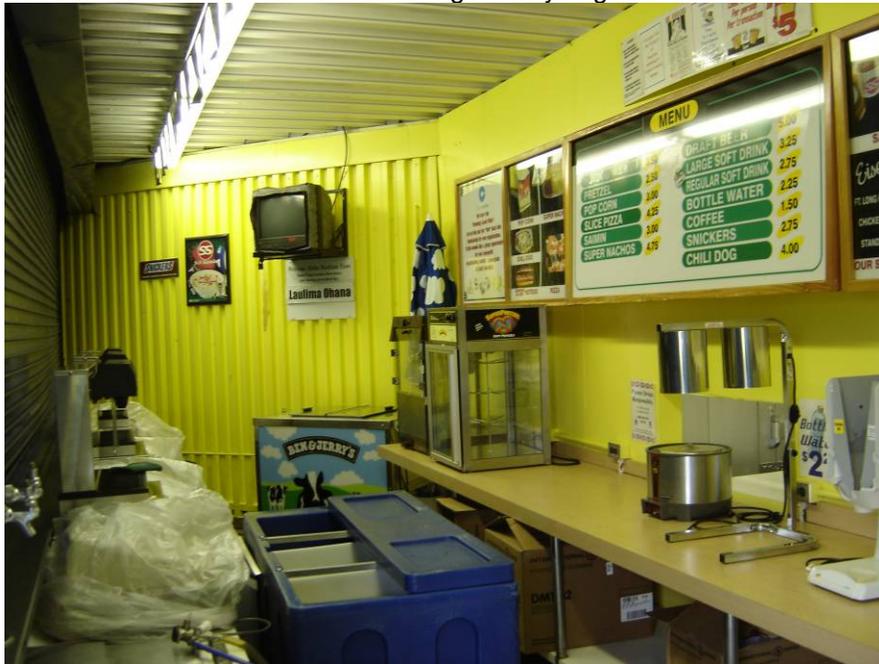
Concession stand outside section KK looks is generally in good condition.

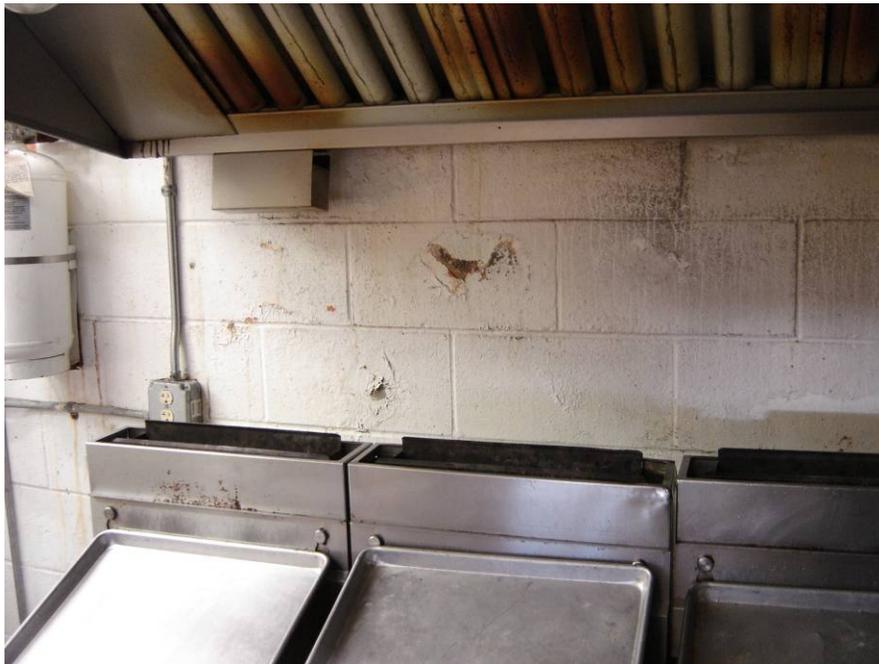
Concession stand Gordon Birsch main concourse across from section AA needs general cleaning and maintenance. **Recommend a regularly scheduled cleaning program to address dust and cobwebs in concession stands.**

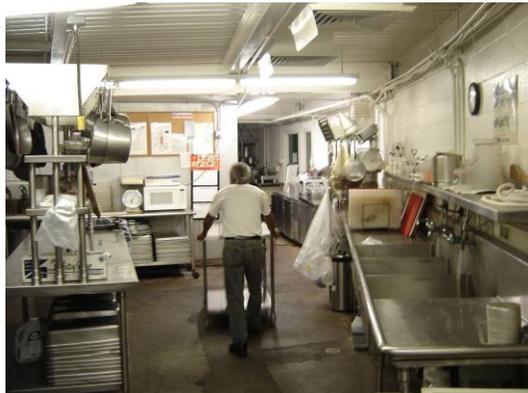
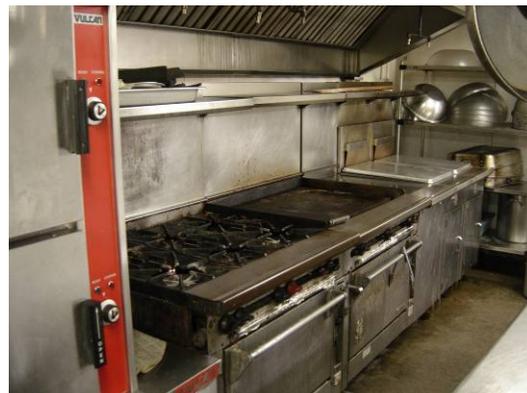
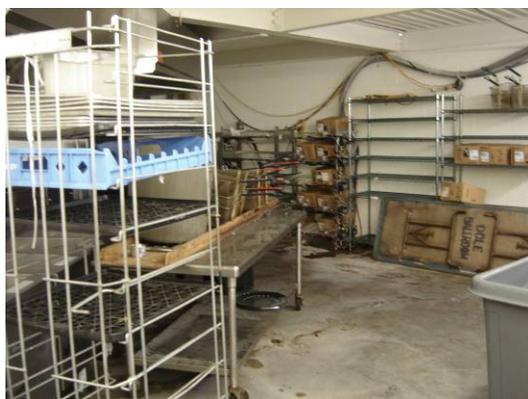
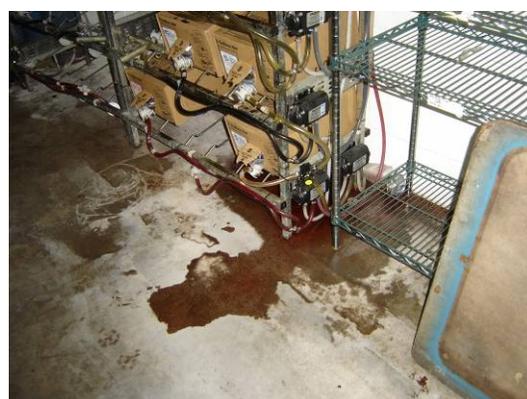
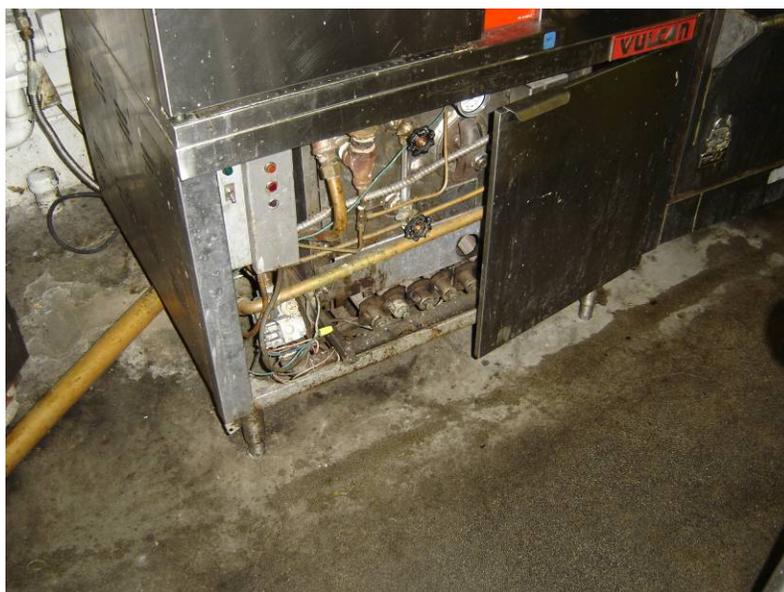
Main commissary on the main concourse next to the Eisenberg Gourmet Foods concession stand across from section U. **Recommend a review of cleaning procedures to address spills, dust and cobwebs in the kitchen areas.**

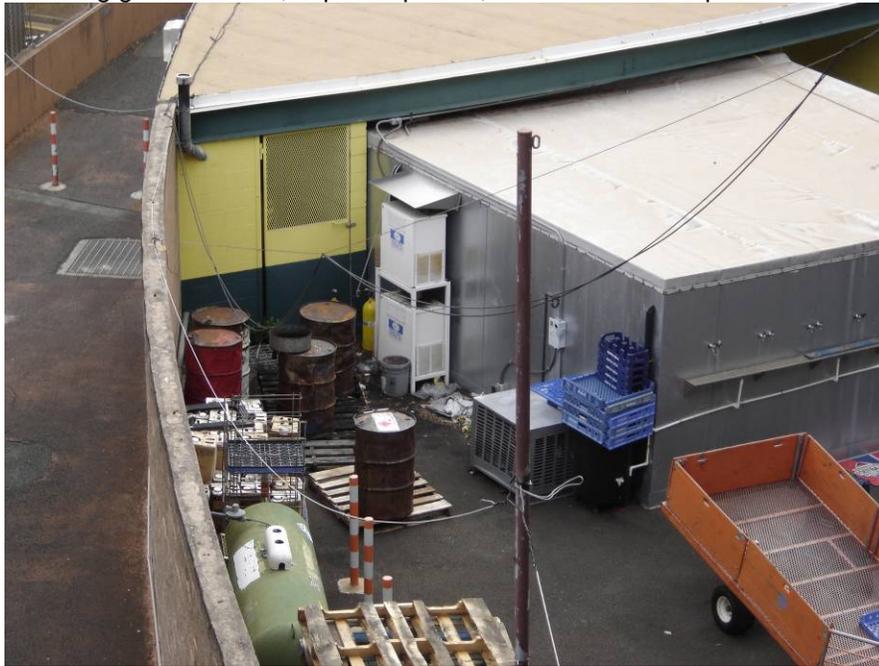
Photo of the area outside the main kitchen for Centerplate, the food service operator, shows the back area having grease drums, exposed pallets, and some food exposed.

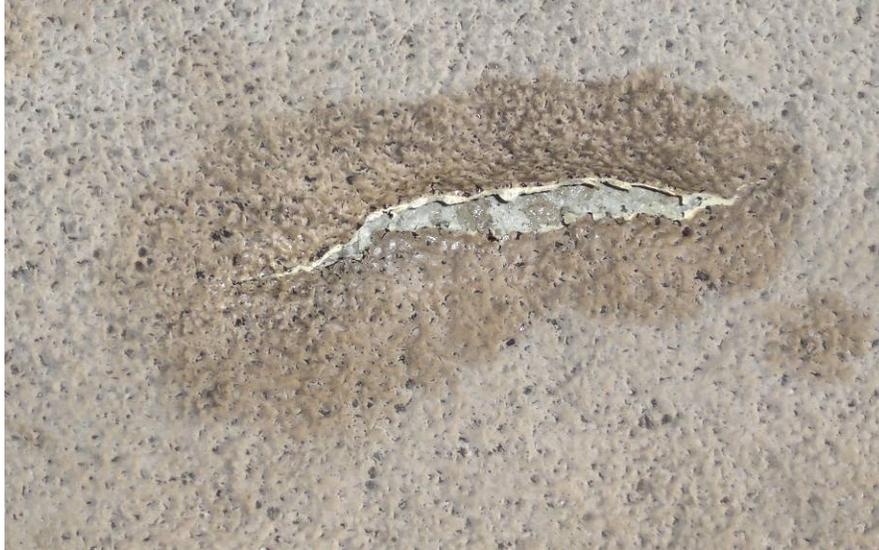
- I1. Walkway ramp A - area where floor surface has cracked and is pulling away. **Recommend a review of maintenance procedures to address tears and cuts in rubberized floors surface.**

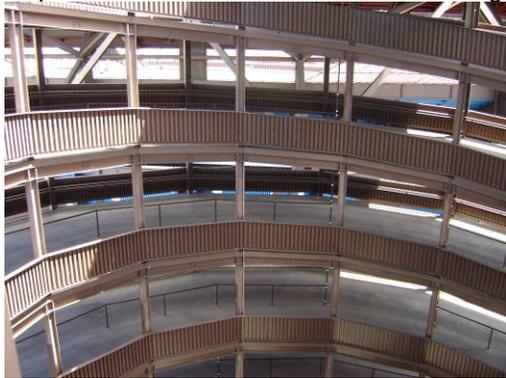
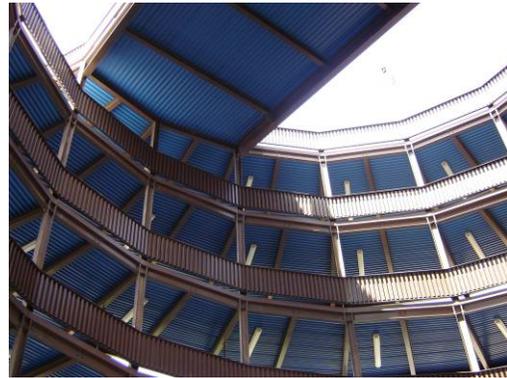
Concrete and steel surface conditions – The concrete and steel on the ramps appear to be in good condition. The coating system also appears to be in good condition except for a few areas near the bottom of the ramps where it has been cut and damaged. This is probably due to a heavy amount of vehicle traffic using these ramps. The structural steel surfaces are showing some chalking and fading of the paint system used on them. This will become worse over time if they are not repainted. **Recommendation – Repair coating system on ramp concrete surface.**

- I2. Repaint steel surfaces as needed on a regular basis.

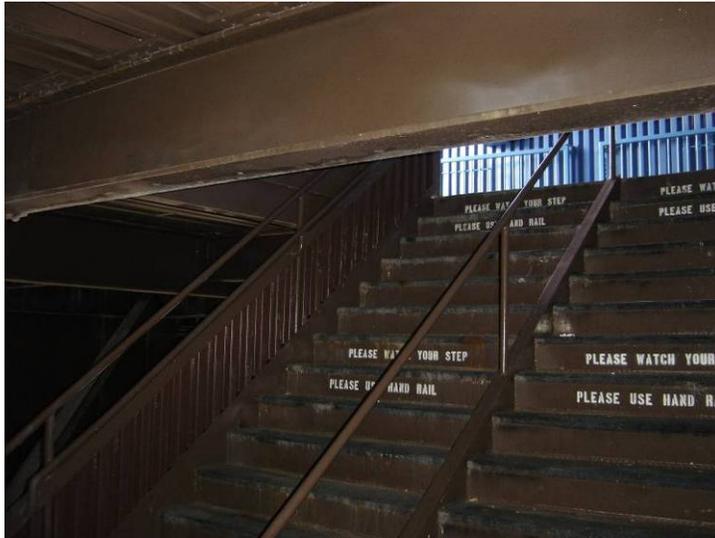
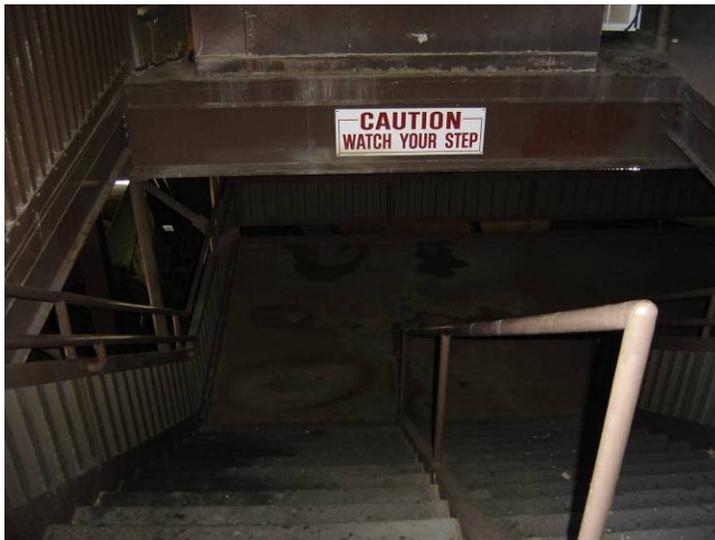
Stair railings for the main stadium stairs (1, 2, 3, & 4) there are steel guard rails and handrails on each side of them. The guardrails are typically 3'-6" high and the handrails are 2'-10" high. Both of these heights are acceptable. The length of the handrails at the bottom of each stair run currently stop even with the last riser location. Per current code requirements these should extend 1'-11" past this point. The length of the stair handrails at the top are also too short. Currently they stop even with the top riser and should extend 12" past it. The guardrails have a top opening between the top rail and the ribbed metal siding infill of approximately 9" clear. There is another 9" clear opening between the bottom rail and the top of the stair landing. Neither of these openings meet current code requirements.

- J3. For the back of house stairs (5, 6, 7, & 8) there is a center guardrail / handrail that is 2'-8" tall. Again this height does not meet the current code requirements. **Recommendation – Lengthen the handrails at the top and bottom of the stair runs to meet current code requirements. Add additional infill rails or cabling to reduce size of gaps in guardrail system.**

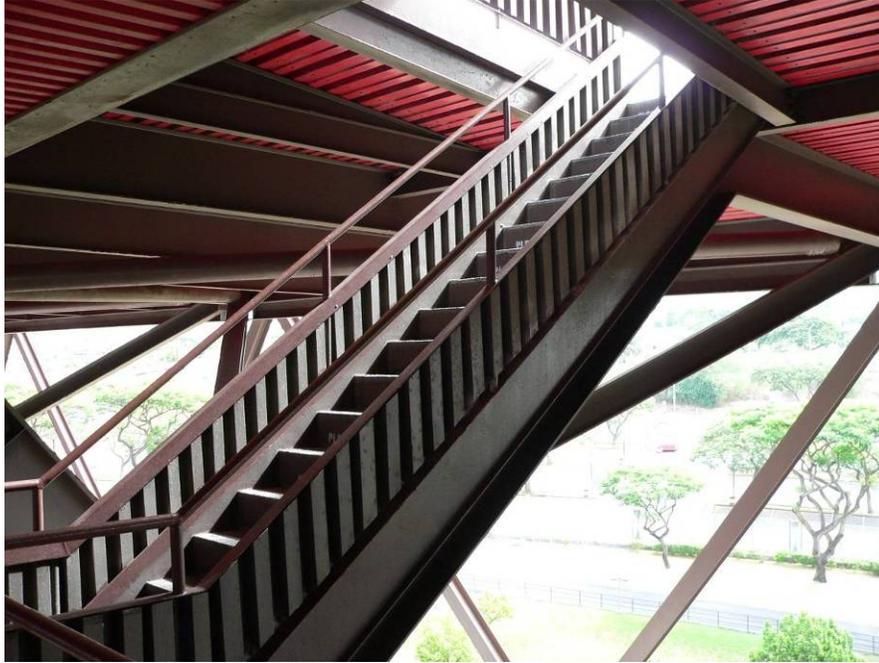
- J4. Stairs between upper concourse and loge level concourse are open straight runs that occur at each seating section. These stairs, along with the bridges accessing the elevators in the endzones, are the only access points to the loge level. **Recommendation: The side rails do not meet code and should be increased to the required 42" guardrail height to meet the code and provide a more secure feeling for patrons.**

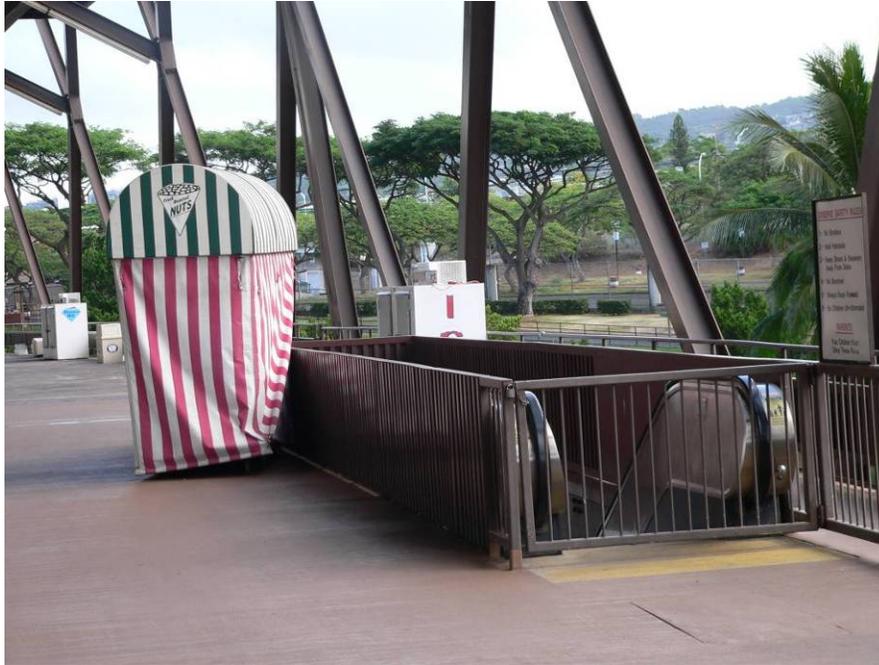
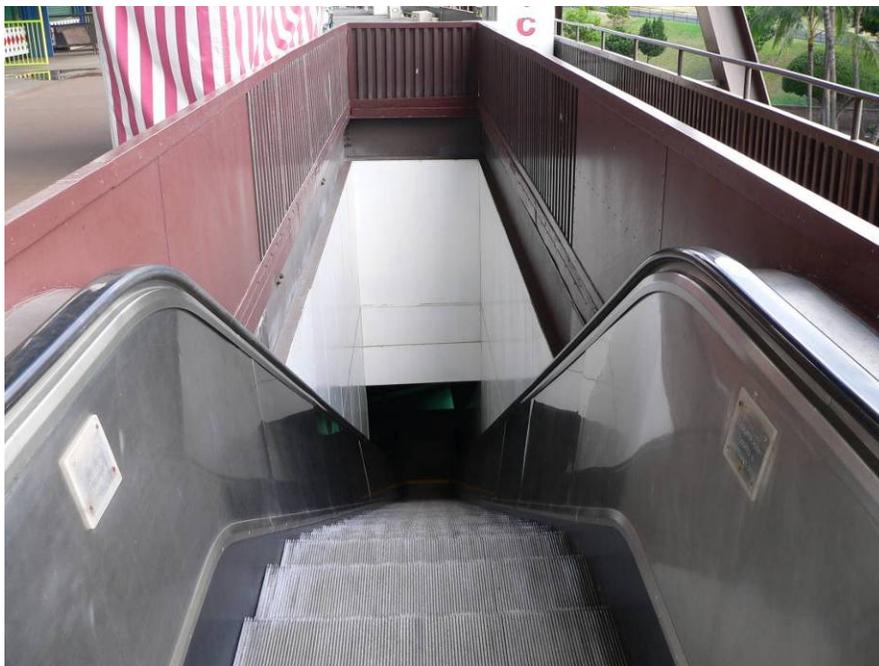
- L1. One escalator is located on each sideline connecting the ground level to the main concourse. Reportedly, the west, makai, escalator in particular is shut down frequently during events due to water presence and other safety shut-off features triggered by overloading or rail pressure. The escalators are open to the sky, which is not permitted under current code regulations. **Recommendation: Provide escalator canopy with sufficient overhang to prevent wind driven rain from entering the escalators. Canopy could provide advertising signage opportunity and could reduce some of the shutdowns of the west escalator.**

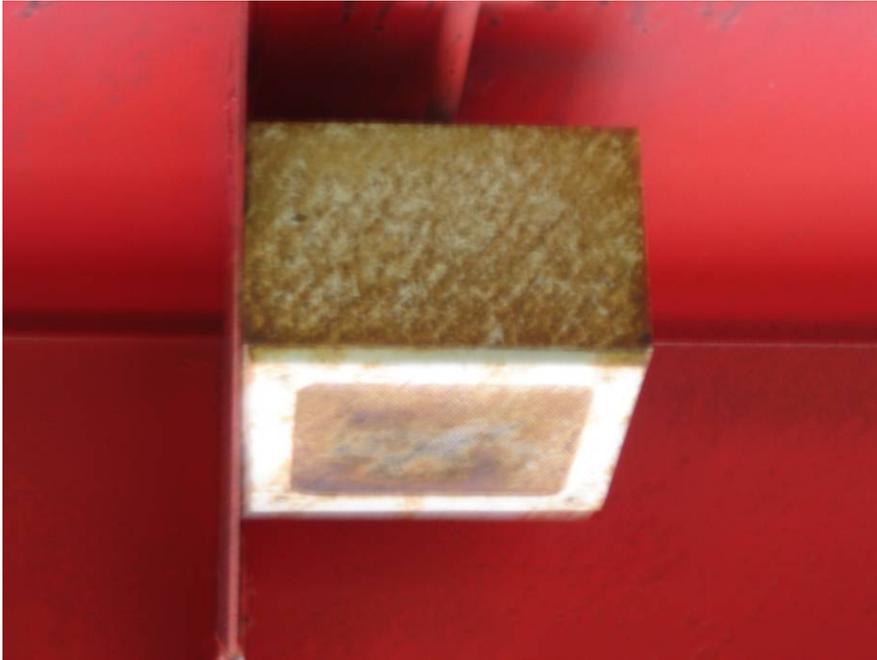
- N1. Section KK - speaker box is rusted and discolored and is representative of the exterior speaker boxes throughout the Loge Level. Housing needs to be replaced. **Recommend a regularly scheduled maintenance program to address replacing or cleaning speaker enclosures.**

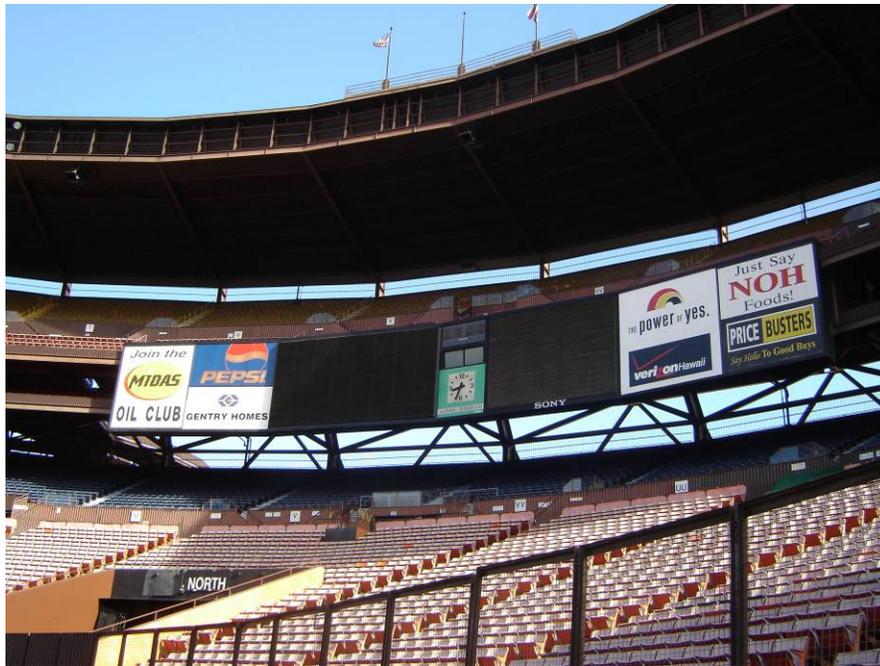
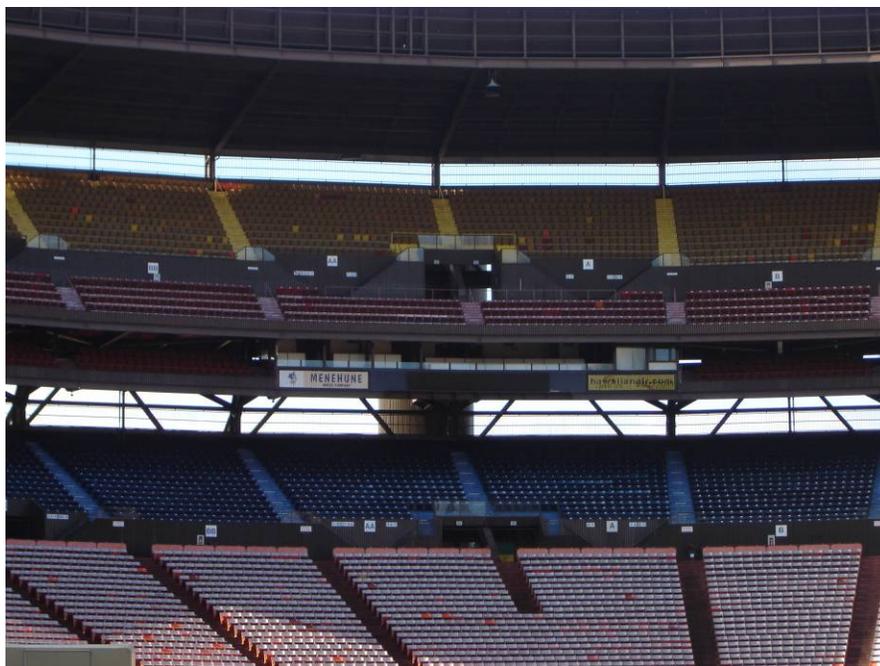
- N2. Systems function – The scoreboard system consists of a large matrix board and video board display at the north endzone in front of the box seats and lower tier seating sections. At the south endzone there is a small matrix display in front of the baseball press box. It appears the video board was manufactured by Sony and the matrix boards were manufactured by Daktonics. The boards and control system were installed in 1991 and are nearing the end of their useful life. **Recommendation – Replace boards and control system with current technology. Incorporate increased advertising components to help fund costs.**

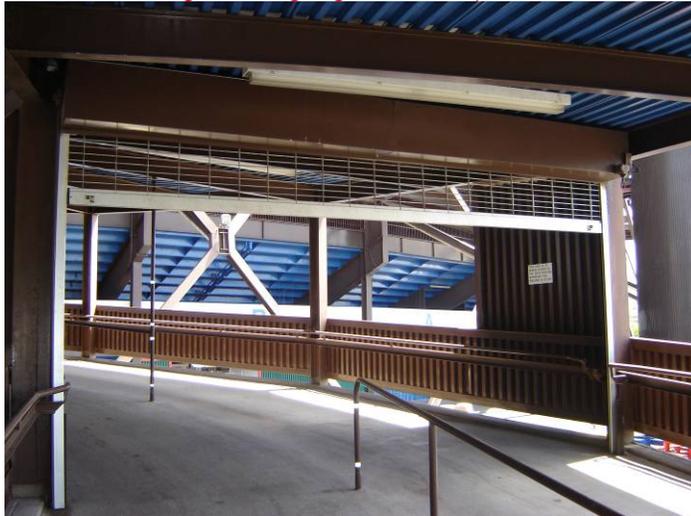
- O2. Circulation – The only vertical circulation through the building is from the ramps, four main stairs, or the south freight elevator. The ramps as constructed do not meet the current ADA requirements as they do not have a flat landing after every 30” of rise. The south freight elevator is one of only 2 elevators in the building and is the only one that stops at all levels of the building. This elevator does not have the capacity to handle all of the ADA and other (concessionaire, stadium staff, press, first aid, etc.) traffic during an event. Nor is it an inviting mode of transportation for disabled patrons. At the upper concourse there are ramps in the vomitories that lead from the concourse to the cross aisle between the upper and lower tier seating sections. The slope of these ramps are over the maximum allowed by the ADA nor do they have the required handrails mounted on the sides of them. This condition also occurs at the lower level vomitories where there are ramps from the concourse to the cross aisle. **Recommendation – Correcting the above items will be a major undertaking. We recommend determining what level of improvements can be made to accommodate the highest priority ADA provisions. Minor improvements like adding additional railings and signage could help some of the conditions.**

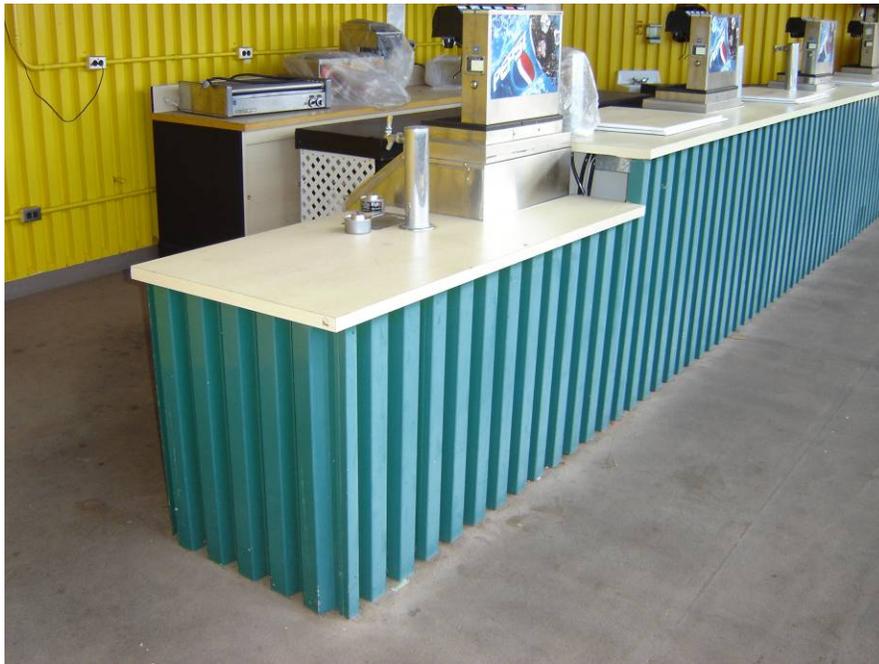
Other stadium functions and spaces – For most of the public spaces some level of provisions have been made to make them ADA accessible. There is at least 1 point of sale at every concession counter at an accessible height, in the restrooms there is at least one stall and lavatory that is accessible. Inside the stadium there is very little signage helping to instruct people to where ADA accessible provisions have been made. As for the back of house areas and the employee areas, there are some provisions made but less than in the public spaces. One example of this is the ramp between the stadium office level and the team locker room level. The slope of this ramp is over 12% and there are no hand rails mounted on either side of it.

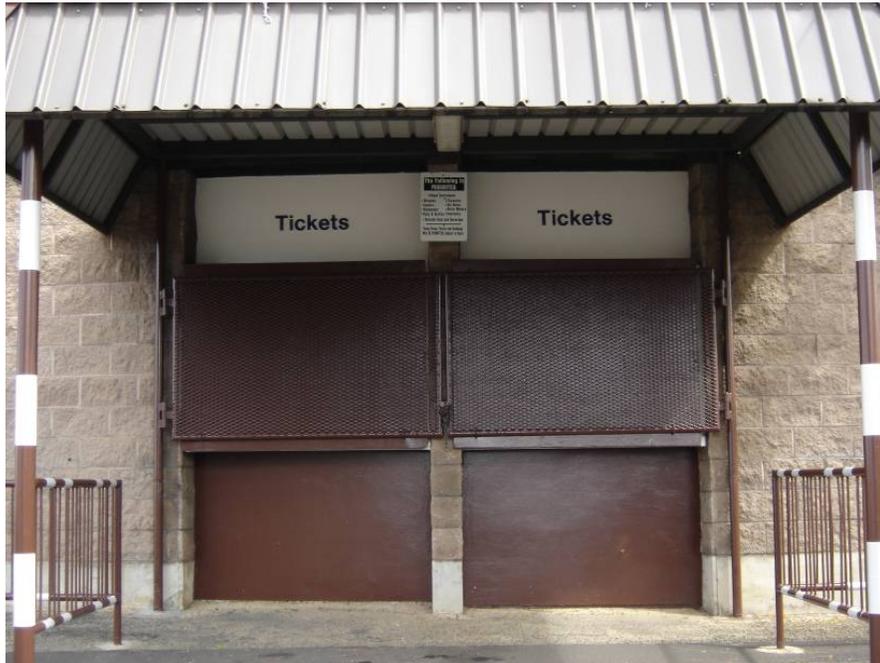
O3. Ticket windows between Gates 1 and 2 are not ADA compliant. Recommend a renovation of exterior ticket booths next to gates as well as main box office area to conform to the ADA guidelines.

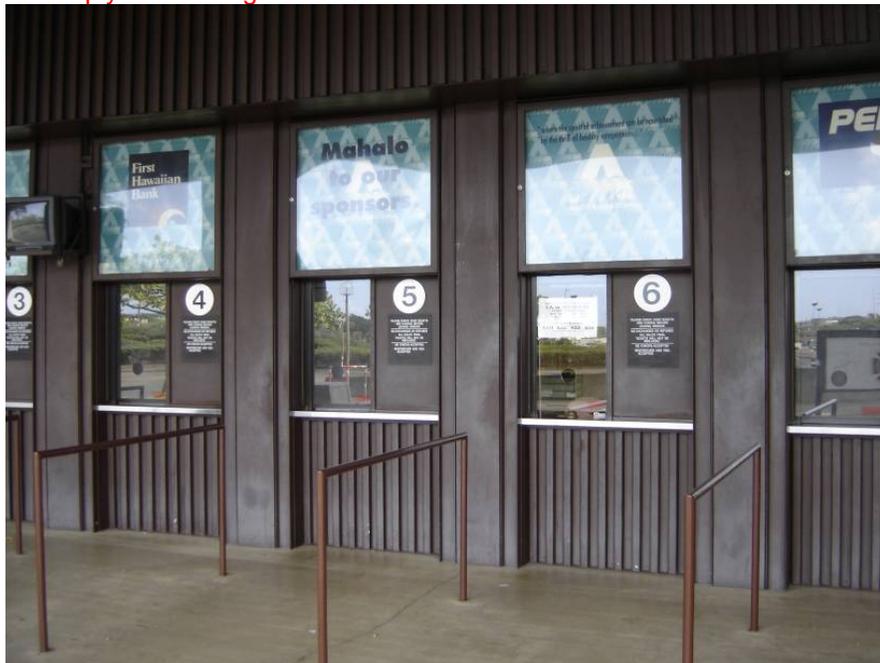
O2. Main Box Office windows are not ADA compliant. Recommend modification of one window to comply with ADA guidelines.

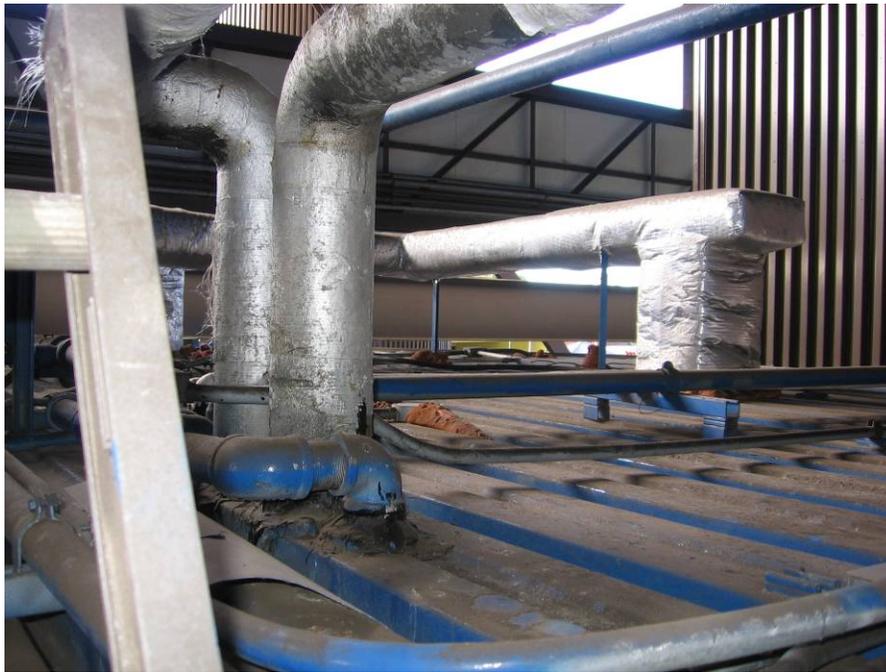
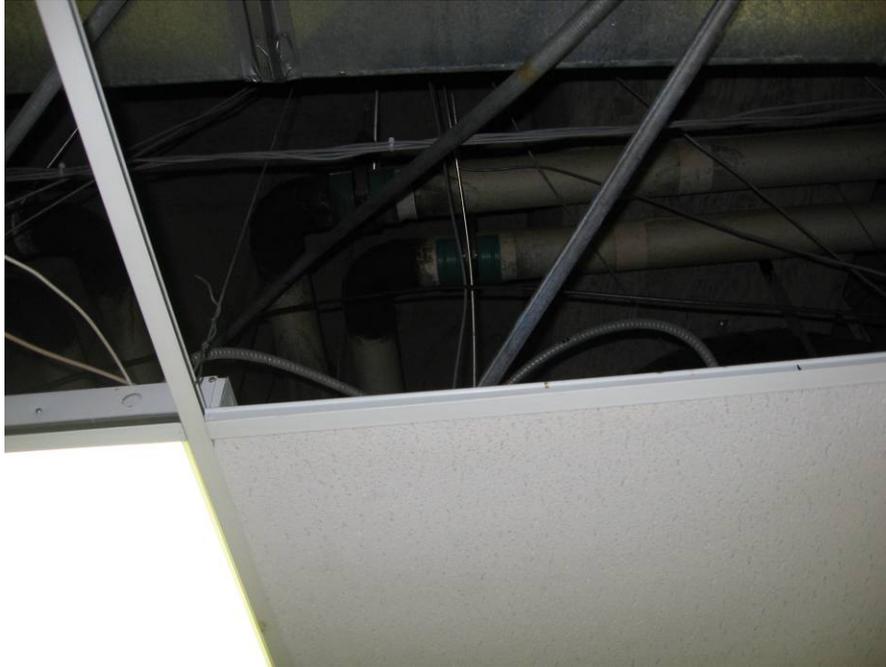
P1. The fiberglass insulation throughout the stadium show that the vapor barrier jacket has water stains along with growth of mold and mildew in various areas. Our visual inspection shows that the chilled water, condensate drain, and hot water pipe and duct insulation should be changed. **We recommend that the insulation for the pipes be changed to close cellular foam insulation. For the ducts, removed and reinstall new fiberglass insulation with VINYL FACED vapor barrier jacketing. The following are the areas the insulation should be changed:**

P1d. Mechanical Equipment room - piping, pumps, ducts and packaged AC unit

P1e. Sound booth @ Press Box area - ducts only
