VOLUME 2: EXISTING CONDITIONS

aloha stadium PLANNING STUDY FINAL REPORT - 12.22.05

SECTION II: CONDITION SURVEY

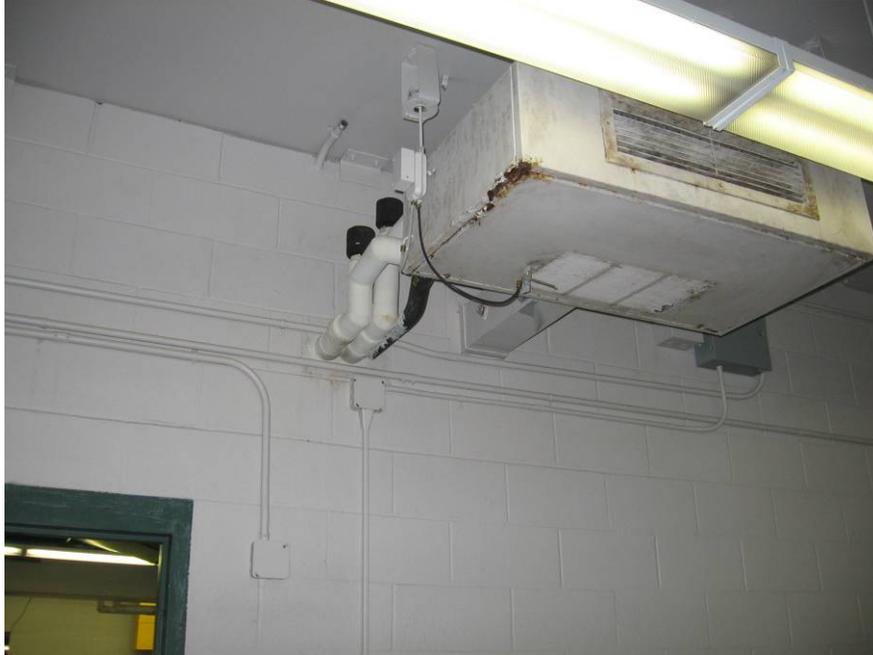
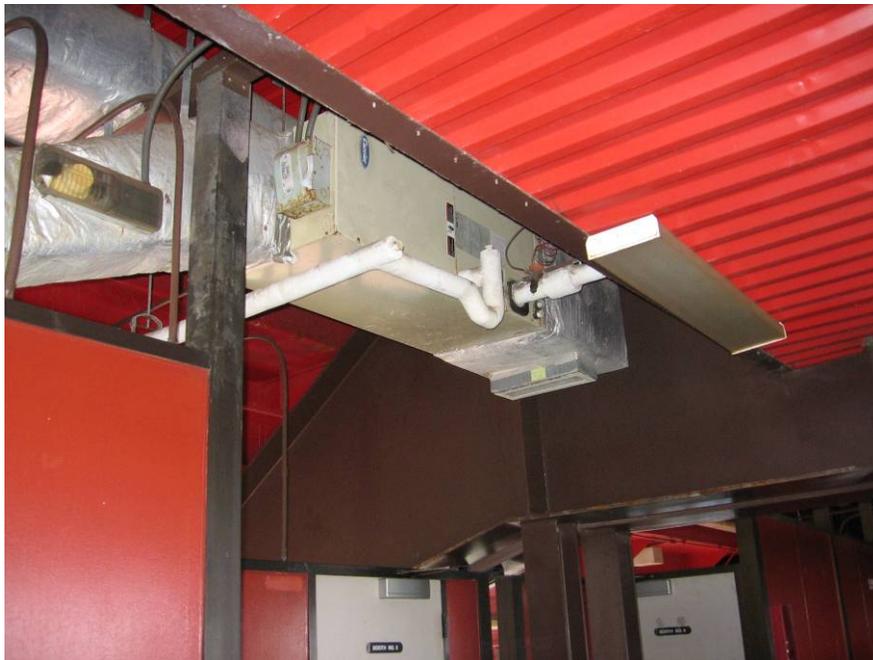
P2. HVAC systems are generally in good condition. Various areas require immediate attention. Built up chiller system appears to be providing the proper chilled water needed for the air conditioning system. **Consideration should be made to reduce the chilled water supply temperature to assist in the deterring the growth of mold on pipes and in ducts.** Except for units as listed below, it appears that the air conditioning units and exhaust fans could have another 5 to 10 years life span. **Proper maintenance must continue.**

P2a. Jumbotron AC unit is a 10 ton split system. **This unit should be changed immediately. We recommend the use of two each 7 1/2 ton packaged units**

P2b. First Aid room AC unit is a 2.5 ton roof top package unit. **This unit should be replaced with new, of equal size.**

P2c. Baseball Announcer room AC unit is a 1 ton packaged unit. **This unit should be replaced with a new 1 ton split system unit.**

P2d. North End Zone Maintenance Office AC unit appears to be approximately 2 1/2 ton water cooled unit. **This unit should be changed to a 3 ton unit either split or packaged unit.**

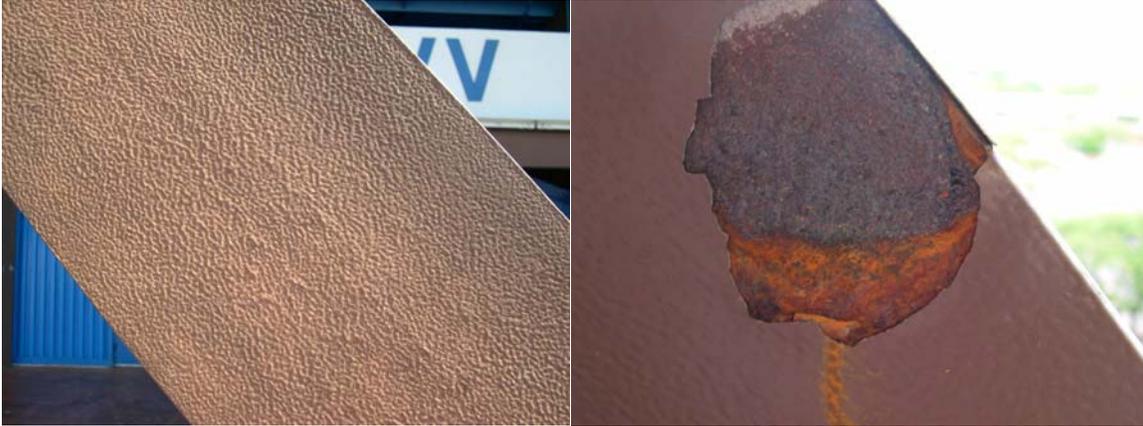
The weathering steel at Aloha Stadium was exposed to the elements for a number of years prior to receiving its first paint coating. As such, the steel surface became pitted due to corrosion caused by exposure to chloride-rich (salty), humid atmospheric conditions. Corrosive pitting of the steel surface makes the extent of steel section loss difficult to evaluate. Additionally, it makes

Figure R-1. View of a pitted weathering steel surface that was coated.

Figure R-2. Close-up view of recent weathering steel corrosion.

surface preparation and painting difficult. Figure R-1 shows a representative example of a heavily pitted surface that was coated. Figure R-2 shows an example of the nature of weathering steel corrosion, where heavy corrosion pitting and laminar corrosion planes are created.

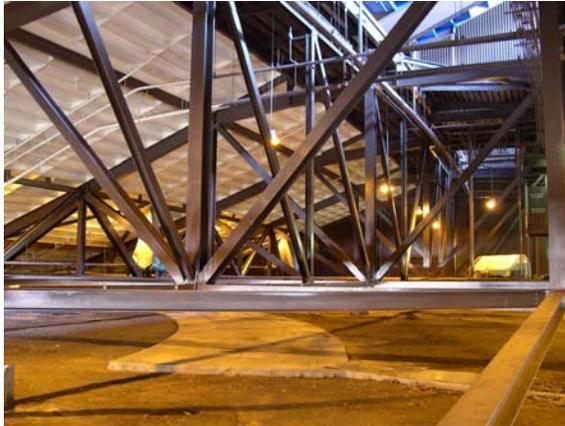
Below the stands, we also noticed a difference in the coatings. Below the East Moveable Stands, it appeared the full three-coat system was applied to the steel, as the top coat was brown colored. In the West Moveable Stands, the weathering steel framing beneath the stands apparently had only the primer coat and white colored epoxy intermediate coat applied. Evidently, the lack of UV exposure in this area below the stands led to a reduced coating on the steel, possibly as an economic savings at the time the steel was painted.

Figure R-3. Three-coat system observed beneath the East Moveable Stands.

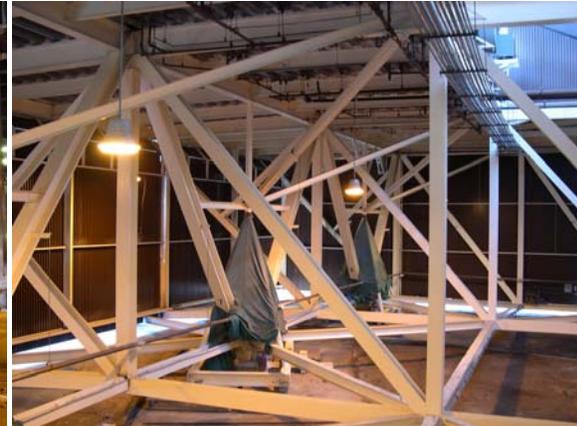
Figure R-4. Two-coat system observed beneath the West Moveable Stands.

When various areas of the steel in the structure are being readied for maintenance coating, the existing coating system should be thoroughly reviewed for coating types and for instances of improper coating sequences. Incorrect existing coating components and incorrect coating layer sequence will influence how the maintenance coating system will be applied.

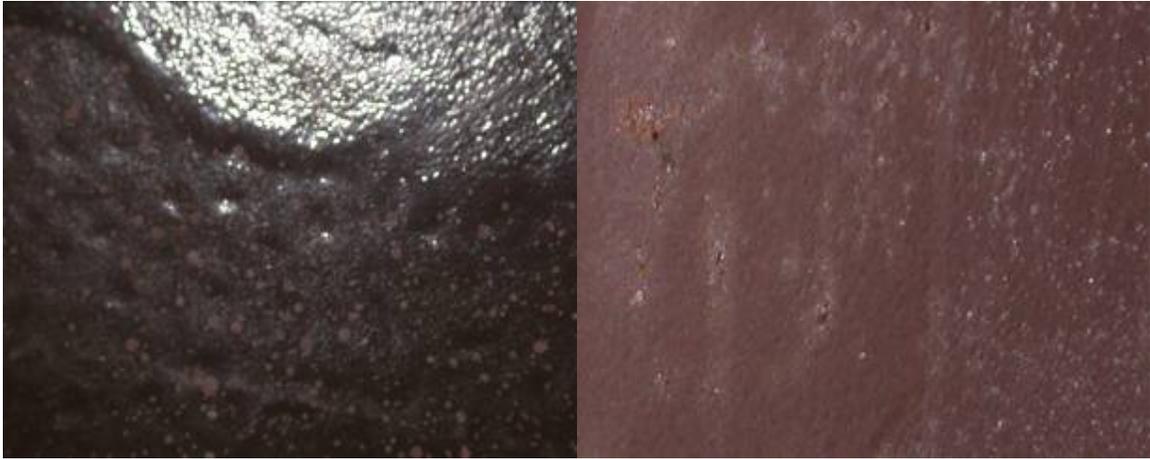
Pinholes were observed in the coated surfaces of several areas. Pinholes provide an immediate path for intrusion of chloride and moisture. The consequence is corrosion of the steel beneath the coatings. Figure R-5 illustrates rust nodules on the top flange of a beam under the East Stands, which are the consequence of chloride penetration into pinholes. Figure R-6 shows a more advanced consequence of the corrosion that developed.

Figure R-5. Close-up view of pinholes in the coating

Figure R-6. Close-up view of pinholes in the coating where rust has developed.

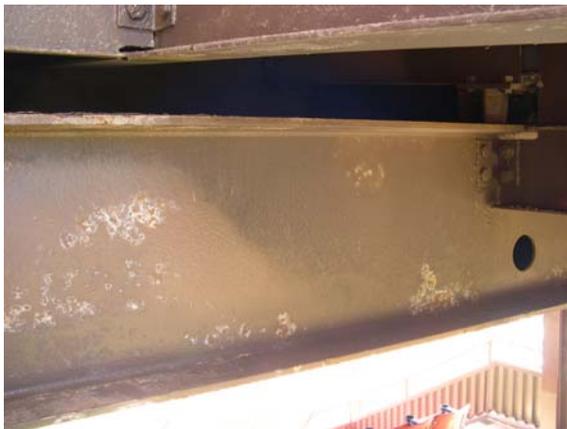
The conditions illustrated in Figures R-7 and R-8 show more advanced underfilm corrosion, and the paint blisters and pitting that result from these coating breaches. In Figure R-7, the zinc-rich primer is being consumed, causing the white colored corrosion around the corrosion pits.

Figure R-7. Coating blisters, steel pitting, and white corrosion from the zinc-rich primer.

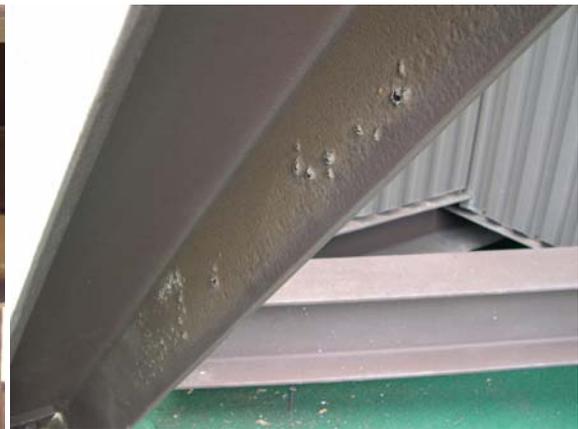
Figure R-8. Paint blistering observed on a diagonal flange interior.

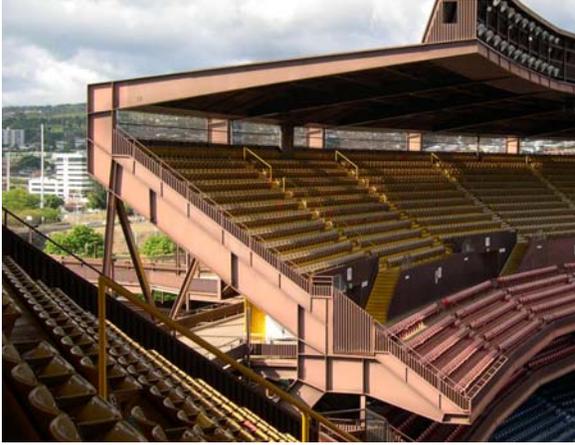
The topcoat was chalked and discolored in various areas. Infrared analysis of the topcoat indicates that its binder contains an aromatic component. Coatings with an aromatic component are not generally UV resistant and therefore prone to chalking. Figures R-9 and R-10 show examples of a chalked coating, which has a dull hue.

Figure R-9. Chalked coating on a raker bent of the upper level

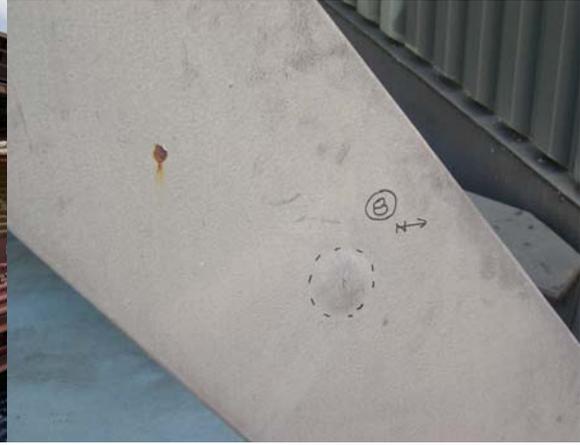
Figure R-10. Close-up view of the chalked coating on a diagonal member

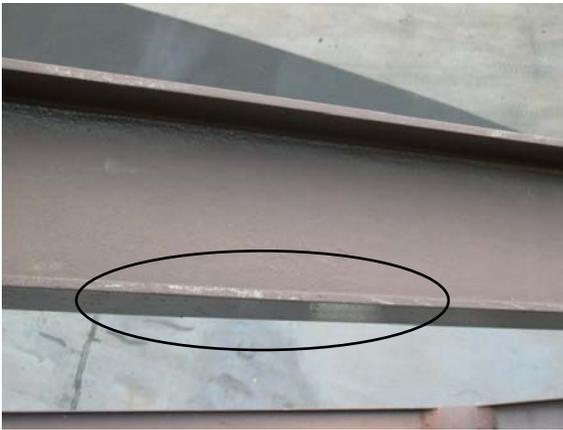
In several areas of the East Stands, the effect of sunlight on the topcoat has led to the formation of a thin, poorly-bonded (Rating 0A, the lowest rating), deteriorated layer of topcoat. Structural steel edges exhibit the exposed intermediate coat due to erosion of the topcoat layer, as shown in Figures R-11 and R-12. In both photographs, the white epoxy intermediate coat is showing through.

Figure R-11. Thin top coat observed on the flange tip.

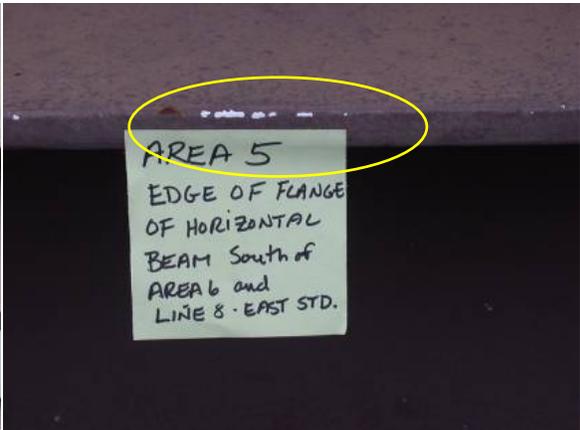
Figure R-12. Close-up view of the thin top coat at the tip of a flange.

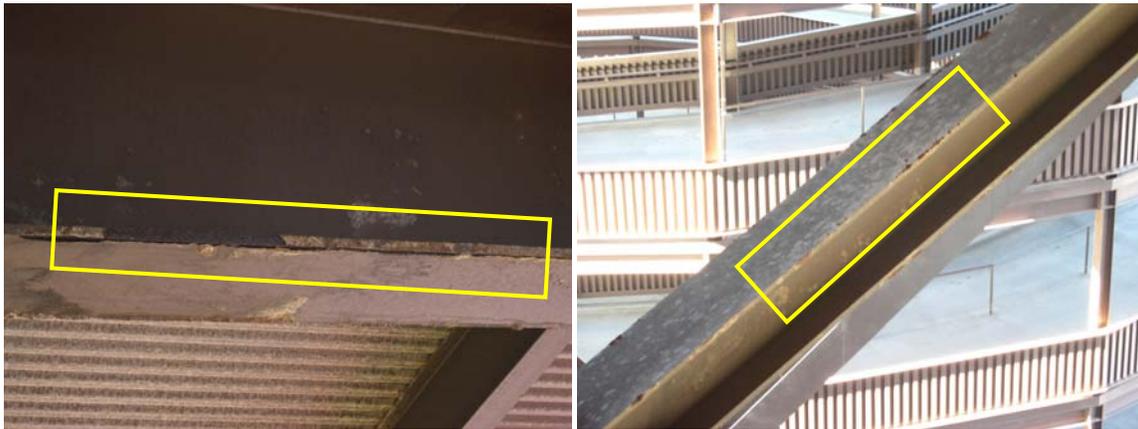
Edge corrosion - Edge corrosion on the flange tips of the structural steel was frequently observed, shown in Figures R-13 and R-14. The coating at edges is often thin due to increased surface tension effects around the 90° corners as the coating system cures. Thin coatings are more susceptible to penetration by chloride and moisture, which can later result in corrosion.

Figure R-13. Advanced flange tip corrosion observed on a roof beam in the upper balcony.

Figure R-14. Flange tip corrosion observed on a diagonal bracing member.

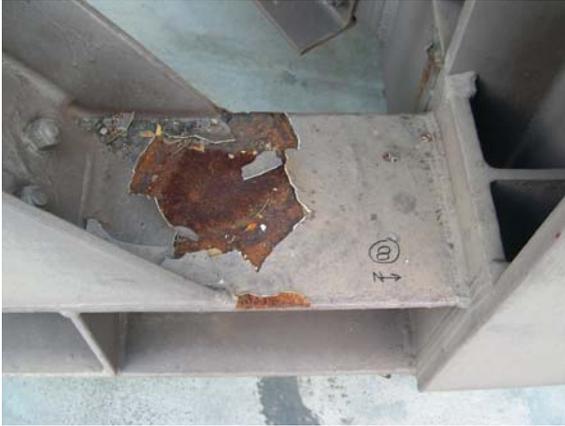
Corrosion patches - A variety of random occurrences were observed on the structure with notable areas of corrosion and coating loss. Figure R-15 illustrates an example of such an area; the corrosion shown occurs at the end of a diagonal element where water and contaminants wash down and inundate the coating. In this particular area, the coating system was up to 70 mils thick, chalked, and brittle. Figure R-16 shows corrosion on a beam web laid flat, which tends to collect water.

Figure R-15. Brittle failure of a thick coating layer, exposing the underlying steel.

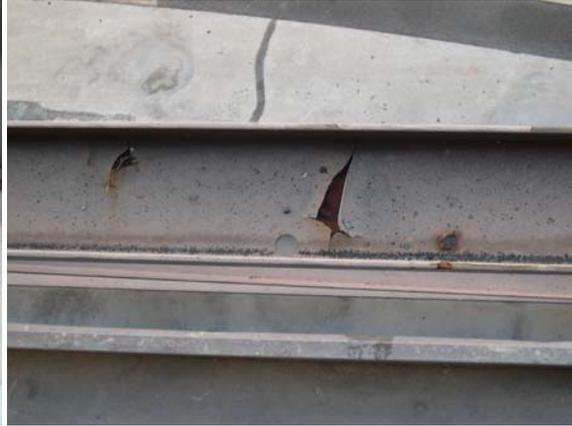
Figure R-16. Cracked coating on a beam web that led to underfilm corrosion.

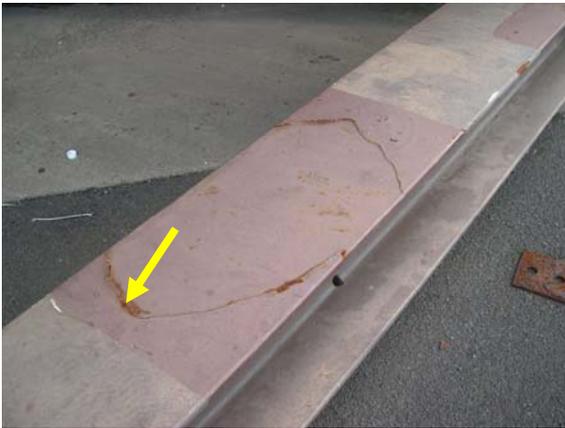
Maintenance painting - Repair of localized failures has been attempted with limited success. Coincidentally, a number of maintenance painting areas were observed to be only within “arms reach” of the nearby access. Regions requiring maintenance painting in difficult access locations tended to be avoided or missed entirely. Figure R-17 shows a typical maintenance painting repair where corrosion is apparent at the periphery of the repair. Coating compatibility was another issue observed in the field. Figure R-18 shows apparent repainting of a corrugated wall section with a reddish-brown paint has resulted in a peeling failure.

Figure R-17. Corrosion observed at the periphery of a repair area.

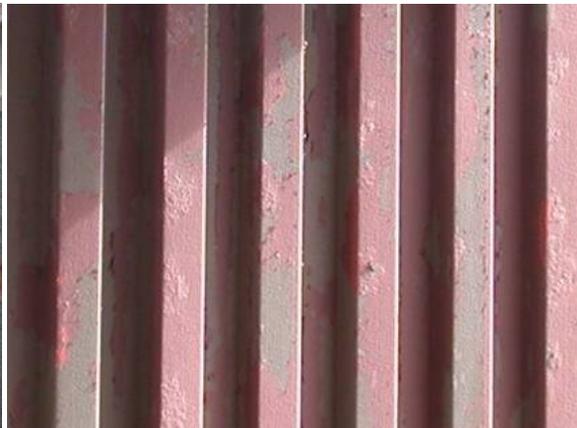
Figure R-18. Incompatibility of the maintenance paint over a corrugated panel.

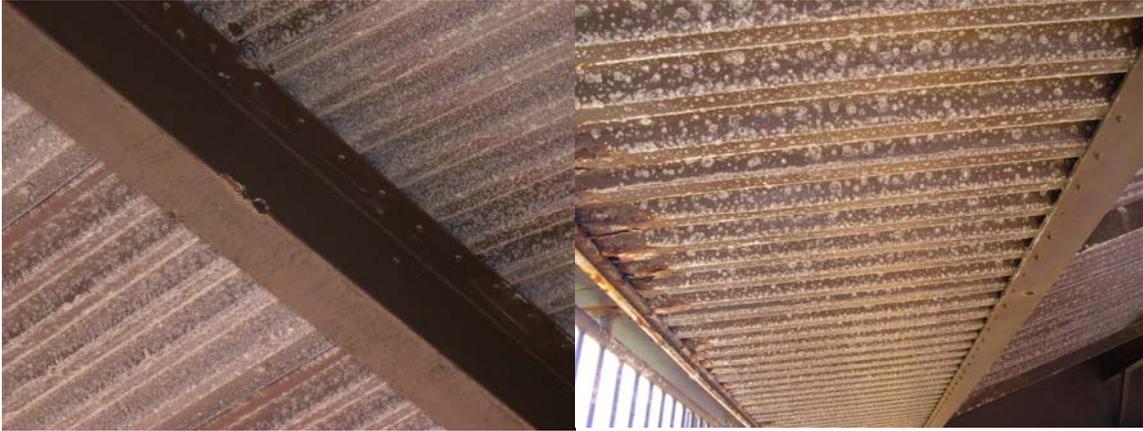
Galvanized steel elements were installed as part of structural repairs in the 1980s and 1990s. The zinc protective coating is typically being consumed in this aggressive environment, which is the expected performance for this coating. Figures R-19 through R-22 show examples of white corrosion product bleeding through the painted elements. On Figure R-20, the trough for the roof

gutter is lined with copper. Therefore, the corrosion shown in Figure R-20 could be at least in part due to galvanic corrosion of dissimilar metals.

Figure R-19. Typical metal roof deck corrosion

Figure R-20. Metal roof deck corrosion beneath the gutter trough on the roof.

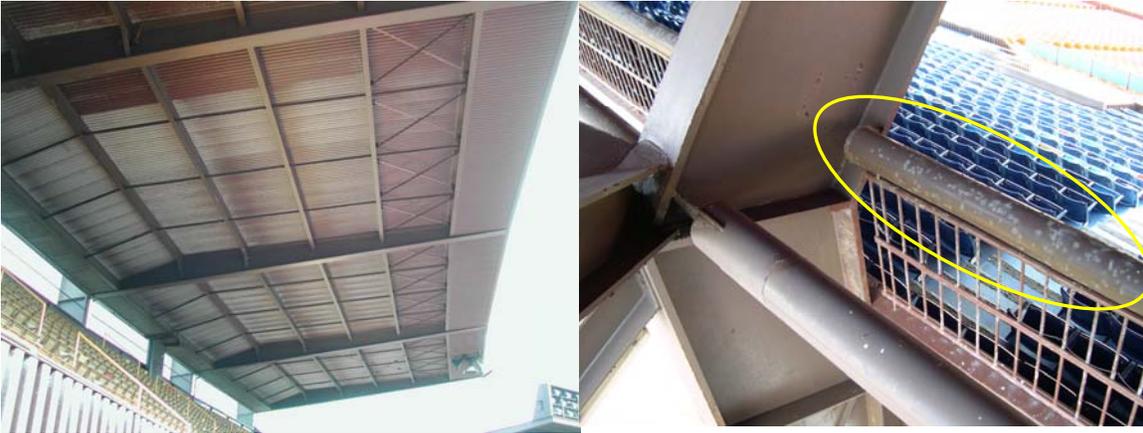
Figure R-21. Overall view of the underside of a roof deck showing the extent of roof deck corrosion.

Figure R-22. White corrosion bleed through on a painted pipe brace member.

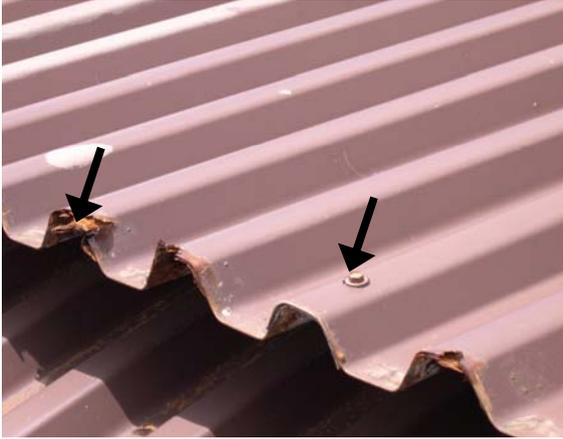
Figures R-23 and R-24 show conditions observed at the top surface of the metal roof panels. Here, stainless steel screws are used to fasten the metal roof deck to the underlying weathering steel structure. The metal roof panels are typically galvanized steel, although aluminum panels were used at some locations. Figure R-24 shows apparent galvanic corrosion of stainless steel screw fasteners used with aluminum roof panels. At other locations, the fasteners have fractured due to corrosion.

Figure R-23. Metal roof deck corrosion along the panel edge. Note the corroding galvanized fastener even with a neoprene washer.

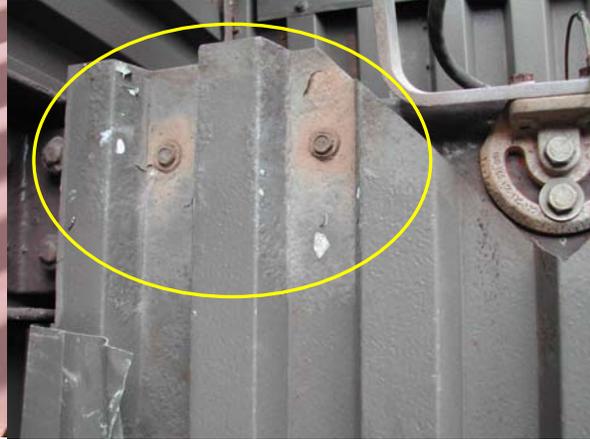
Figure R-24. Corrosion of the galvanized fasteners and aluminum deck panel in the light enclosures.

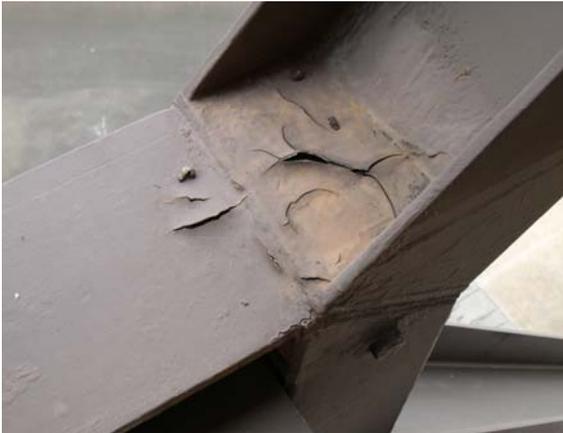
Figure R-25. Cracked coating over a hub pocket filler.

The fillers at a number of the hubs and connection nodes have localized failures. At the lower hubs, the “polymeric” filler seemed to have more evidence of distress. Figures R-25 and R-26 show breaches of the coating system applied over the “polymeric” filler and general failure of the coating on the horizontal steel surface. Figures R-27 and R-28 show other conditions where the paint and underlying “polymeric” filler have cracked or are exhibiting crazing type cracking. Cracks in this barrier typically were accompanied by rust stain bleed-through, thus indicating

corrosion has developed beneath the filler materials at some of these locations. The exact filler materials previously used remain to be identified.

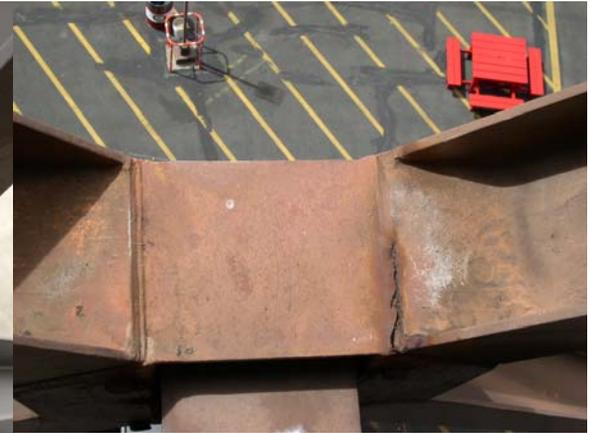
Figure R-26. Cracked coating and corrosion observed at a hub pocket filler.

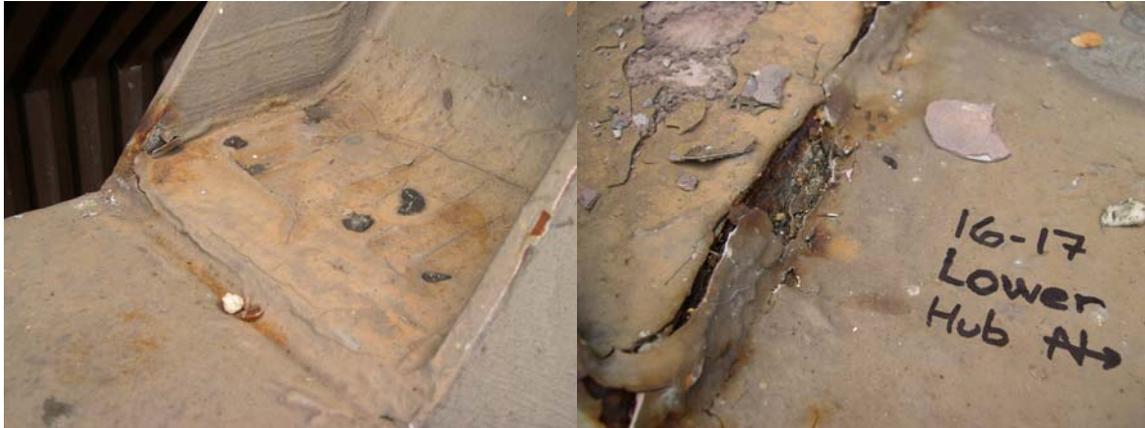
Figure R-27. Crazing type cracks in the coating at a hub pocket.

Figure R-28. Close-up view of the cracked coating and corrosion at a hub pocket filler

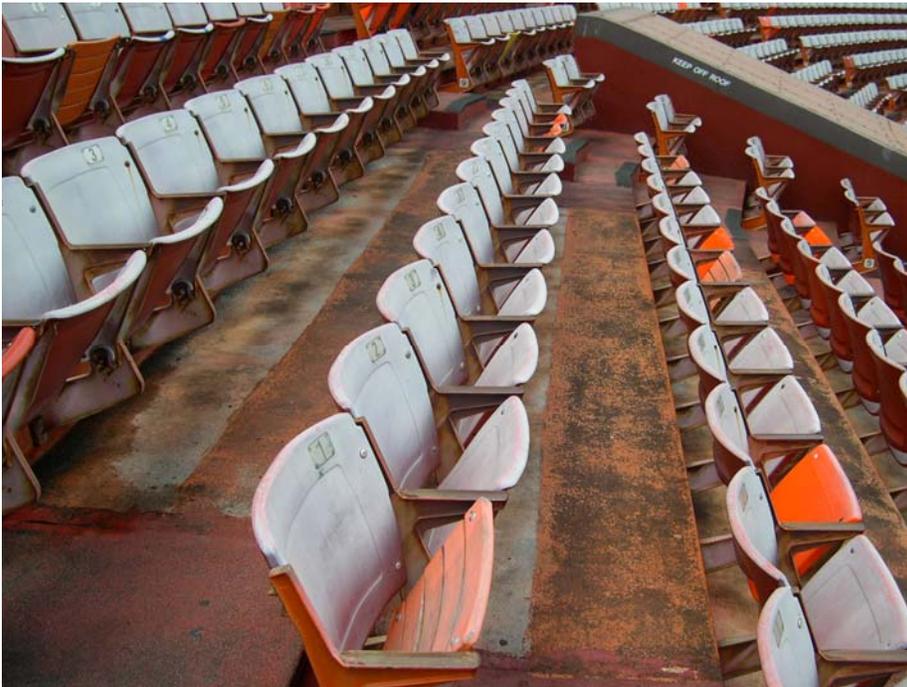
Figure S-5. Top surface of the precast tread and riser members in the lower field seating areas (fixed stands)

- Repair the spalled ends of the precast tread and riser member in the northwest fixed quadrant.
- It is recommended that the shear crack observed in the beam above the tunnel entrance in the north fixed stadium be investigated. The cause of the shear cracking, an evaluation of the beam capacity, and the source of the moisture intrusion should be included in this investigation.

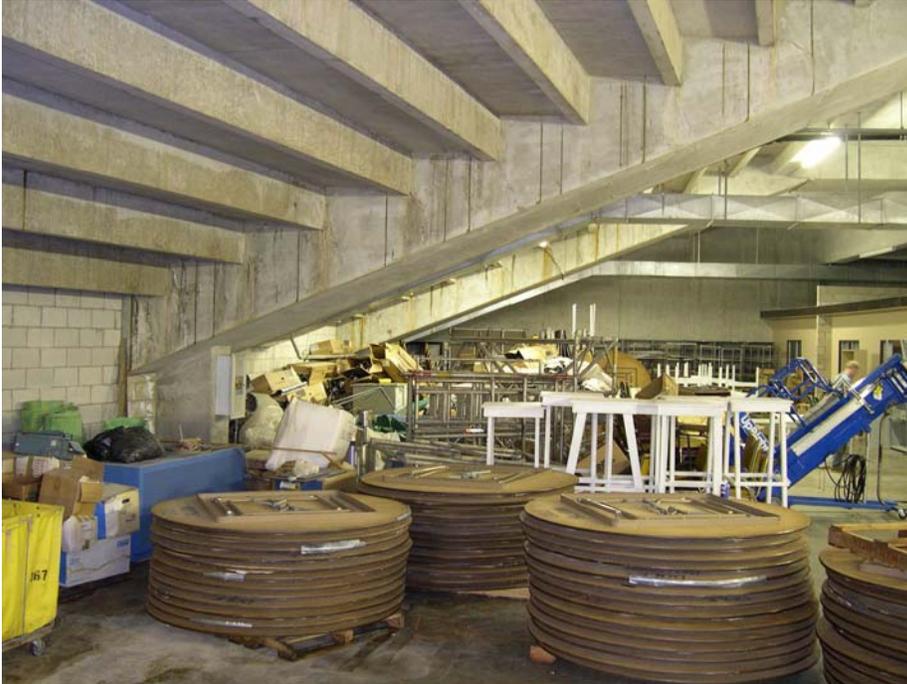
Figure S-6. Typical underside framing of the lower field seating areas (fixed stands)

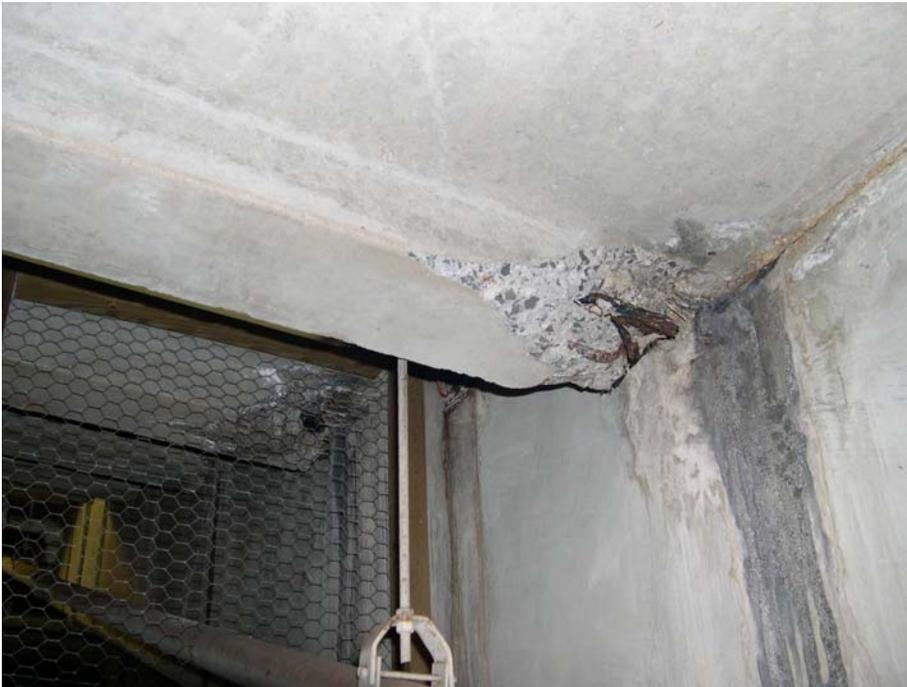
Figure S-7. Concrete spalling observed at the end of a precast tread and riser member

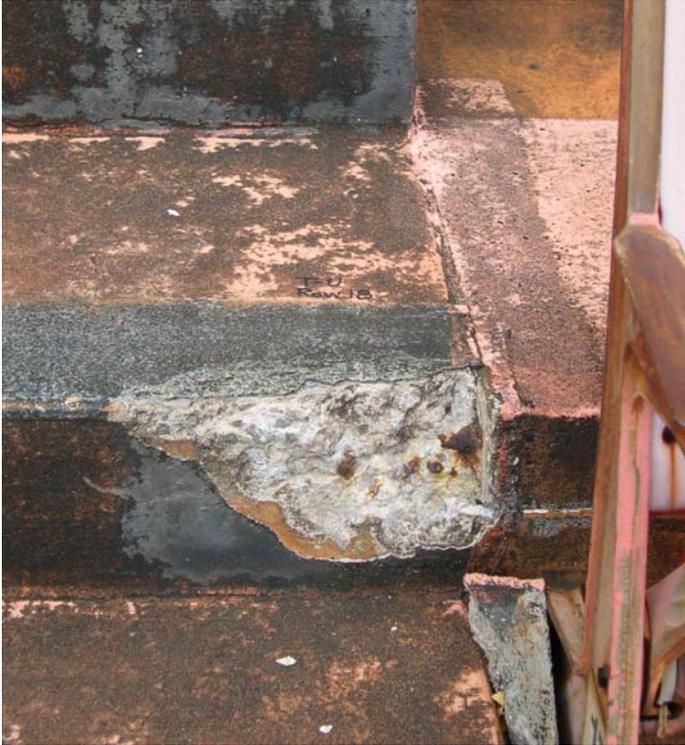
Figure S-8. Typical area of concrete deterioration observed on the precast tread and riser members

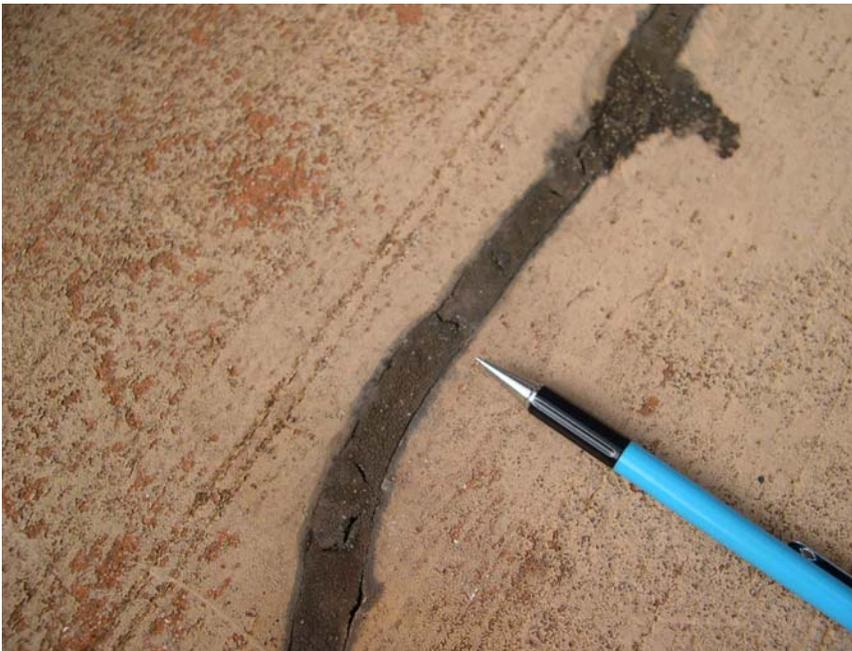
Figure S-9. Weathered sealant in a previous crack rout-and-seal repair observed on the topside of the lower field seating area (fixed stands)

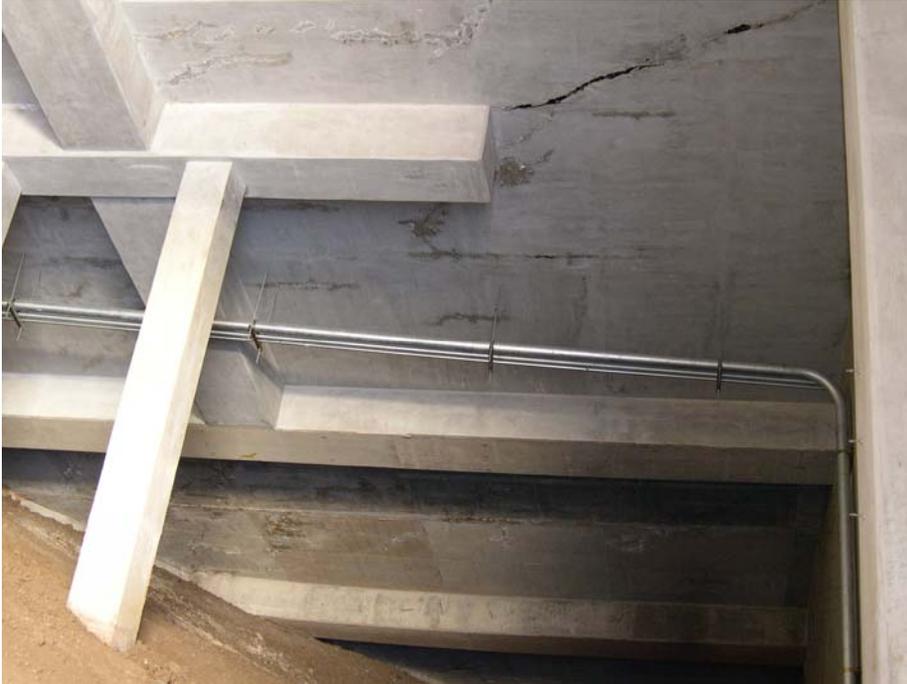
Areas of active and prior leakage were observed throughout the underside of the lower concourse slab. This leakage was evidenced by moisture staining and efflorescence leaching through cracks on the underside of the concrete slab. An example of slab cracking exhibiting efflorescence is shown in Figure S-11.

Figure S-11. Leakage observed and moisture staining on the underside of the lower concourse concrete slab

the concrete slab. Therefore, replacement of the asphalt topping and the waterproofing system over the concrete slab is recommended at the south lower concourse area that is located over the main entrance and offices for the Stadium.

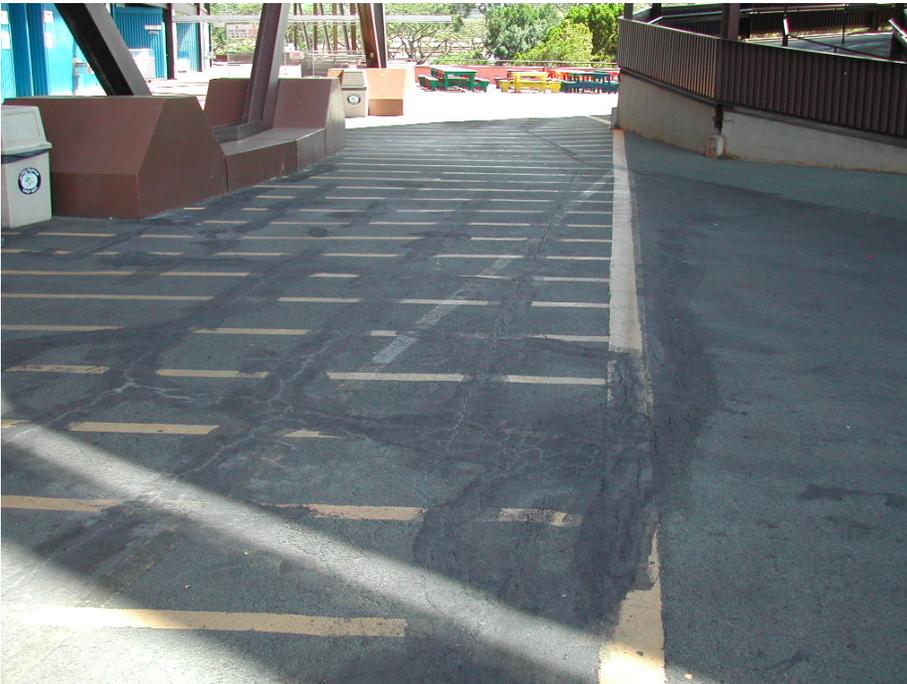
Cracking and other similar deterioration was also observed in the asphalt overlay, as shown in Figure S-12. As a result, an inspection opening was made in the asphalt overlay at the north and south lower concourses of the Stadium to determine the type and condition of the waterproofing system, if any, between the concrete slab and the asphalt overlay. A built-up asphalt waterproofing membrane does exist beneath the asphalt topping above the main entrance and office area at the south region of the lower concourse; however, a waterproofing membrane was not observed beneath the asphalt topping at the north region of the lower concourse.

Figure S-12. Typical deterioration observed in the asphalt overlay above the concrete slab

- The cracking and deterioration in the asphalt overlay allows water to penetrate through the asphalt to the concrete slab below. Currently, water appears to be migrating through breaches in the waterproofing system, resulting in moisture staining on the underside of

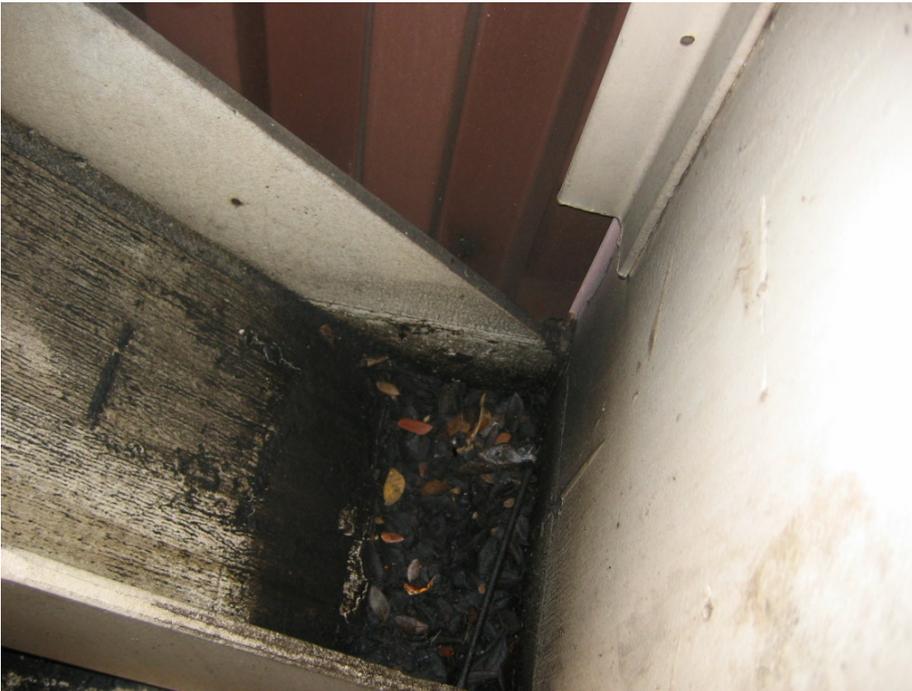
In general, the condition of the paint coating system below the lower field seating appeared to be in better condition than in other areas of the Stadium. This is likely due to the limited exposure to UV and direct weather. A build up of dirt and debris was commonly observed on the steel framing members, as illustrated in Figure S-15. This dirt and debris commonly clogged the weep holes in the lower truss members.

Figure S-15. Clogged weep hole and debris trapped at a lower truss connection node

- All structural steel framing should be powerwashed (P0 repair) to remove the chlorides from the surface of the coating. Powerwashing would also help to remove any build up of dirt and debris on the surface of the members, as well as serve to unclog the weep holes.

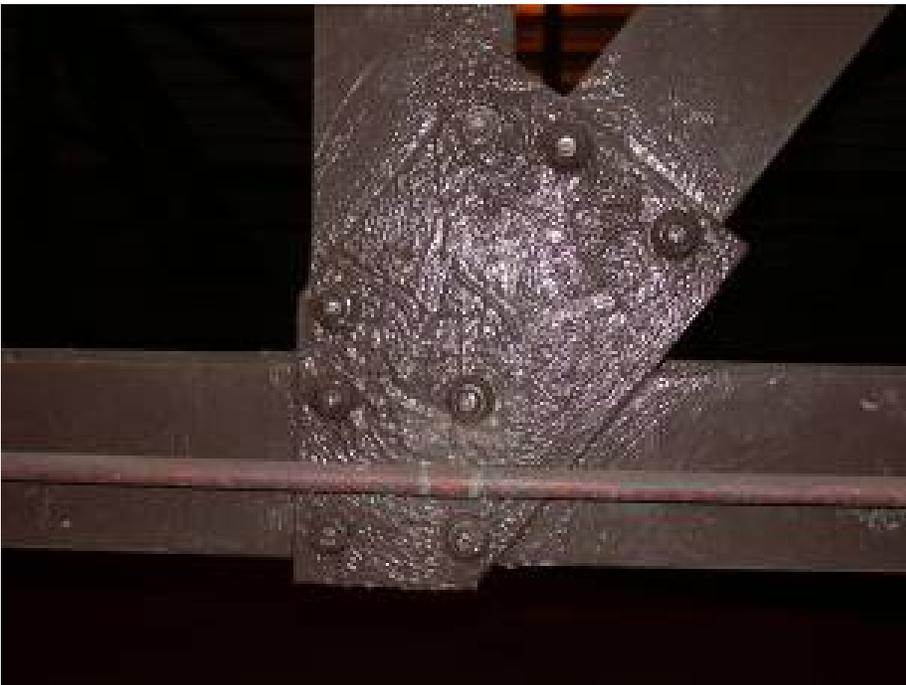
Paint failures and localized corrosion of lower plane bracing members were frequently observed. The paint failures were almost exclusively located at the flange tips of these framing members, as shown in Figure S-16. In the west quadrants, it was estimated that approximately 15 percent of the length of these members exhibited corrosion of the flange tips. In the east quadrants, the flange tip corrosion was more common along the top flange of these members, estimate at up to 50 percent of the member length in some areas. Paint failures were occasionally observed in truss members above the lower plane, such as diagonal members. At several lower connection nodes of the truss members, the coating was observed to be built-up and excessively thick, as shown in Figure S-17.

Figure S-17. Excessively thick coating observed at a lower truss node

- The underside of the seat plate should be powerwashed (P0 repair) to remove chlorides, dirt, and debris from the surface.
- Localized paint repairs (P2) are required at all areas exhibiting paint coating failures and ongoing corrosion. These areas are concentrated in the lower plane of framing members. Furthermore, the corrosion is typically observed at the flange tips of these members. In members with concentrated areas of corrosion (P2 repairs), sandblasting and painting repairs (P3) are recommended.

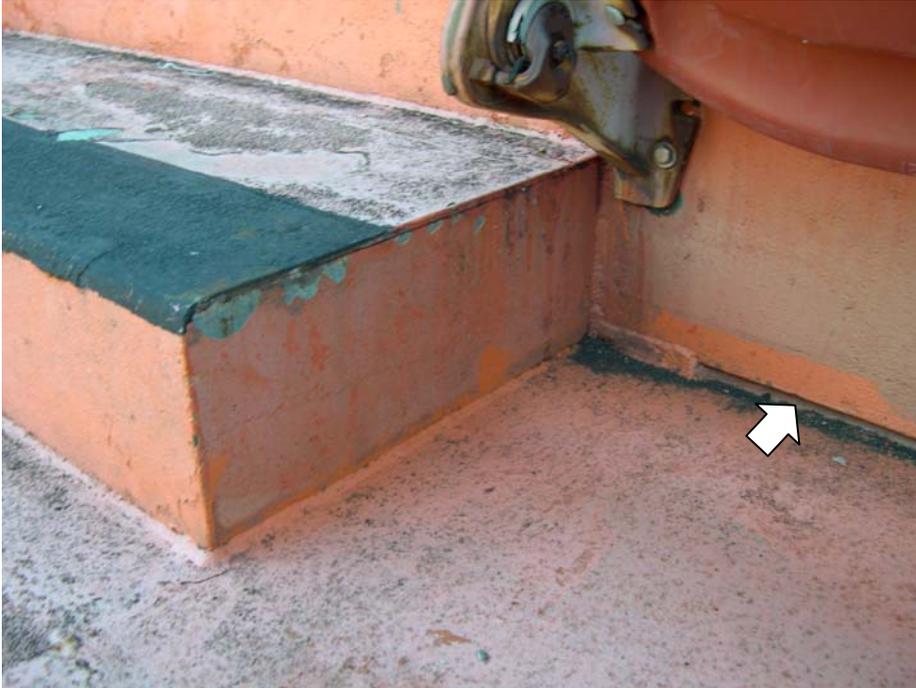
Figure S-20. Joint (at arrow) between tread and riser plates (point of entry for wind driven rain)

- To prevent wind-driven rain from entering the joint in the steel seat plate, it is recommended that a cove bead of sealant be placed in this horizontal joint on the exterior prior to replacement of the waterproofing membrane. The interior side of this same joint may also need sealant treatment. Replacement of the waterproofing membrane on the top surface of the seat plate is recommended and is discussed further in Section D.

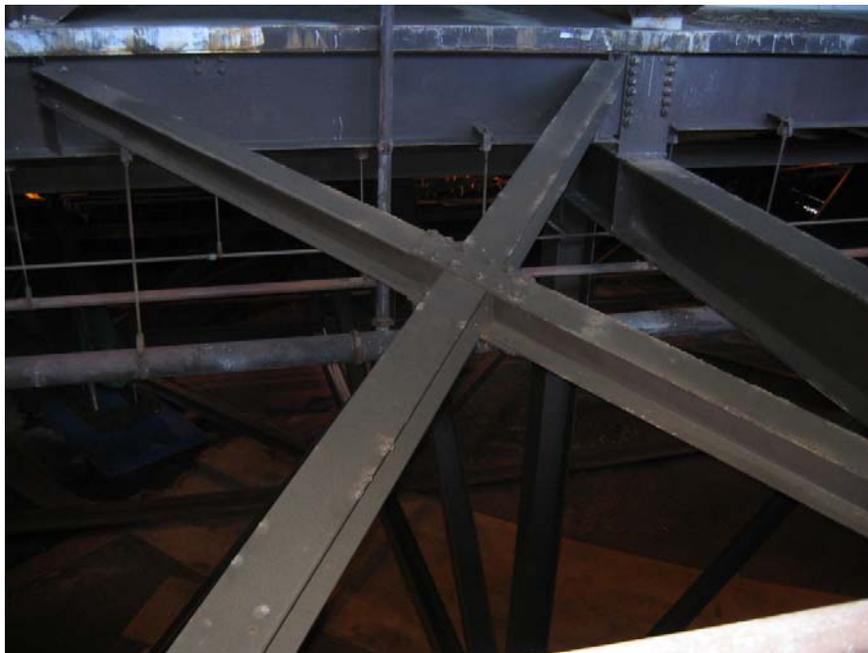
In general, the weathering steel framing members of the lower concourse appeared to be in good condition. However, the framing members adjacent to large openings in the lower concourse, shown in Figure S-23, exhibited widespread areas of paint failures and surface corrosion. The opening in the concourse exposed these coated weathering steel members to the elements, such as wind-driven rain.

Figure S-23. Typical corrosion and paint failures observed in the framing members at typical large opening in the lower concourse

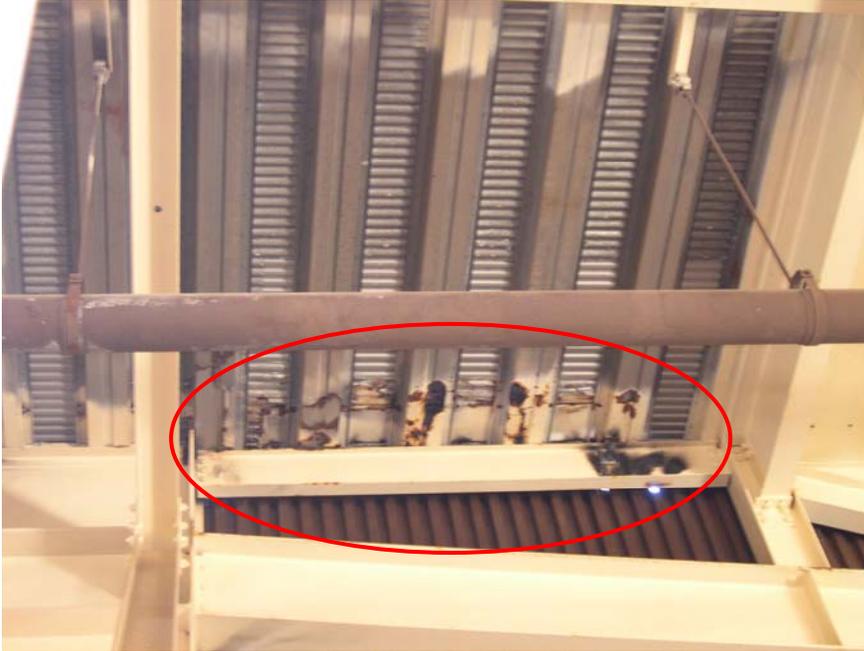
Corrosion of the metal deck flutes was observed in several areas, such as adjacent to expansion joints, as visible in Figure S-24. Some flute ends have been retrofitted to address prior corrosion, as shown in Figure S-25, but in many cases it appears the retrofit is beginning to deteriorate. In addition, the retrofit apparently installed locally at flute ends and it is unclear how it is developed into the original flute. Corrosion of the metal deck flutes was also observed beneath electrical (transformer) room, as shown in Figure S-26, which appears to be the original deck system. The deck in this region consists of very closely spaced flutes, likely overtopped with the thin form deck observed elsewhere.

Figure S-24. Area of metal deck corrosion at the lower concourse adjacent to an expansion joint

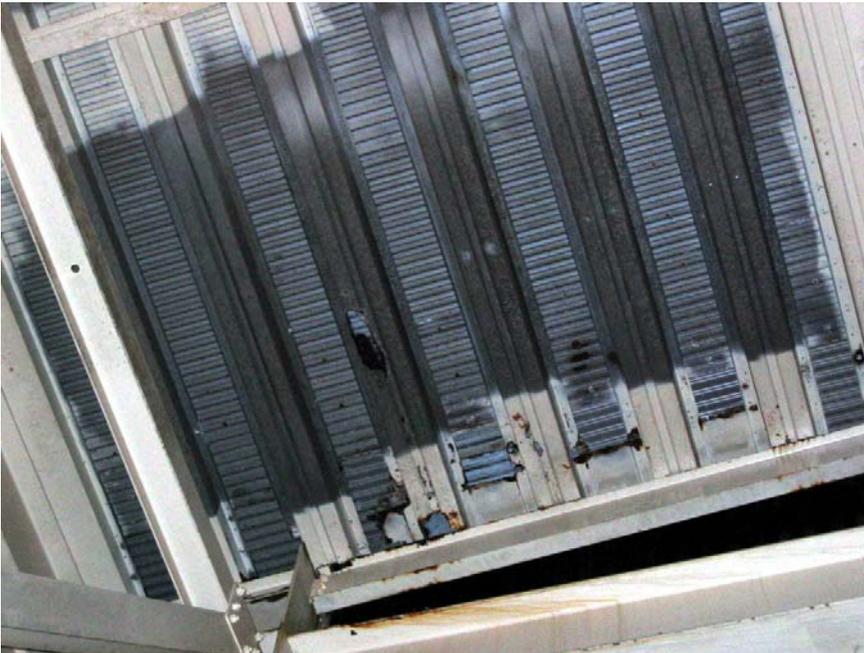
Figure S-25. Area of metal deck corrosion at the lower concourse adjacent to an expansion joint

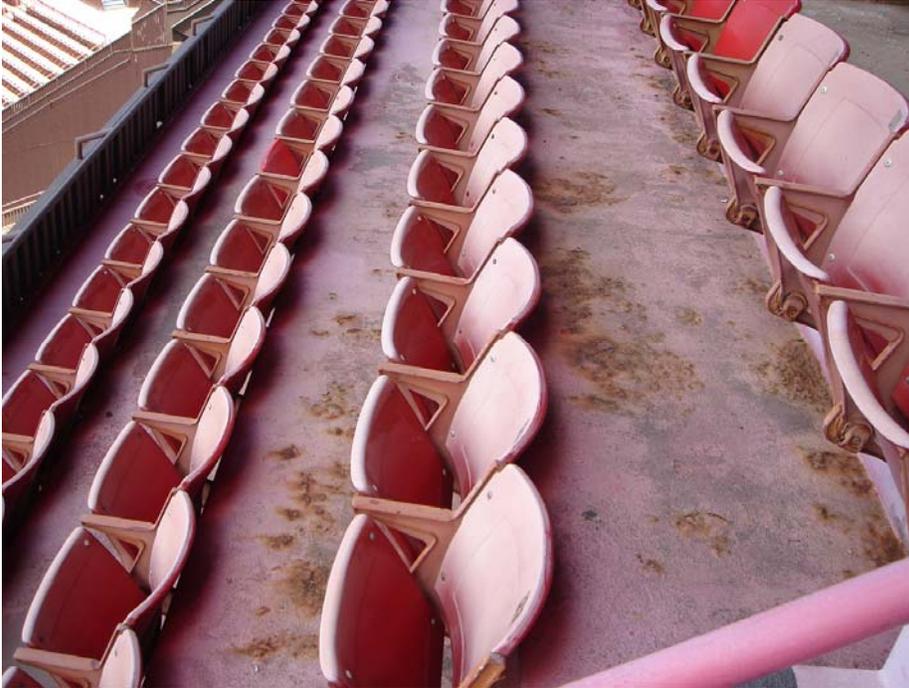
Figure S-44. Areas of surface corrosion observed on the top surface of the tread plate in the lower tier seating section

- Sandblasting the corroded areas on the top side of the seat plate will be required before a new waterproofing membrane is applied. Replacement of the waterproofing membrane on the top surface of the seat plate is recommended and is discussed further in Section D.

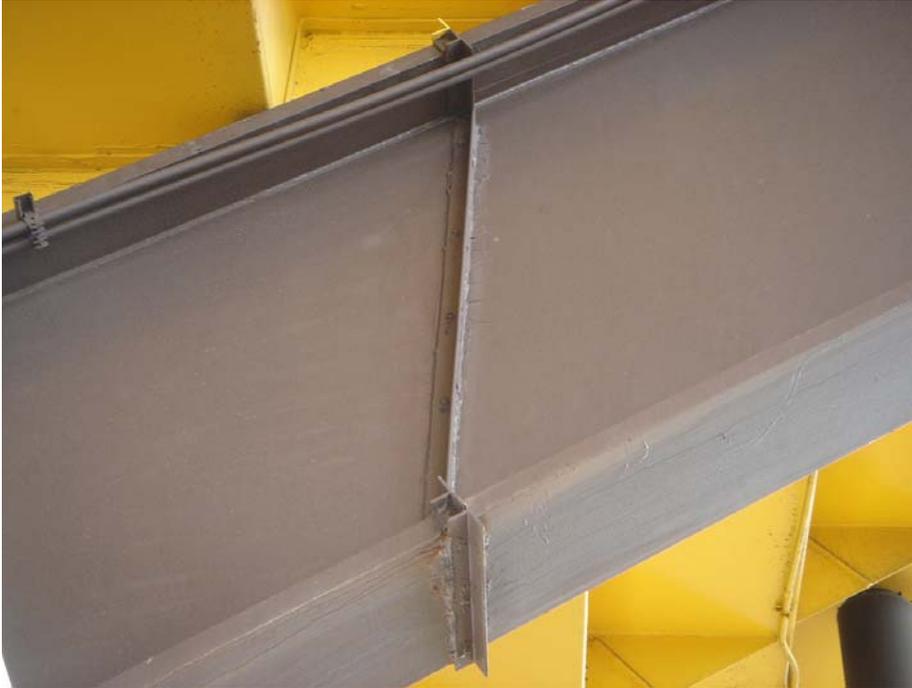
Figure S-46. Typical water runoff retrofit to prevent water from collecting on the bottom flange at the raker elbow

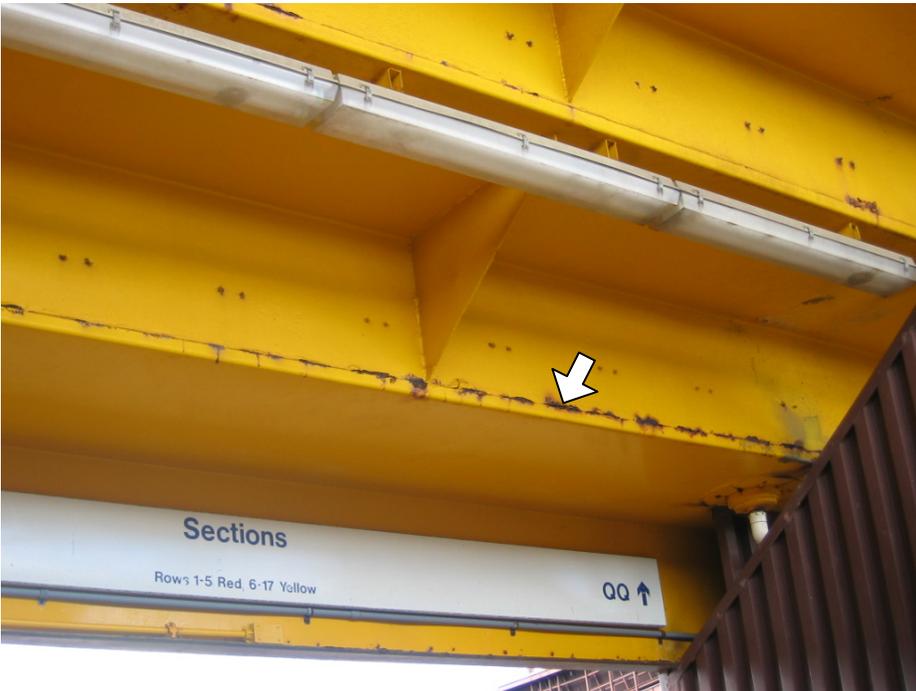
Figure S-47. Corrosion and pack rust at tread/riser plate joint
