VOLUME 2: EXISTING CONDITIONS

aloha stadium PLANNING STUDY FINAL REPORT - 12.22.05

SECTION II: CONDITION SURVEY

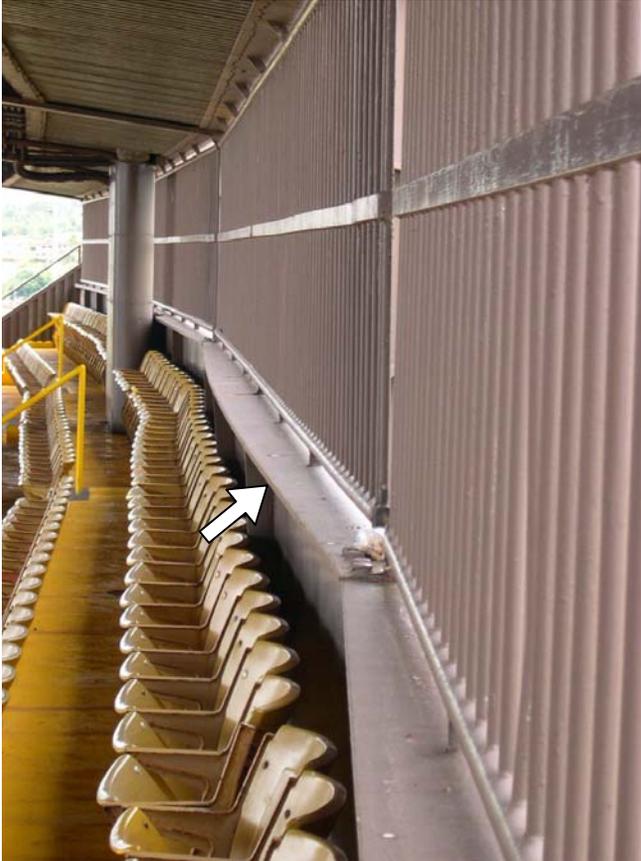
Figure S-48. Lateral sweep of the girder at rear of upper tier seating

- Sandblasting the corroded areas on the top side of the seat plate will be required before a new waterproofing membrane is applied.
- Further investigation regarding the lateral sweep of the girder at the rear of the section is also recommended. The investigation should include an analysis to determine the ability of the girder to transfer lateral loads in its current condition, and to verify whether the girder is required for the transfer of lateral loads. If an overall wind load analysis is performed for the entire stadium structure, the analysis of this plate girder could be included as part of the larger analysis.

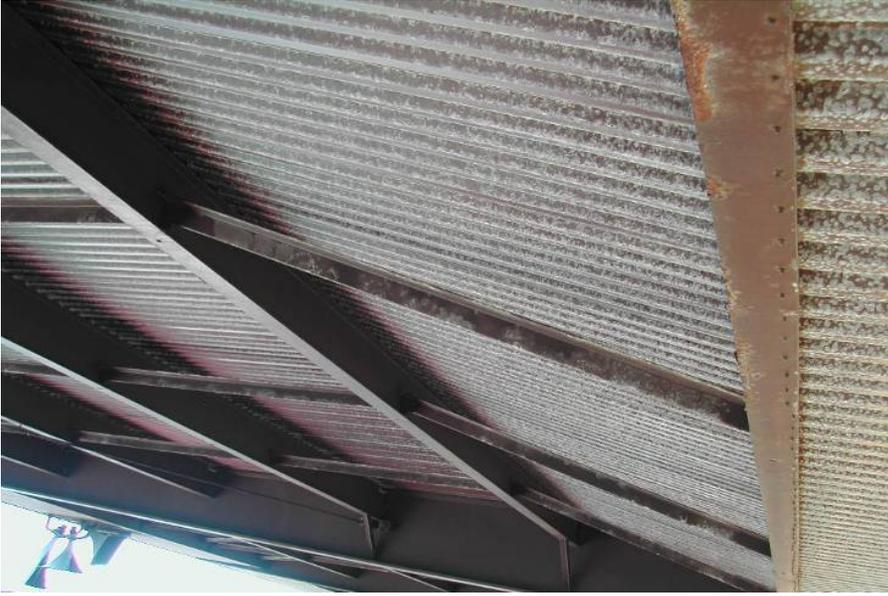
Figure S-51. Galvanic corrosion (white deposits) on the metal deck

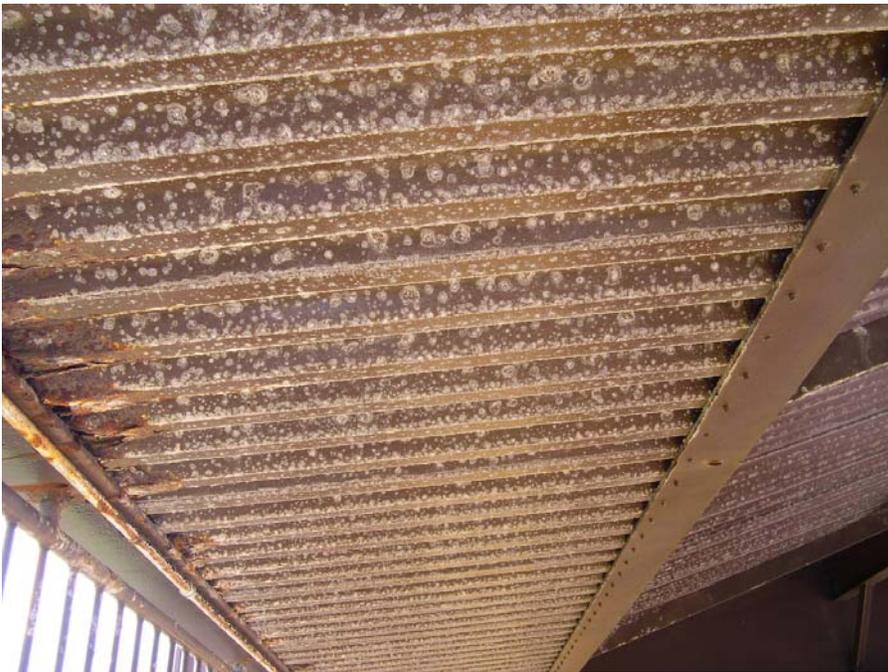
Figure S-52. Severe corrosion and section loss of the metal deck and framing members beneath the rain gutter

- Repairs to the weathering steel framing members of the electrical (lighting) chase are recommended during the replacement of the metal roof deck. The metal deck surrounding the chase should also be replaced at that time.

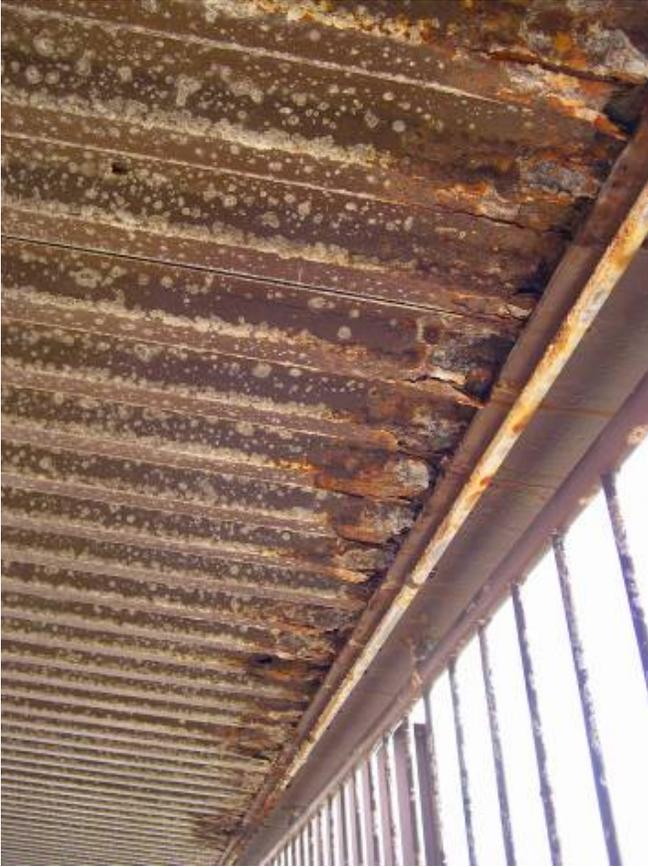
Figure S-53. Severe corrosion and section loss of the metal deck and framing members beneath the rain gutter

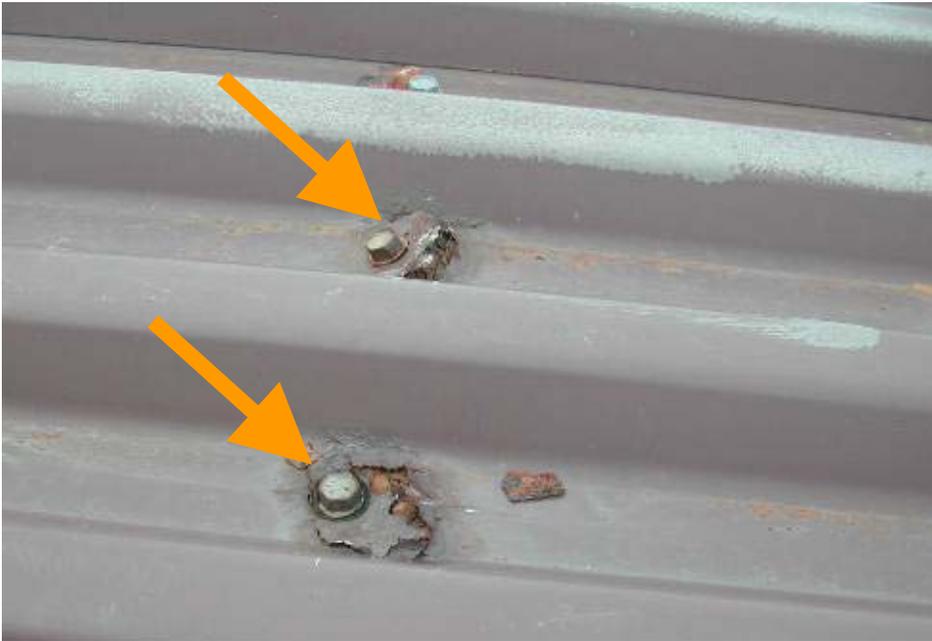
Figure S-55. Corrosion of the metal deck in the vicinity of the fastener

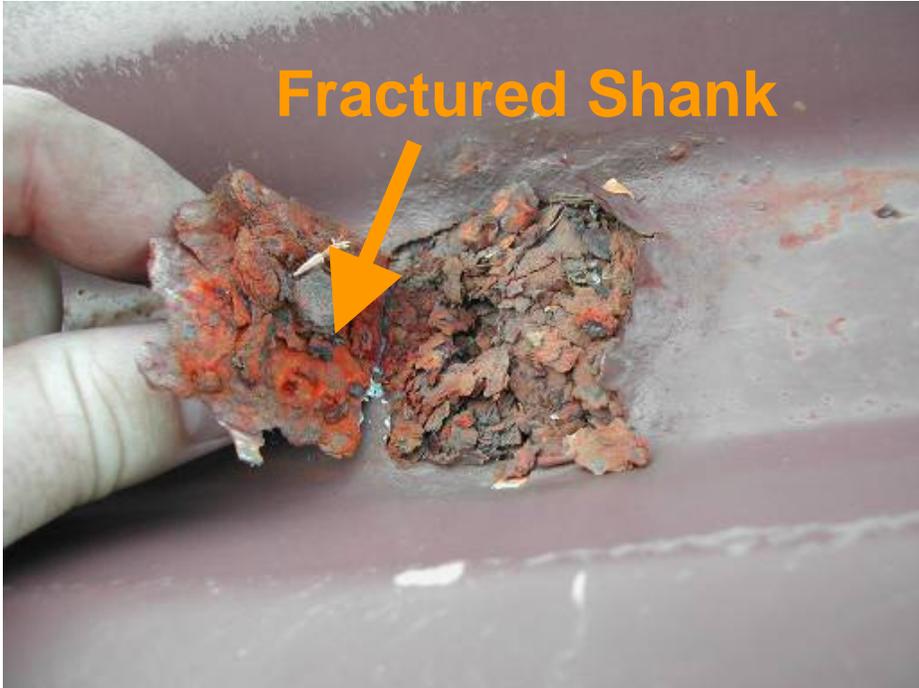
Figure S-56. Failure of the metal deck fastener due to corrosion

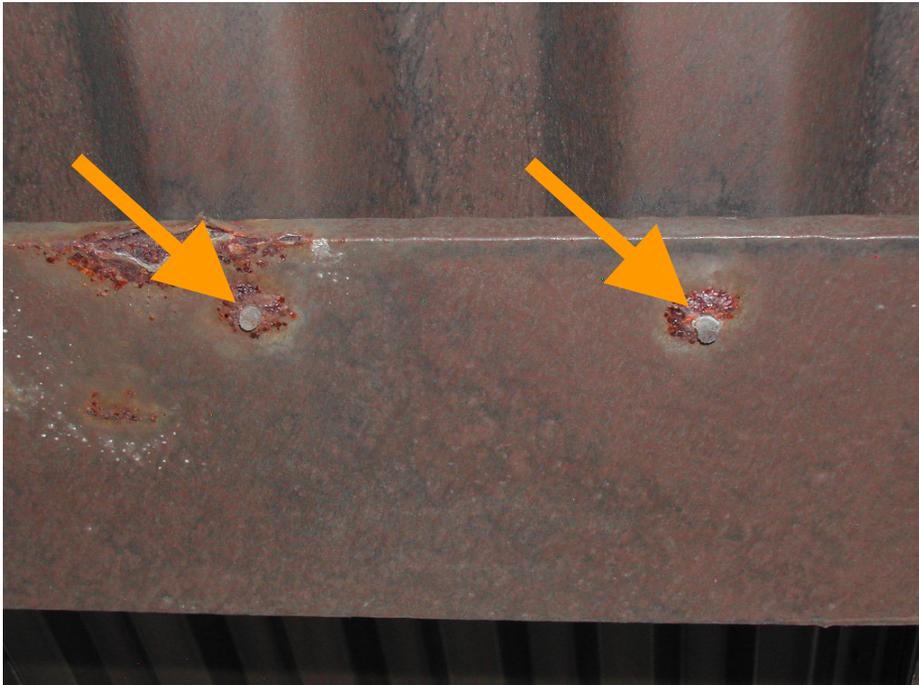
Figure S-57. Corrosion blossoms in the weathering steel member around the metal deck fastener

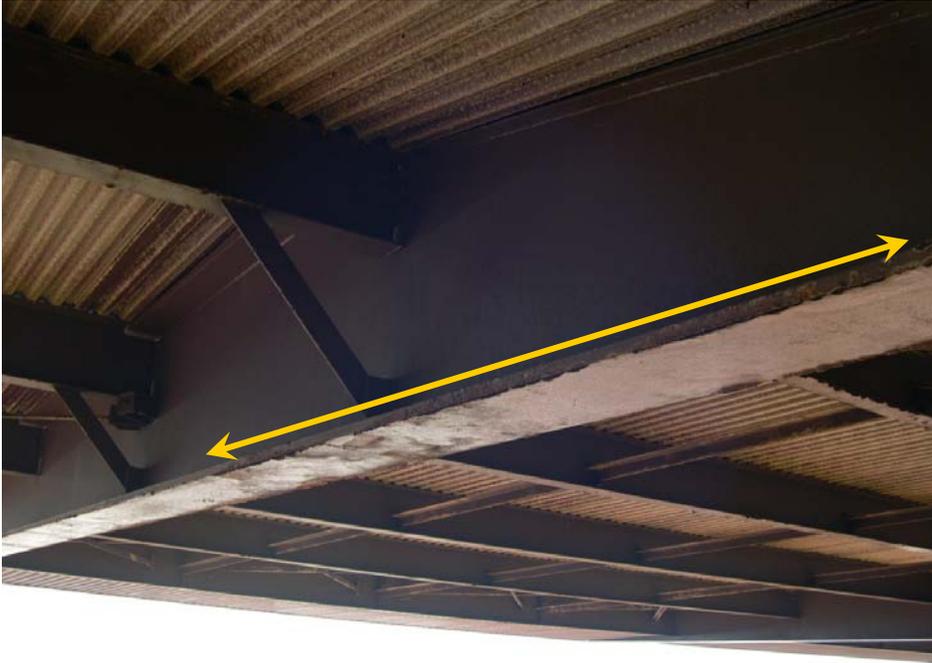
Figure S-58. Flange corrosion observed at the raker cantilever

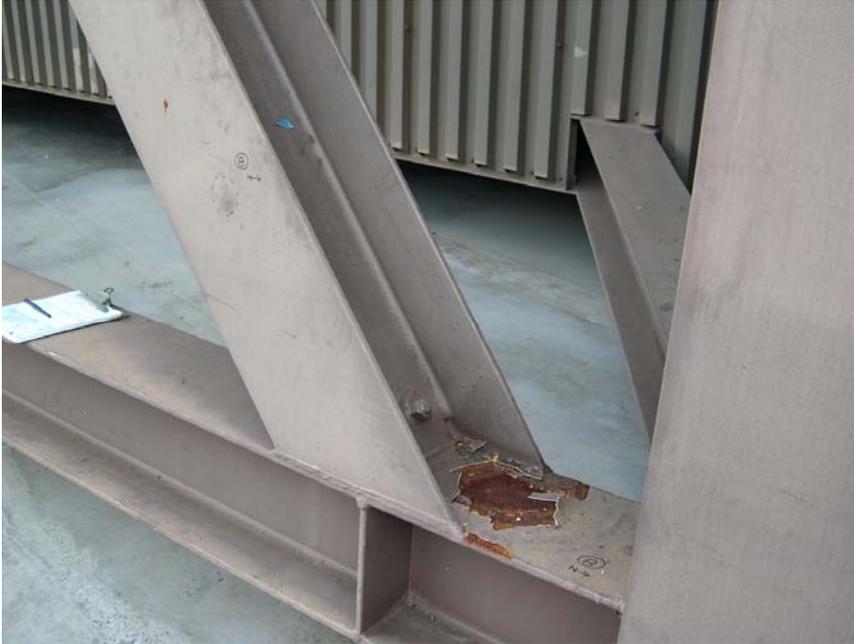
Figure S-61. Exterior bracing members exhibiting a chalked coating surface and peeling of the coating system

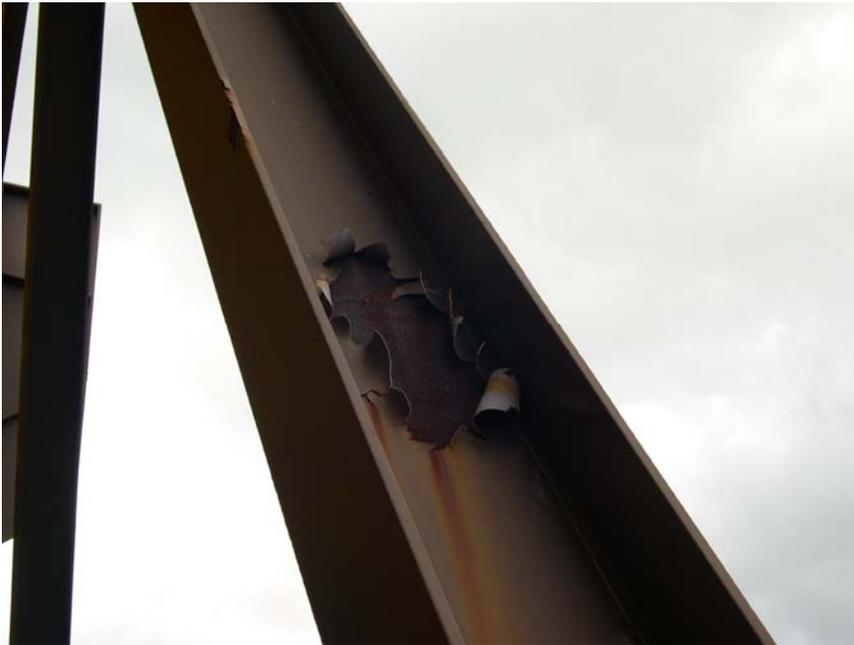
Figure S-62. Area of coating failure on an exterior bracing member

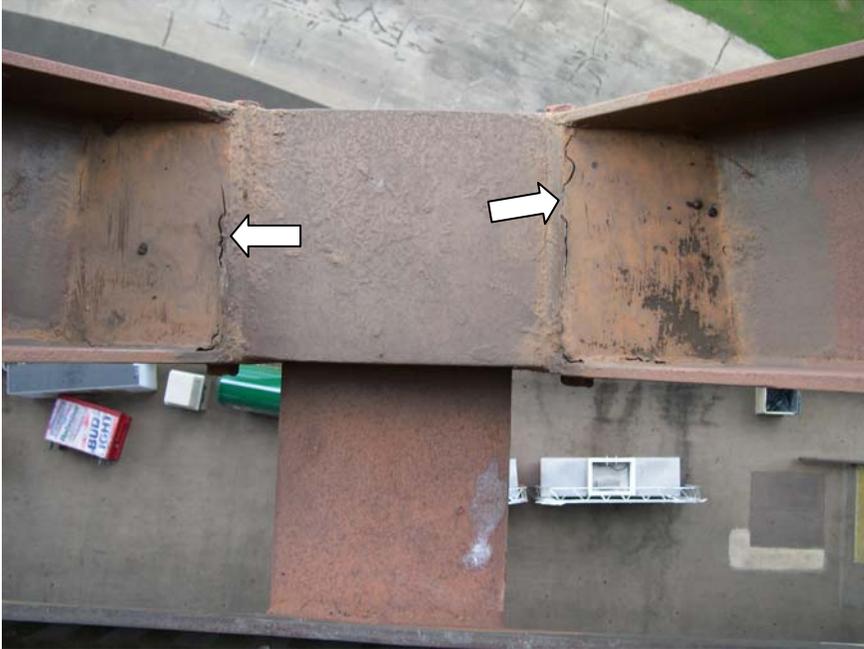
Figure S-63. Breaches (cracks at arrows) in the top coating over the epoxy filler at the hub box

- An alternate coating system on the horizontal surface of the hub should be investigated. A three-coat paint system with a urethane top-coat is not well suited for a horizontal application where water can stand. A urethane waterproofing membrane (40 to 50 mil thickness), a hot-applied roofing membrane, or sheet metal flashing are possible alternates that could provide a covering that is more durable than the present system. Because of the aggressive environment present at the Stadium, it is recommended that a trial repair be installed and its performance monitored.

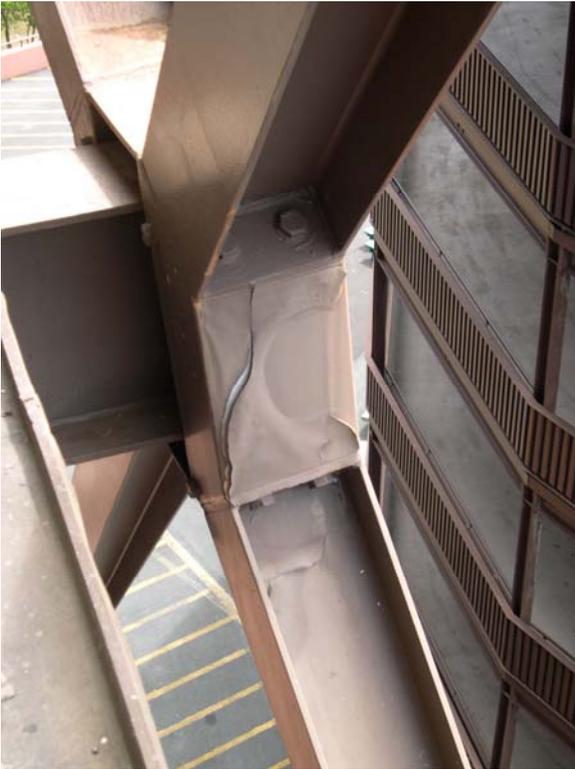
Figure S-64. Coating failure at the hub box

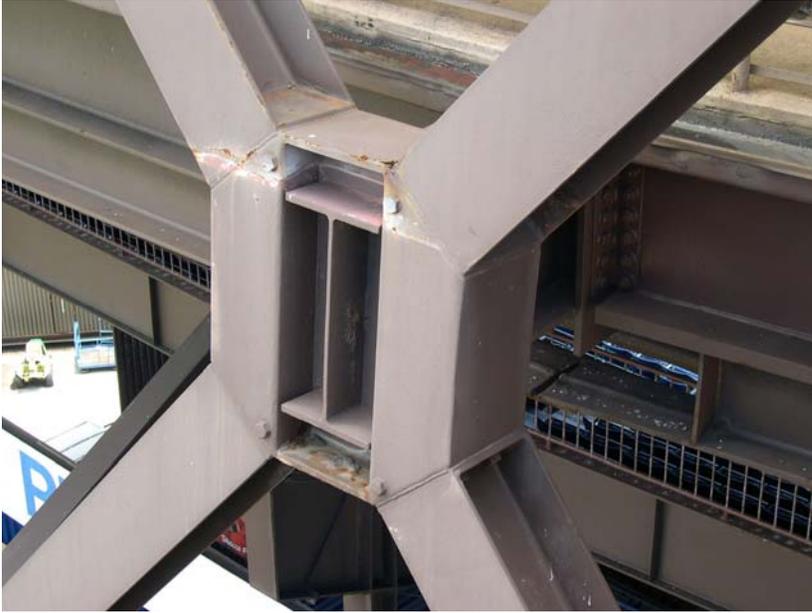
Figure S-65. Steel corrosion observed at the hub box

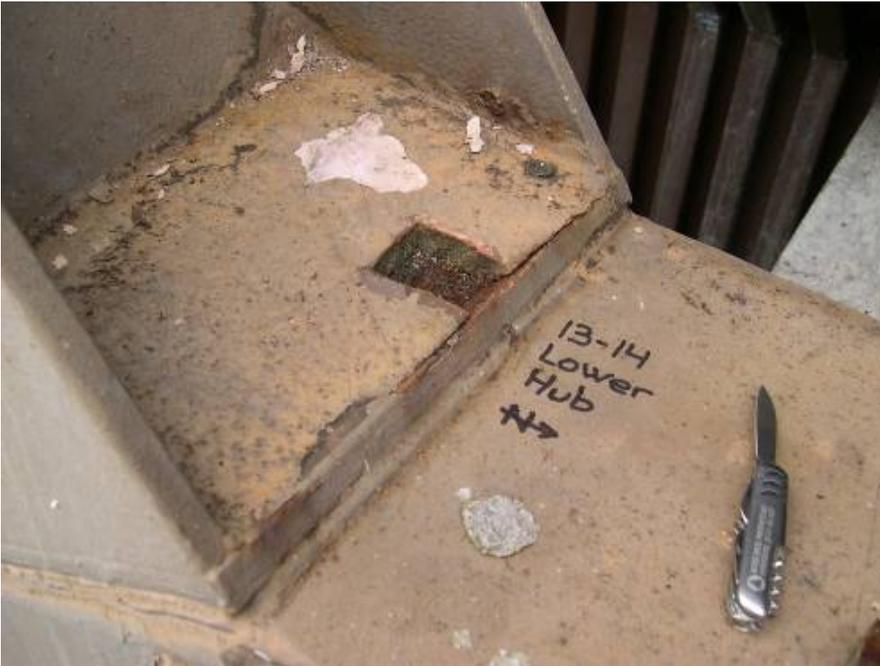
Figure S-66. Exploratory opening in the filler material atop the hub box

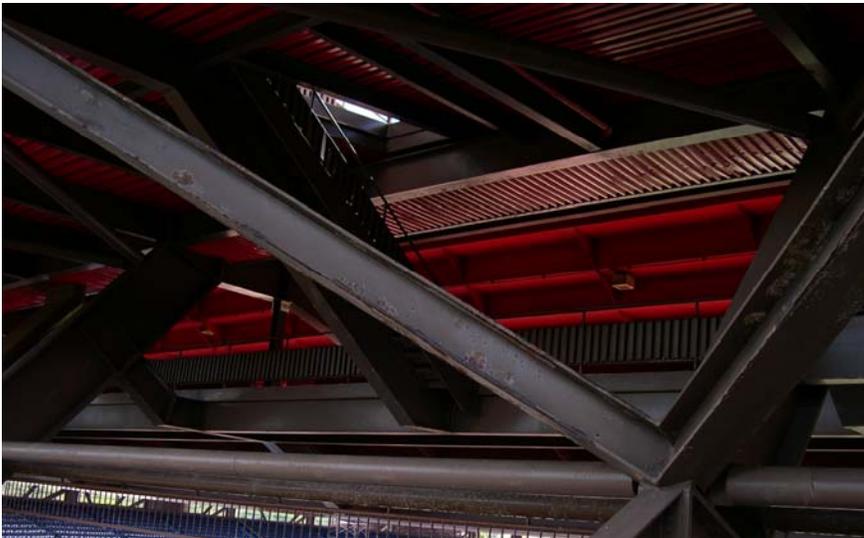
Corrosion of the original bracing members at the raker elbows was commonly occurring at the flange tips along the entire length of the member. This type of corrosion is shown in Figure S-69. The corners of the flange edges on these members appear “sharper” than those of flange edges on other wide-flange beams throughout the Stadium. The sharp corners likely have resulted in shrinkage of the coating system at the flange edge as the coating was initially applied. The likely thinner protective coating at the flange edge corners may have caused the widespread paint failures, resulting in the corrosion observed at the edge corners of these members. In some cases, the surface corrosion extended onto the width of the flange and into the web of the member.

Figure S-69. Widespread corrosion and paint failure of the original bracing members

- In general, sandblasting and painting (P3) repairs are required on all interior bracing members. This includes the original wide-flange bracing members, the diagonal pipe braces beneath the upper concourse, and the horizontal pipe braces at the raker elbow.
- Further investigation should be performed to verify that there is no entrapped moisture within the diagonal pipe braces at the upper concourse.

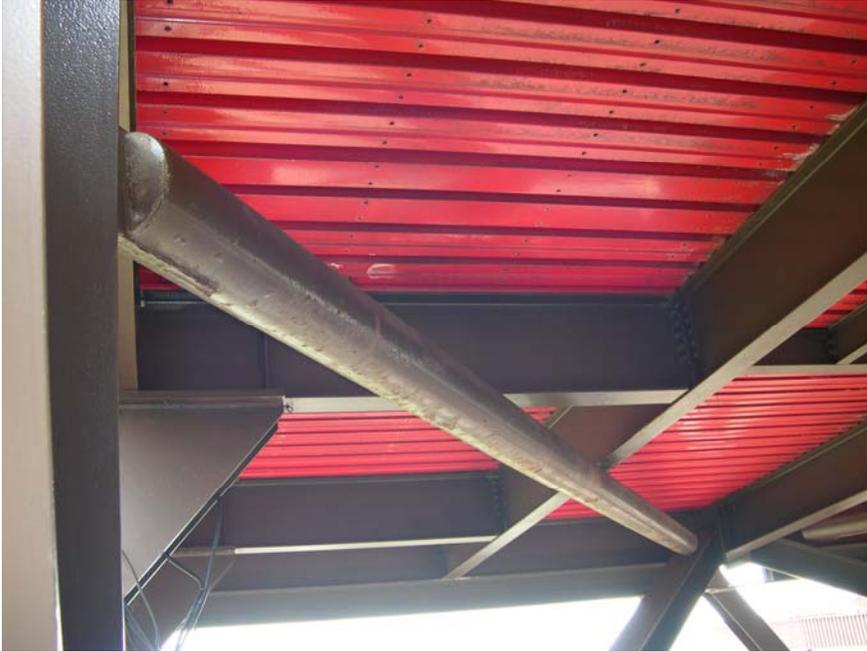
The coatings on the diagonal pipe braces beneath the upper concourse were not performing well. Coating blisters and spotty areas of corrosion were typically observed along the length of these bracing members, as shown in Figure S-70. Also, the connection plates at each end of the member are exhibiting localized corrosion. It is possible that there is trapped moisture within these sealed pipe bracing members. Airborne moisture and humidity may have migrated into the pipe through weld breaches.

Figure S-70. Corrosion of diagonal pipe brace beneath upper concourse

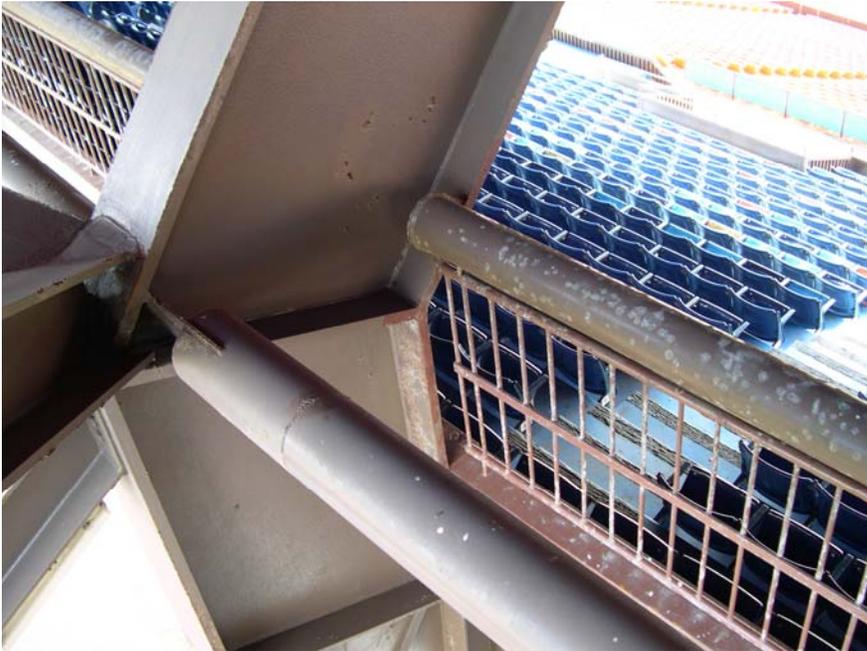
White deposits were typically observed throughout the horizontal pipe braces located at the raker elbows. The white deposits on these members, as shown in Figure S-71, indicate that the zinc protective coating on the galvanized pipe braces is being consumed in this aggressive environment. Corrosion of zinc protective coatings is discussed further in Section R.

Figure S-71. Corrosion of horizontal pipe bracing members that connect raker elbows

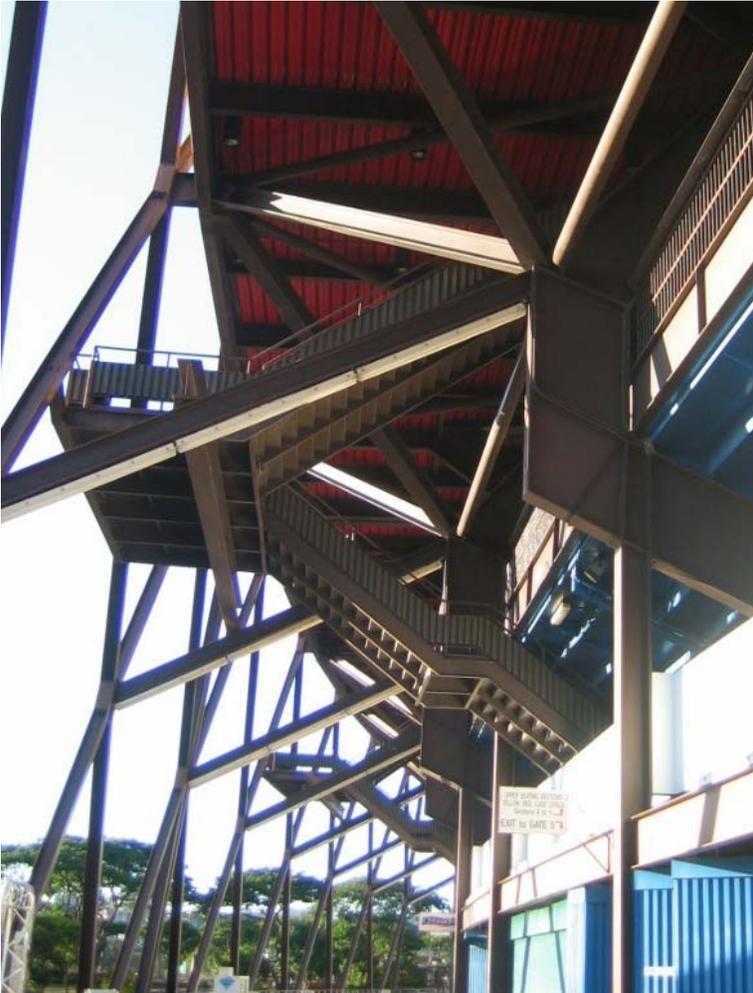
It appears that the stairwell framing members above the lower concourse are not shielded by other surrounding elements. Consequently, exposure to the aggressive wind environment (such as wind-driven moisture and airborne chlorides) seems to have resulted in widespread corrosion of the weathering steel framing members and the tread and riser plates. This corrosion is illustrated in Figure S-73. Below the lower concourse, the stairwell framing members are sheltered by the wall panels surrounding the lower field seating structure. Because of this sheltering, the stairwell framing below the lower concourse is performing better than the stairwell framing above the lower concourse. However, several areas of corrosion and pack rust were observed in the joint between the tread and riser plates, as shown in Figure S-74, often resulting in corrosion-related deformation of the riser plate.

Figure S-72. Typical stairwell framing above the lower concourse

- Perform global sandblasting and painting (P3) repairs to all structural elements of the stairwells above the lower concourse.
- The stairwell framing below the lower concourse should be powerwashed (P0 repair) to remove the chlorides from the surface of the coating. Powerwashing would also help to remove any build up of dirt and debris on the surface of the members.
- Localized paint repairs (P2) are required at the framing members below the lower concourse exhibiting paint coating failures and ongoing corrosion. In members with larger areas of corrosion, sandblasting and painting repairs (P3) are recommended.
- Tread/riser replacement repairs are recommended in areas where corrosion and pack rust has resulted in deformation of the tread/riser plate.

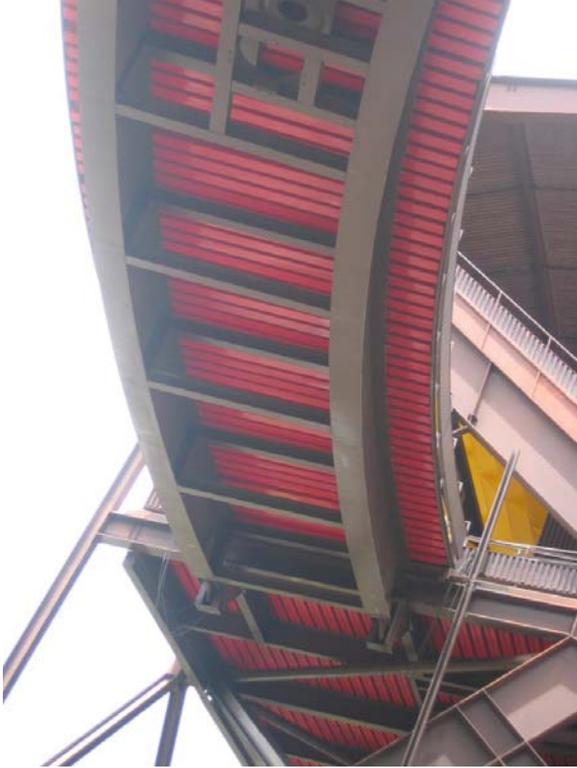
Localized paint failures and corrosion was observed at the steel framing members of the moveable bridges. These areas of deterioration were concentrated at the bottom flange tips of the framing members.

Figure S-76. Close-up view of the bridge structural framing

- The paint top coat should be re-applied (P1 repair) to all weathering steel framing members, in addition to localized repairs to areas exhibiting paint coating failures or corrosion (P2 repair).
- The installation of a drainage system within the decks of the moveable bridges should be considered.

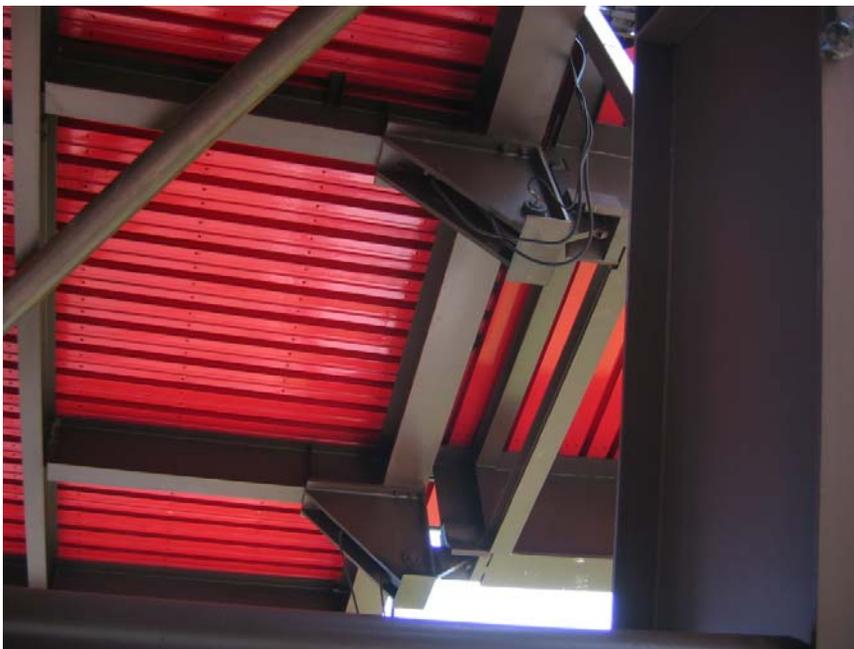
Figure S-77. General view of the hanger mechanism on one end of a demountable bridge

- Nondestructive testing of the hanger mechanism, particularly the prawl plate and pin components, is recommended to verify their structural integrity.

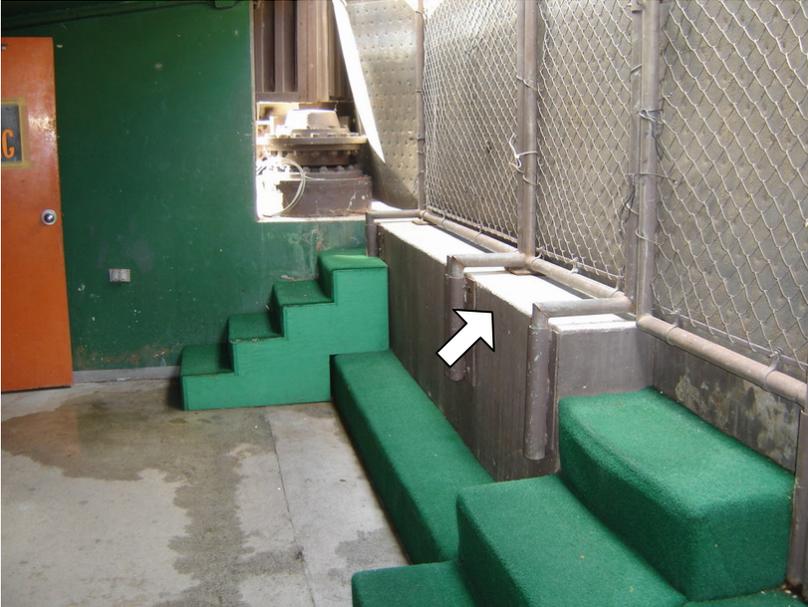
Figure S-85. Thickened wall section at southwest pivot point as indicated by arrow

- Sandblast and recoat corroded sections of the steel pivot assemblies and adjacent structural steel.
- Rout-and-seal cracks observed on the concrete pedestals and walls to prevent water from infiltrating to the level of the steel reinforcement and cause future spalling.
- Demolish the round concrete base section directly below the steel pivot assembly and reconstruct a larger base with additional steel reinforcing to prevent cracking of this section during moving of the stands.

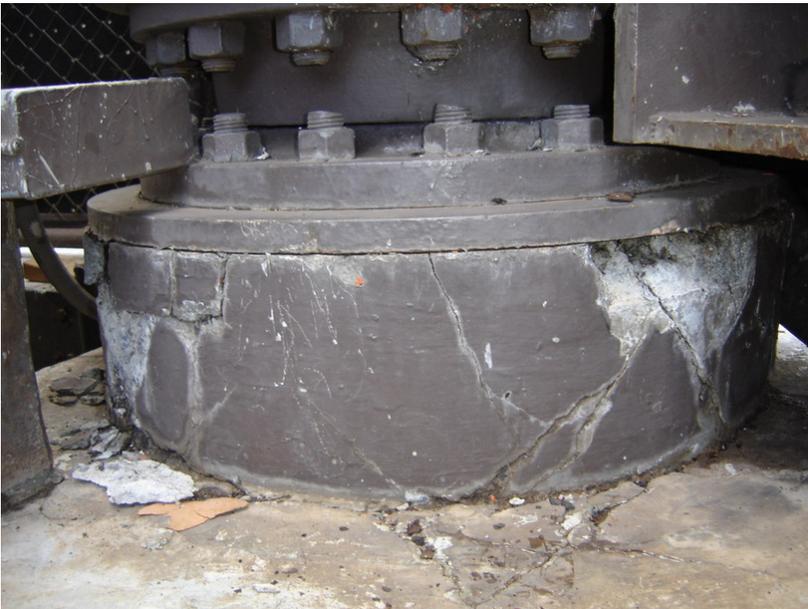
Figure 86. Cracking in base at southeast pivot point

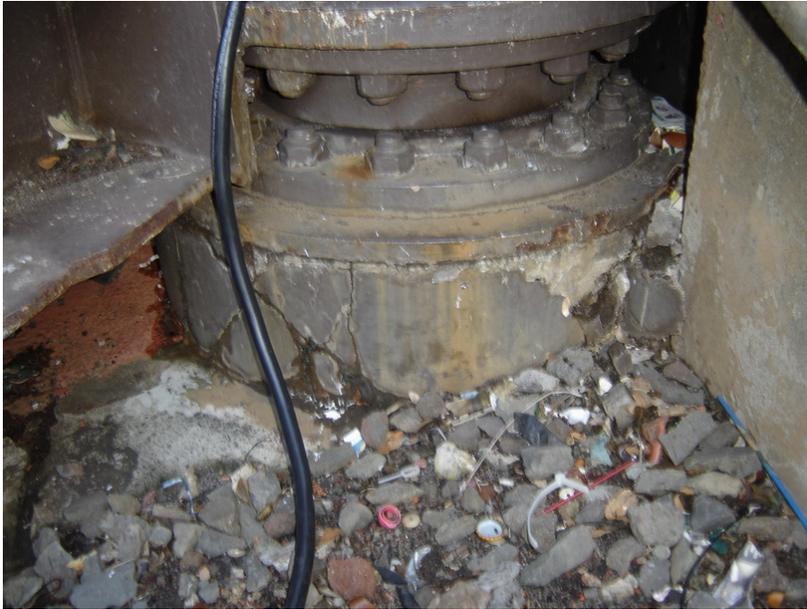
Figure 87. Cracking in base at northeast pivot

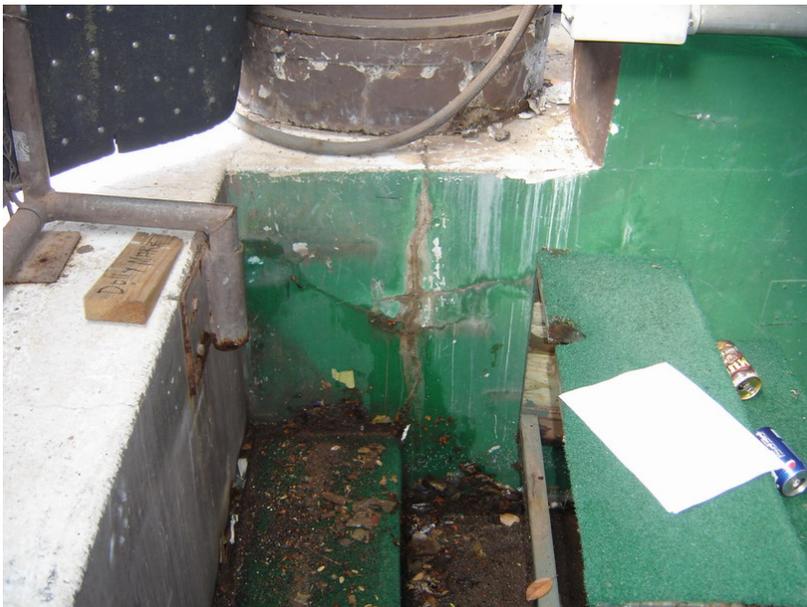
Figure 88. Cracking in pedestal and dugout wall at southeast pivot

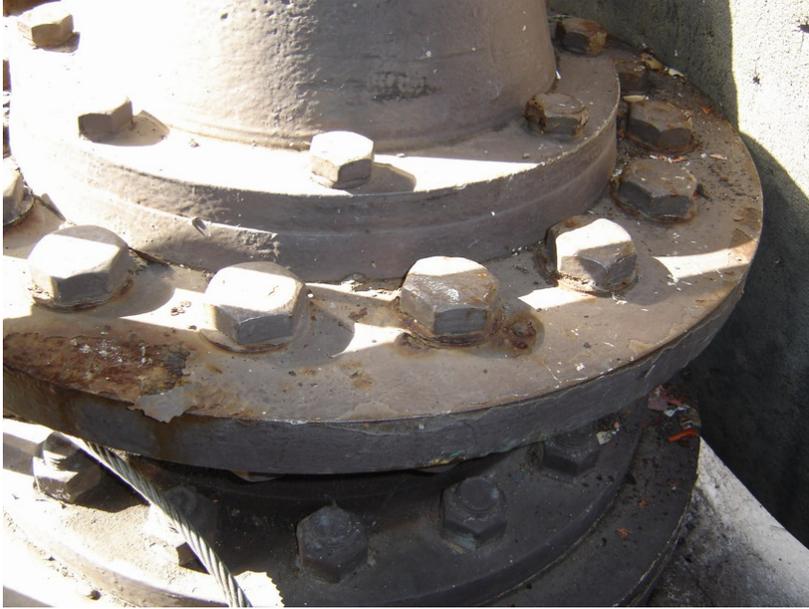
Figure 89. Typical spot corrosion of steel pivot assembly at southwest pivot
